Annual Inspection

Rusper Parish Council

High Street Playground

High Street, Rusper, West Sussex, RH12 4PX

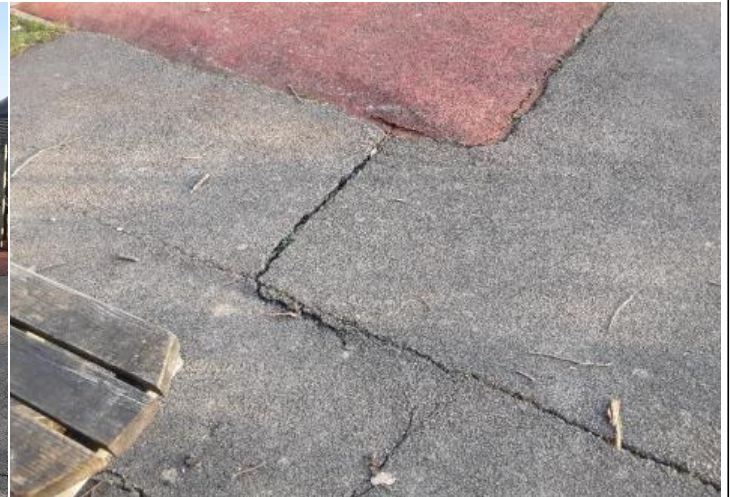
Finding: There is moderate damage to the surface

Action: Repair the damaged areas of surfacing

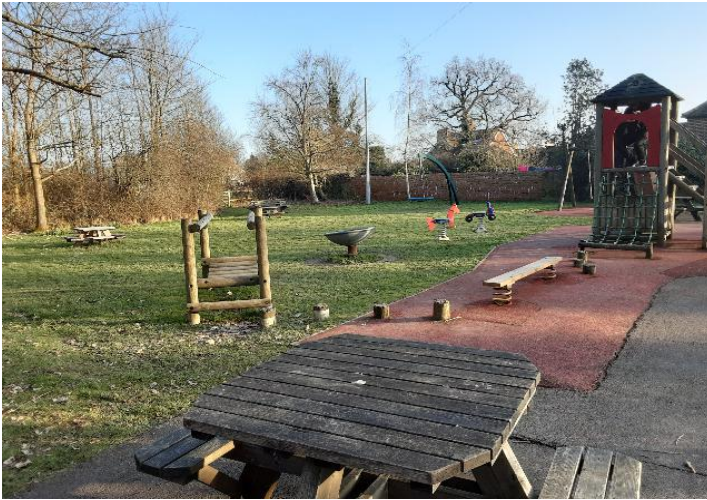
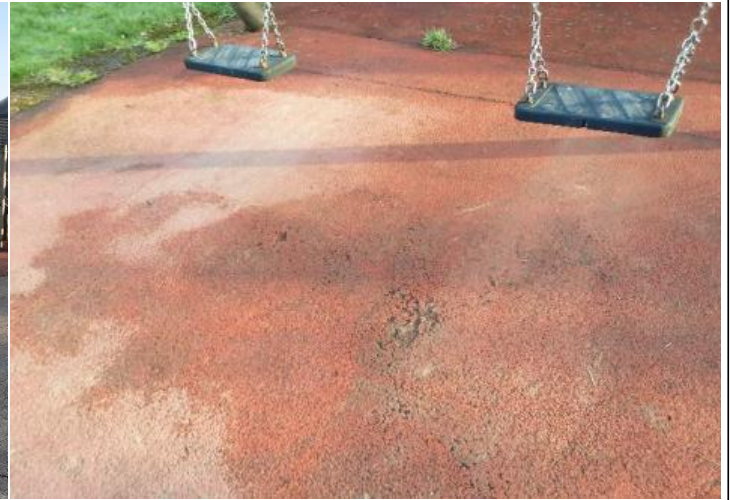
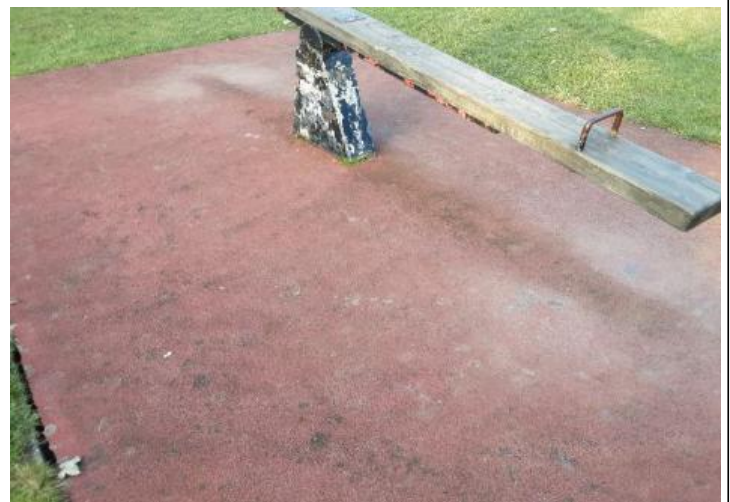
Finding: The safety surface around the area is beginning to wear

Action: Monitor for any further deterioration and repair as required

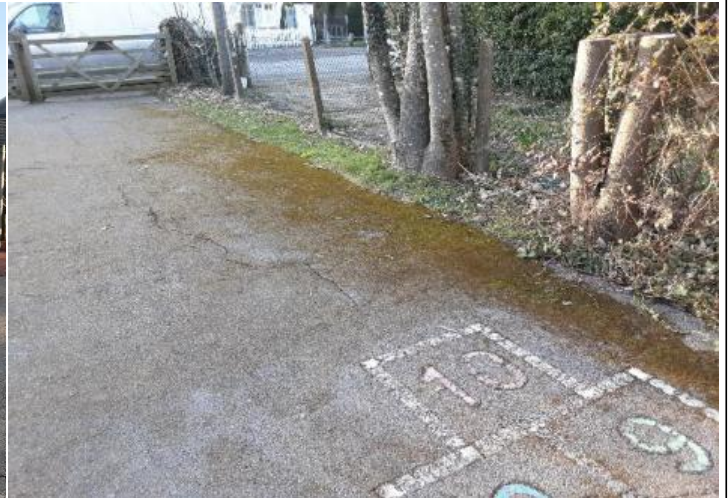
Finding: There is algae, silt or moss growth on the surface resulting in slippery conditions

Action: Clean and treat appropriately

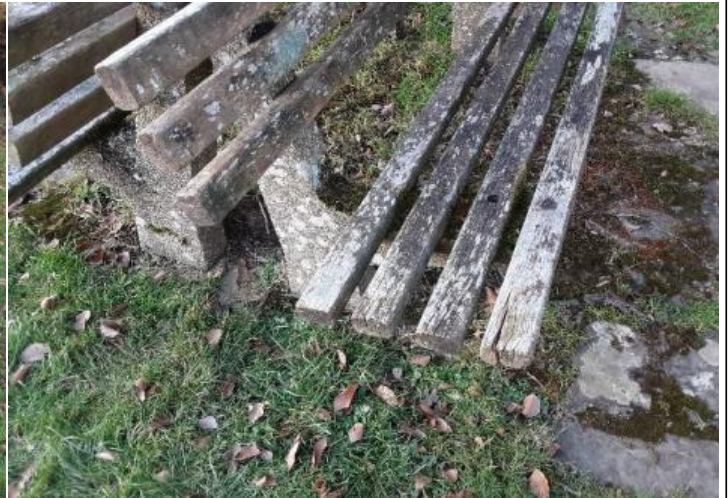
Finding: There is some evidence of rot in the timber

Action: Monitor for any further deterioration and replace as required

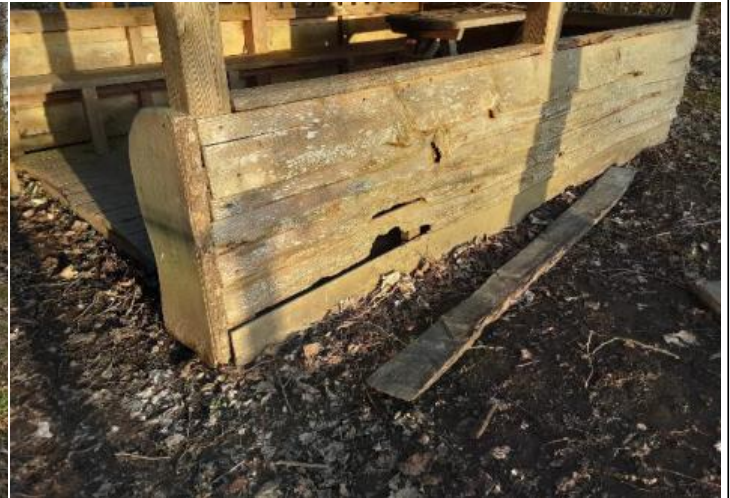
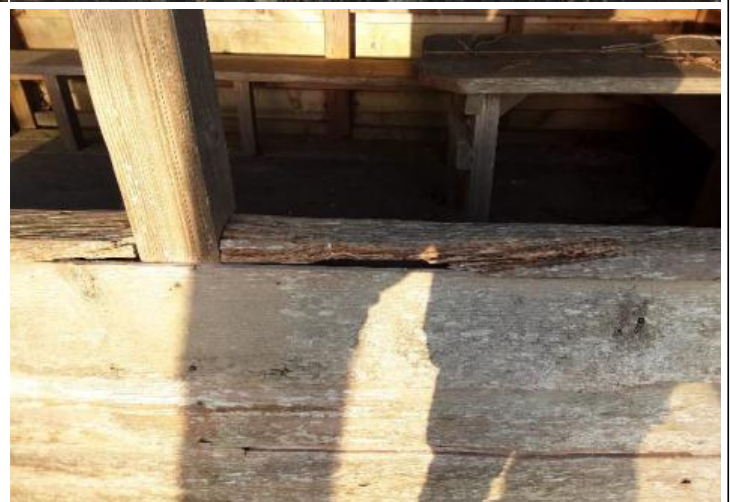
Finding: There are areas or parts of the timber on the structure that have rotted

Action: Replace all affected timbers

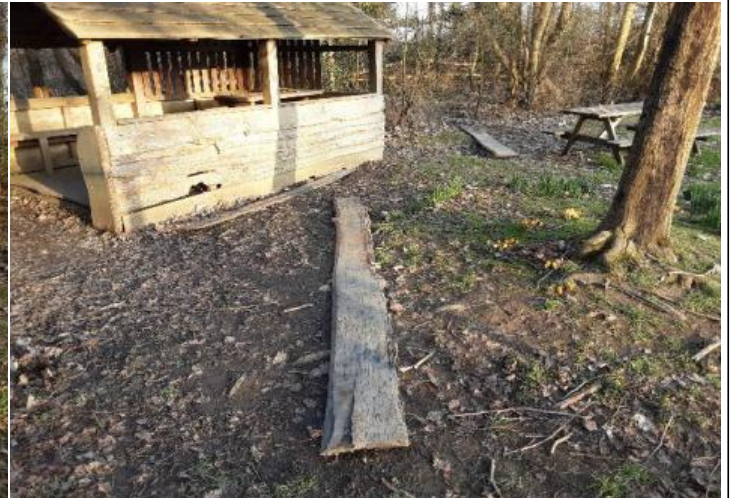
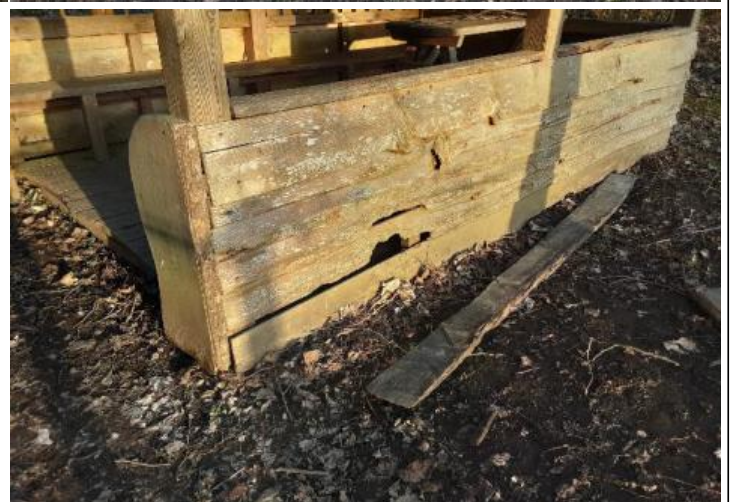
Finding: The item has been damaged and there are planks of wood scattered around the area
Action: Remove all loose timber and repair the item

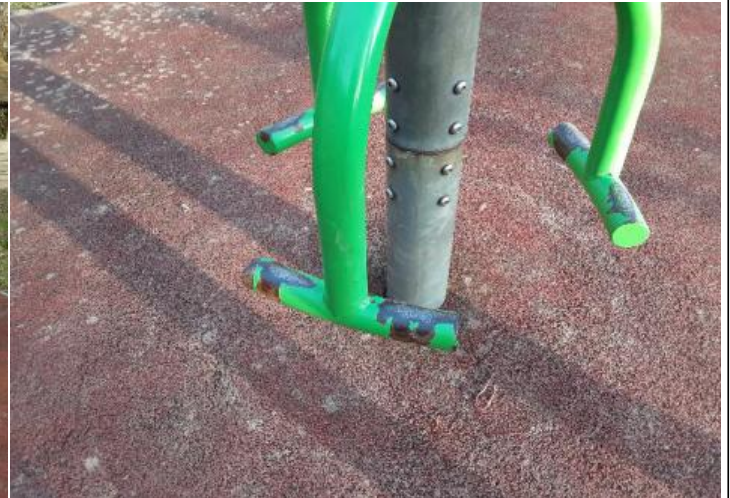
Finding: The paintwork on this item has been damaged or worn exposing the metal underneath which is rusting

Action: Treat any rusting components and repaint

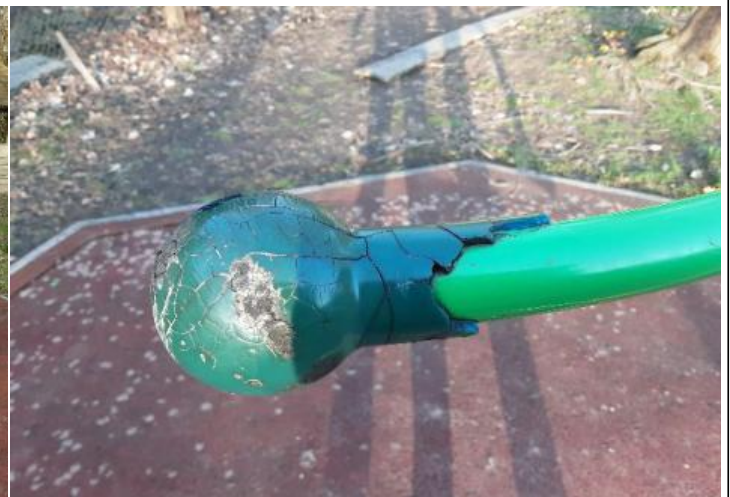
Finding: There is some damage to the handgrips

Action: Replace all affected components

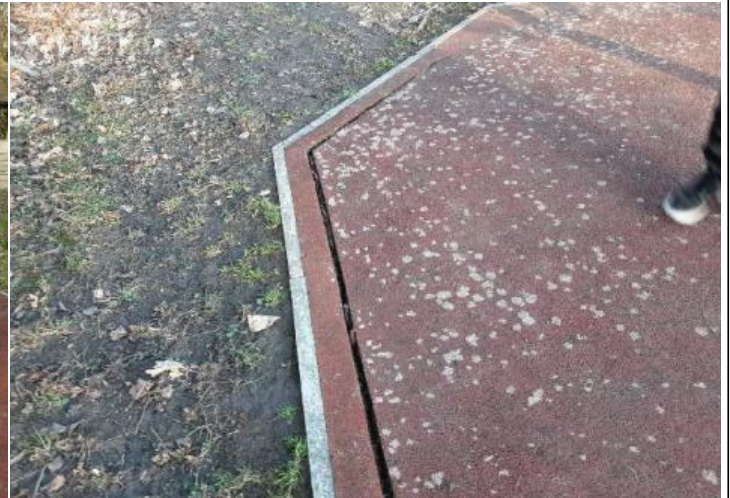
Finding: There are gaps opening between the surfacing and the edging surround or between the joints in the surfacing
Action: Monitor for any further deterioration and repair as required

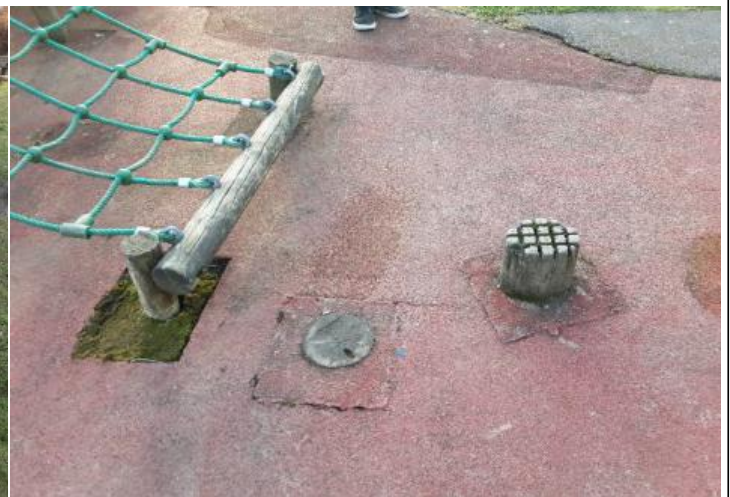
Finding: The adjacent log beam forms a hard object within the falling space of the equipment in contravention of the requirements of BS EN 1176 Part 1
Action: Monitor - No remedial work recommended

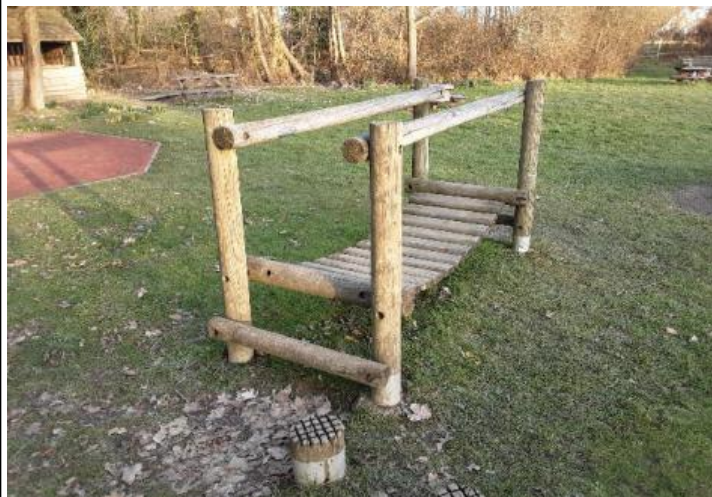
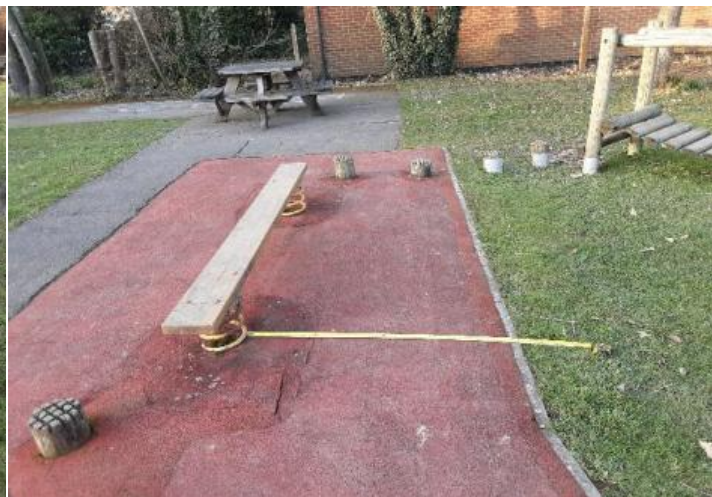
Finding: The surfacing dimensions are short and do not meet with the requirements of the current applicable standard

Action: Monitor - no remedial action recommended

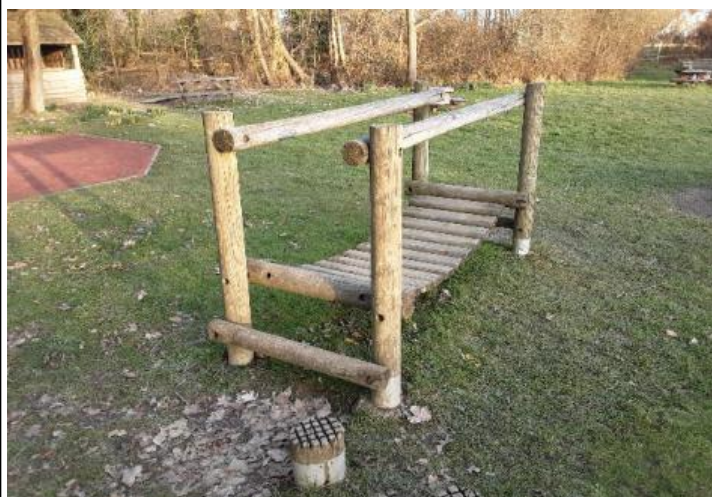
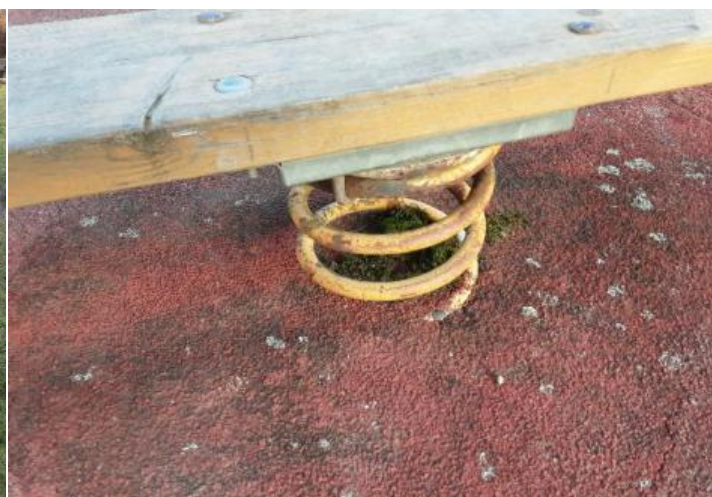
Finding: The paintwork on the spring has been damaged or worn exposing the metal underneath which is rusting

Action: Treat any rusting components and repaint

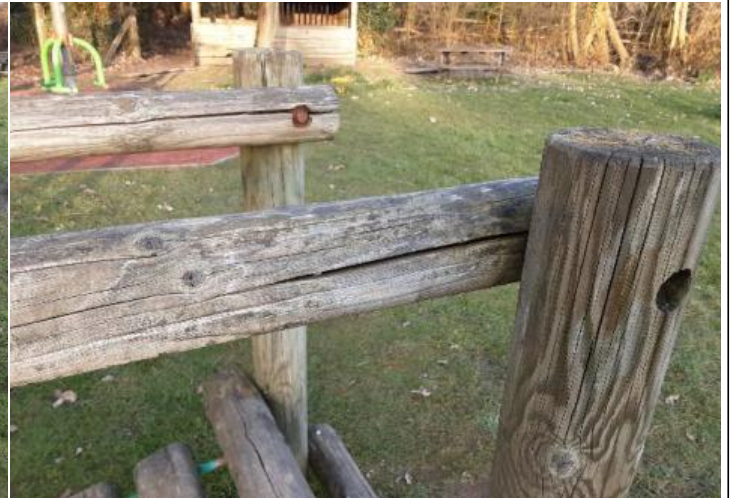
Finding: The timber has a number of splits/shakes or air cracks and this may affect the stability or allow water ingress which will accelerate the rotting process
Action: Monitor to ensure the splits do not cross through fixing points of the structure and/or cause any instability

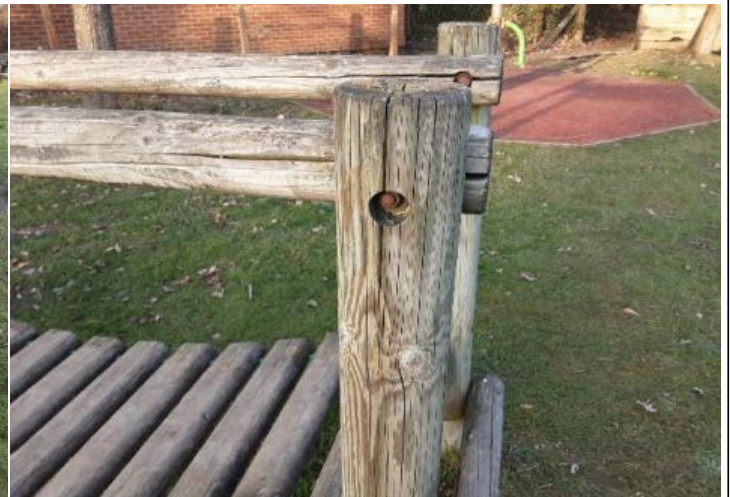
Finding: There is/are bolt cap covers missing or damaged on the item
Action: Replace missing or damaged bolt cap covers

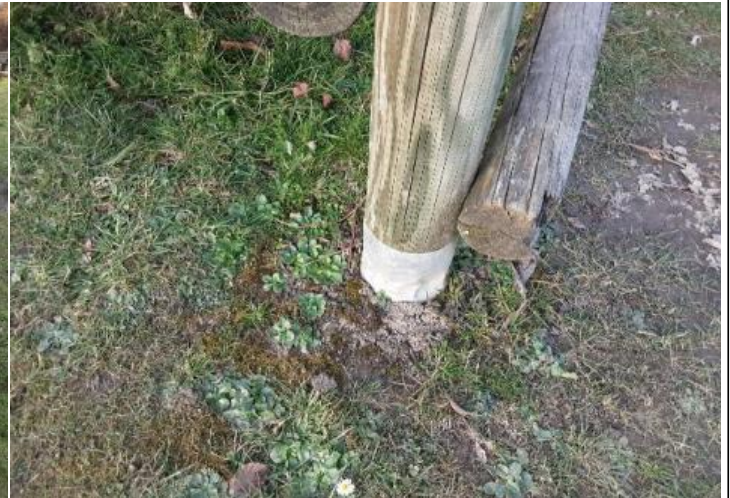
Finding: There is some evidence of rot in the timber

Action: Monitor for any further deterioration and replace as required

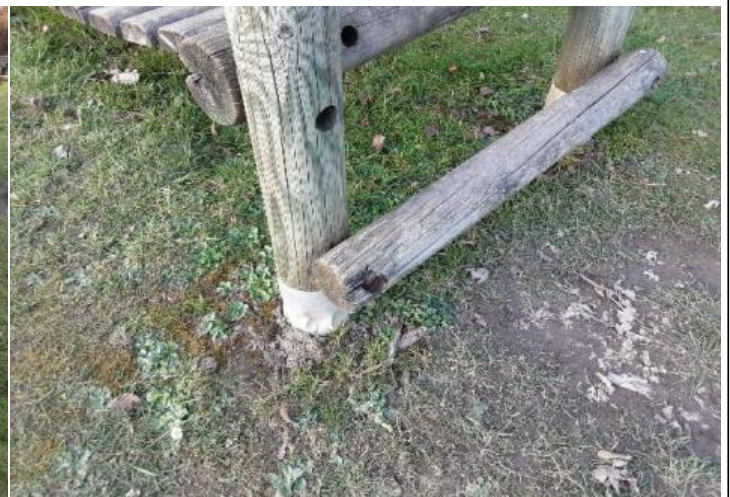
Finding: There is some damage to the timber

Action: Monitor for any further deterioration and repair as required

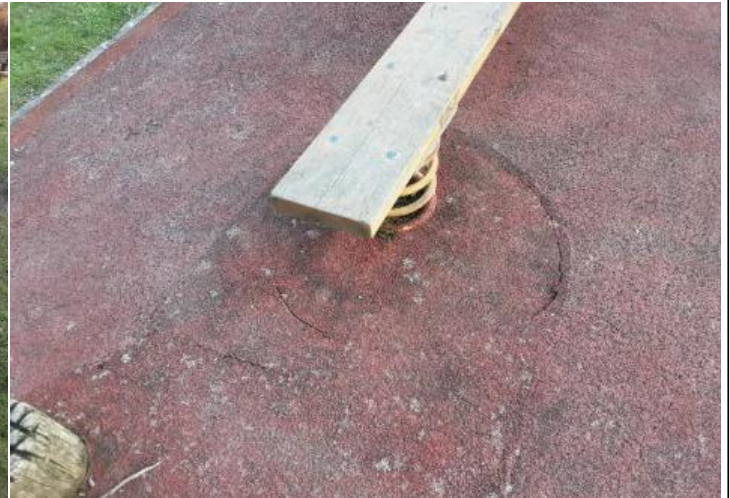
Finding: There is some minor damage to the surface

Action: Monitor for any further deterioration and repair as required

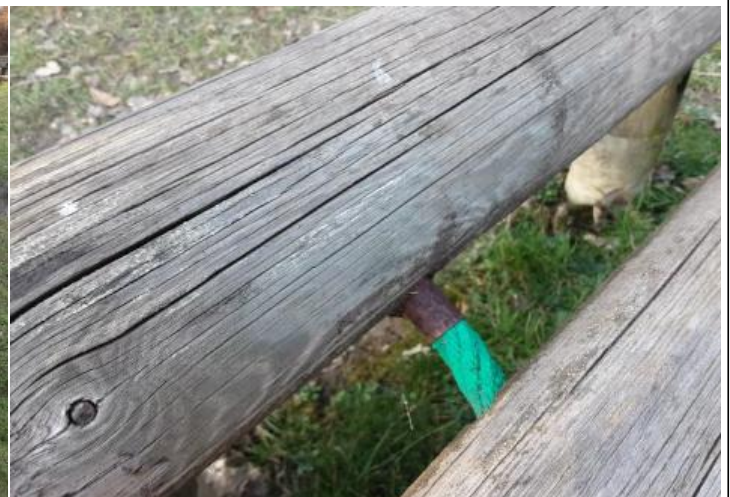
Finding: The rope connectors are showing signs of corrosion

Action: Monitor for any further deterioration and replace as required

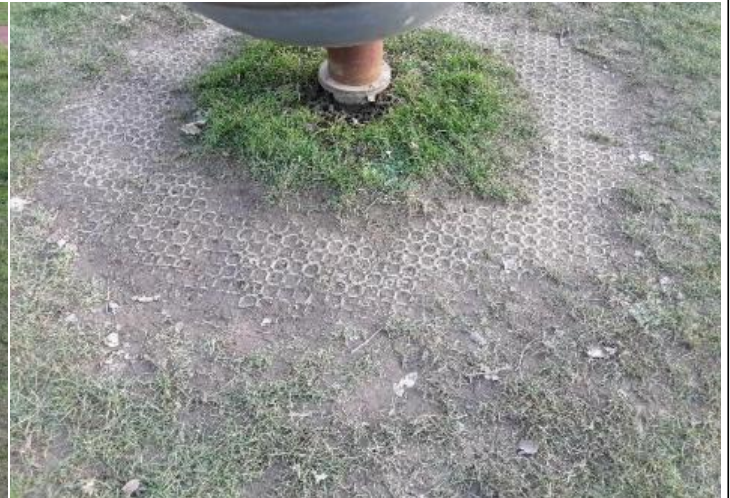
Finding: The grass mats are silted up and the soil is compacted; this may have an effect on the impact absorbing properties of the surface

Action: Consider HIC testing impact absorbing properties to ensure the correct surface qualities are maintained for the equipment and replace as required

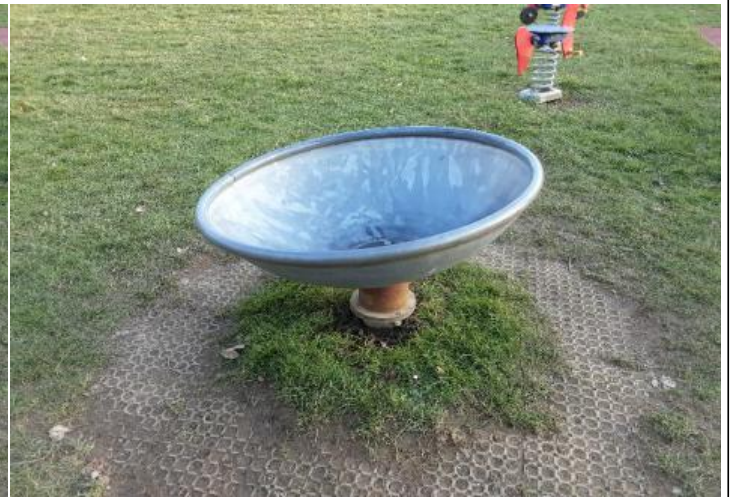
Finding: The paintwork on this item has been damaged or worn exposing the metal underneath which is rusting

Action: Treat any rusting components and repaint

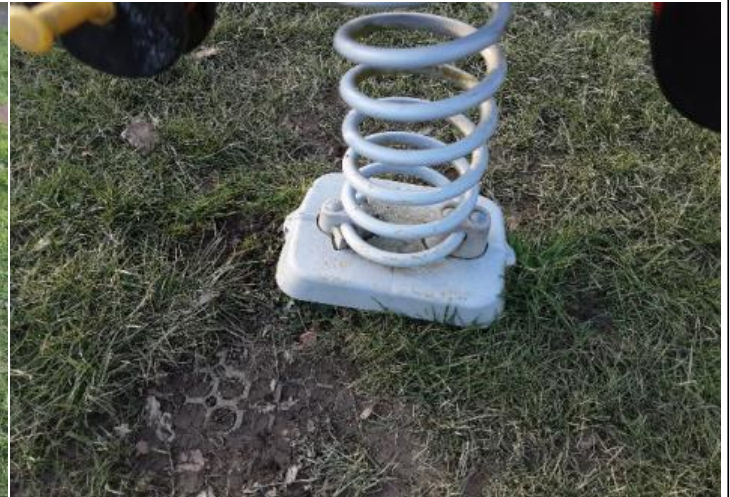
Finding: The spring clamps are loose

Action: Tighten all loose fixings

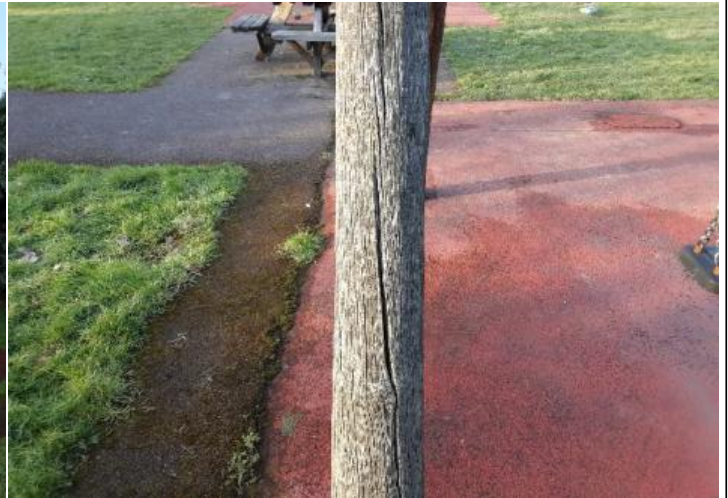
Finding: The timber has a number of splits/shakes or air cracks and this may affect the stability or allow water ingress which will accelerate the rotting process

Action: Monitor to ensure the splits do not cross through fixing points of the structure and/or cause any instability

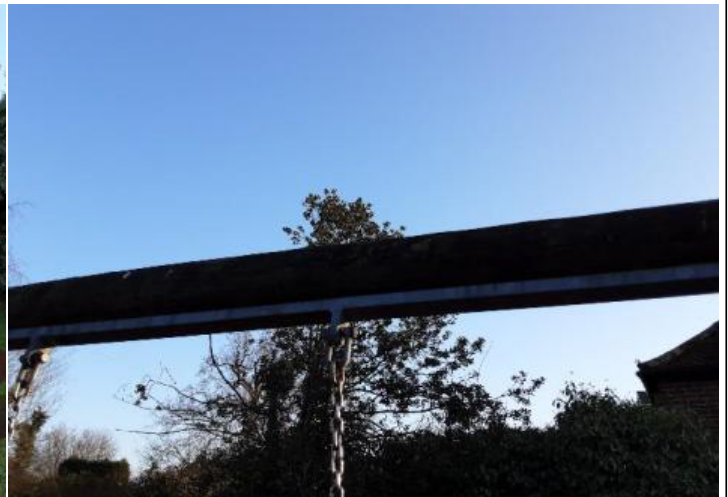
Finding: The bushes are showing signs of wear

Action: Monitor for any further deterioration and replace as required

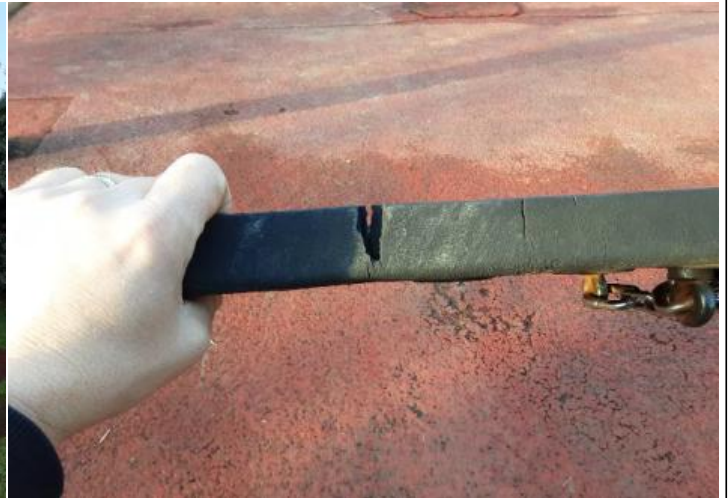
Finding: The seat has minor damage or wear

Action: Monitor for any further deterioration and replace as required

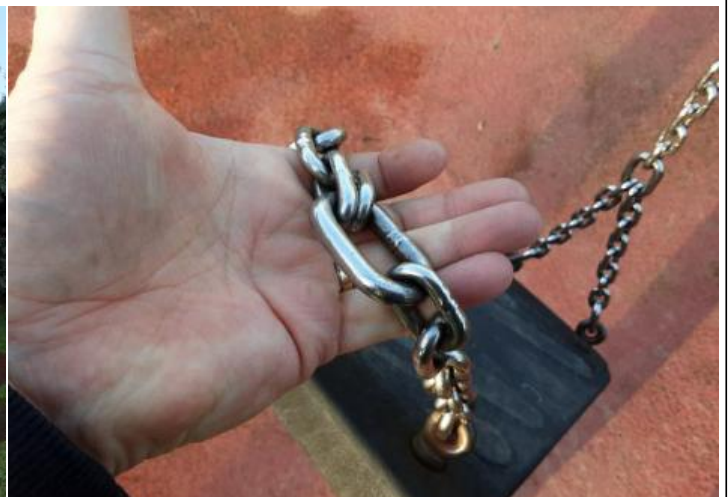
Finding: There is some notable evidence of chain wear

Action: Monitor for any further deterioration and replace when 40% worn

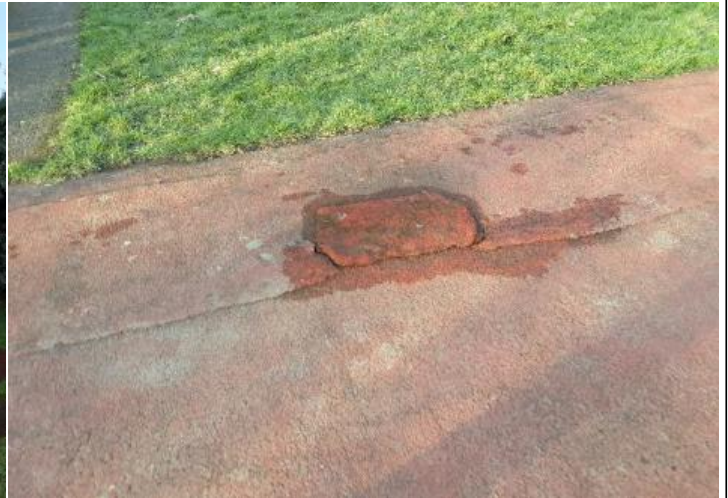
Finding: There is moderate damage to the surface

Action: Repair the damaged areas of surfacing

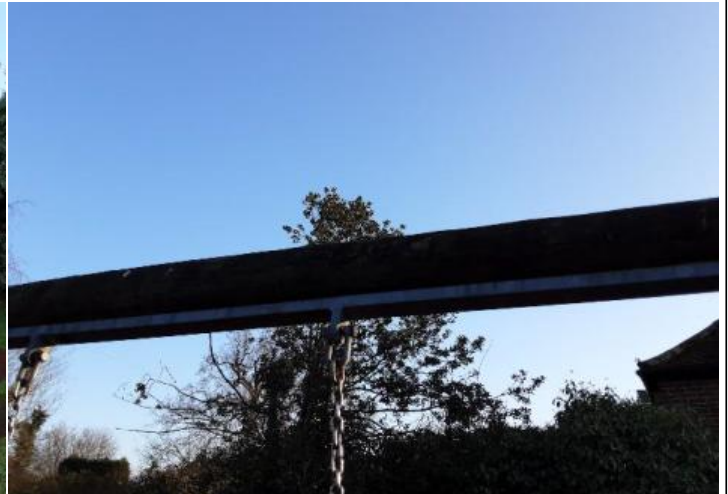
Finding: There is some evidence of rot in the timber

Action: Monitor for any further deterioration and replace as required

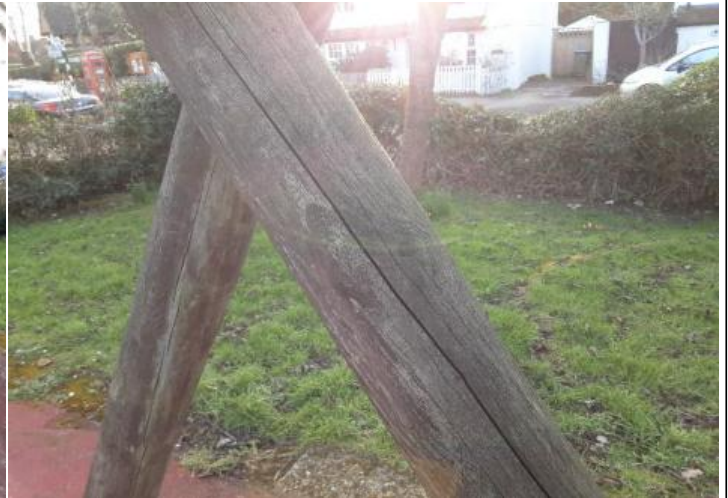
Finding: The timber has a number of splits/shakes or air cracks and this may affect the stability or allow water ingress which will accelerate the rotting process
Action: Monitor to ensure the splits do not cross through fixing points of the structure and/or cause any instability

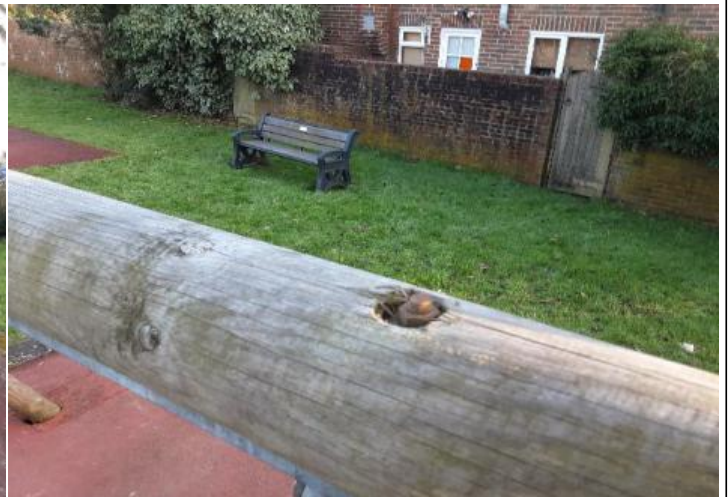
Finding: There is/are bolt cap covers missing or damaged on the item
Action: Replace missing or damaged bolt cap covers

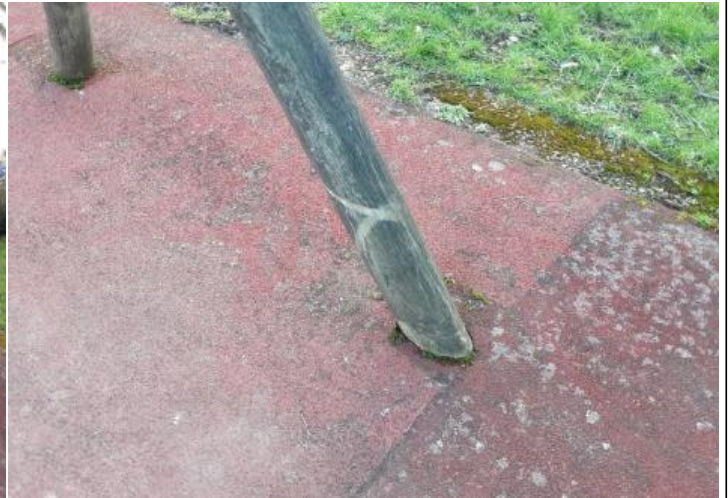
Finding: There is some evidence of rot in the timber

Action: Monitor for any further deterioration and replace as required

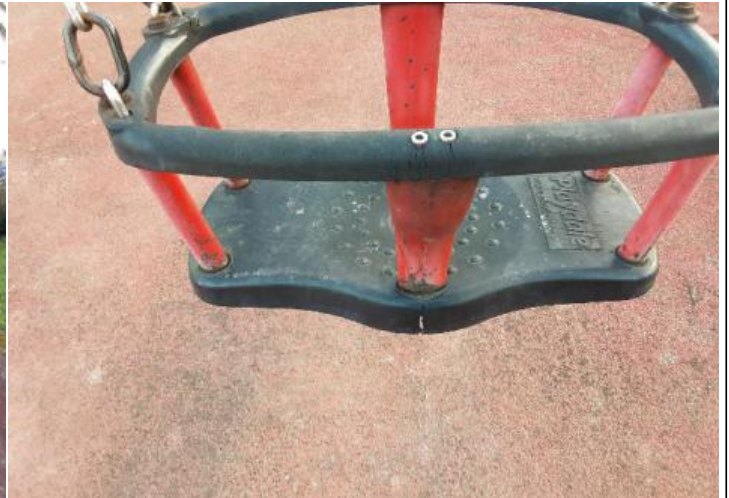
Finding: The seat has minor damage or wear

Action: Monitor for any further deterioration and replace as required

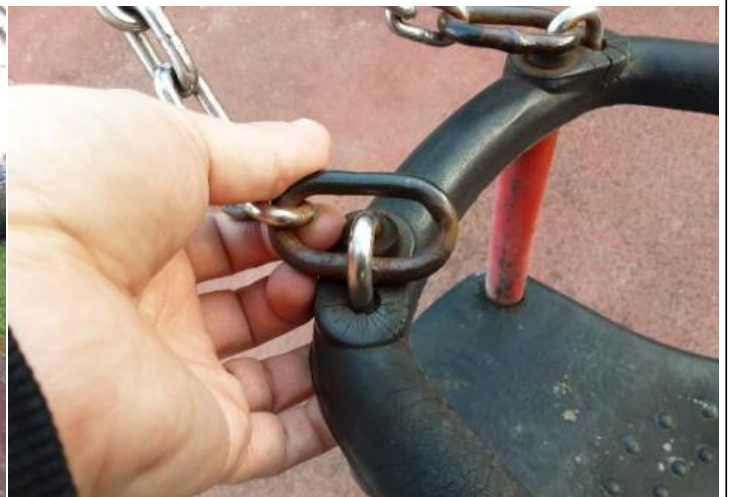
Finding: There is some notable evidence of chain wear

Action: Monitor for any further deterioration and replace when 40% worn

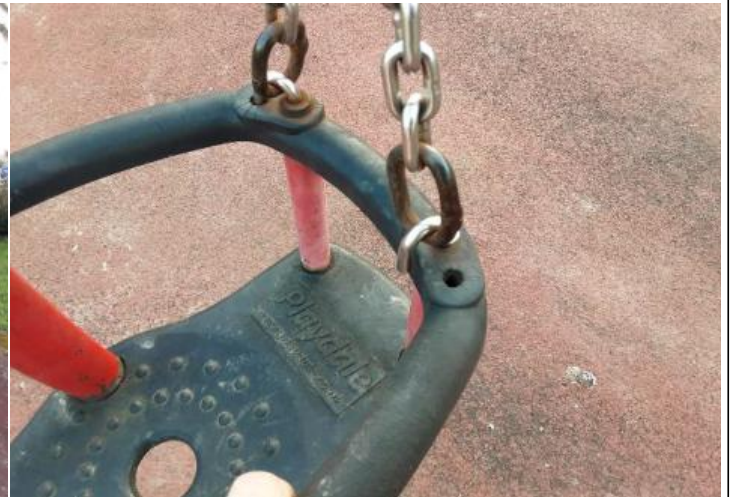
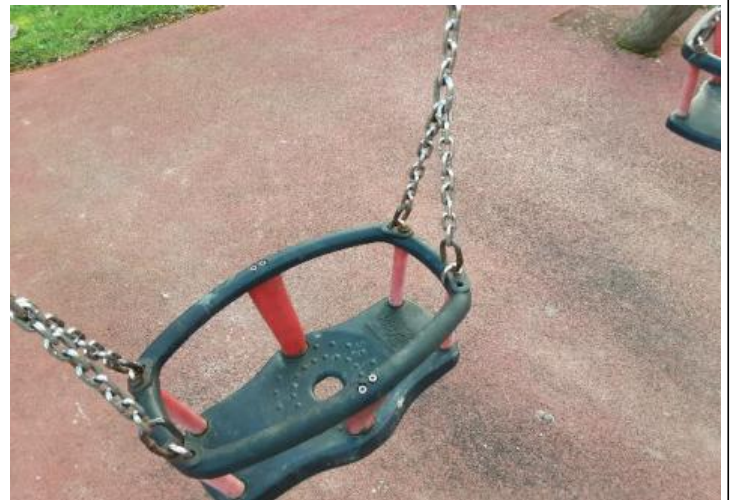
Finding: One of the seat connectors is loose

Action: Secure all loose connections

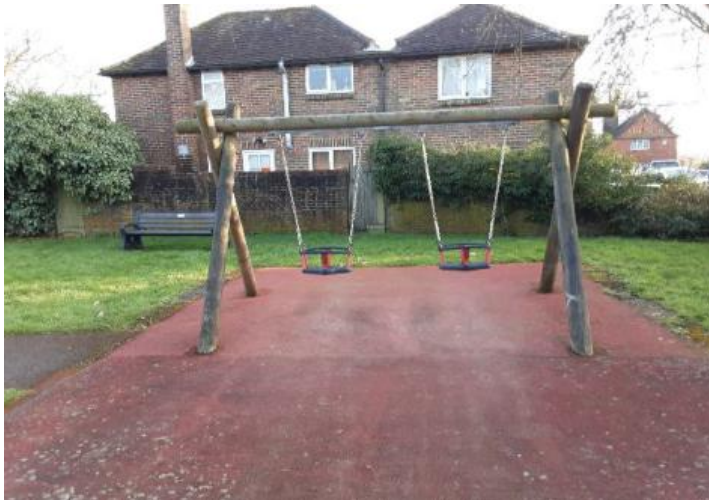
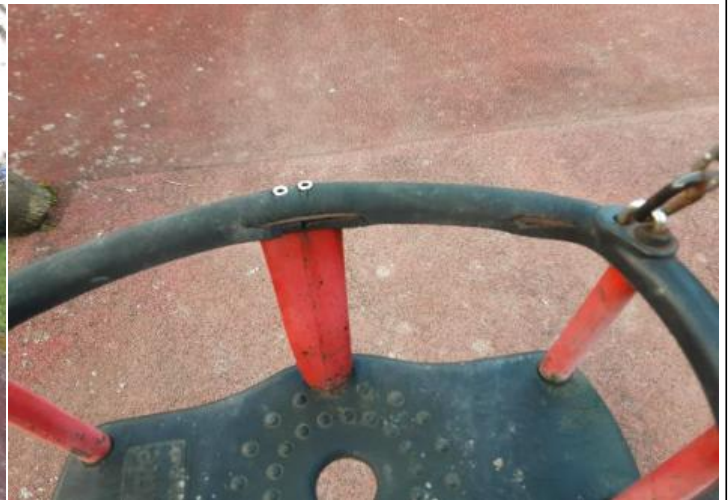
Finding: The swing seat frames are corroding

Action: Monitor for any further deterioration and replace as required

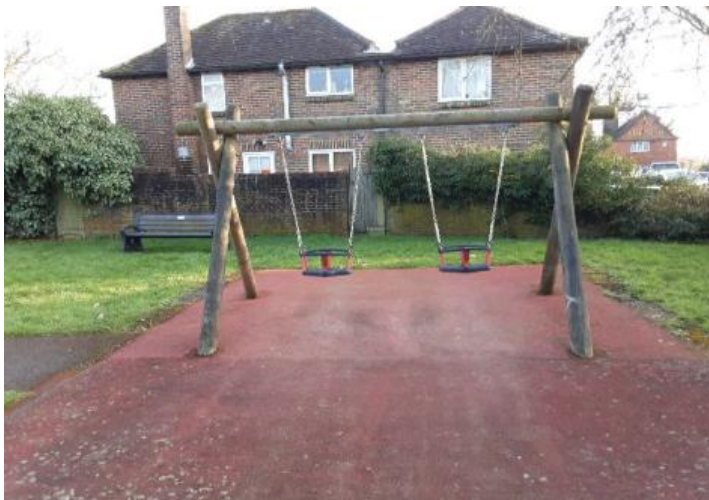
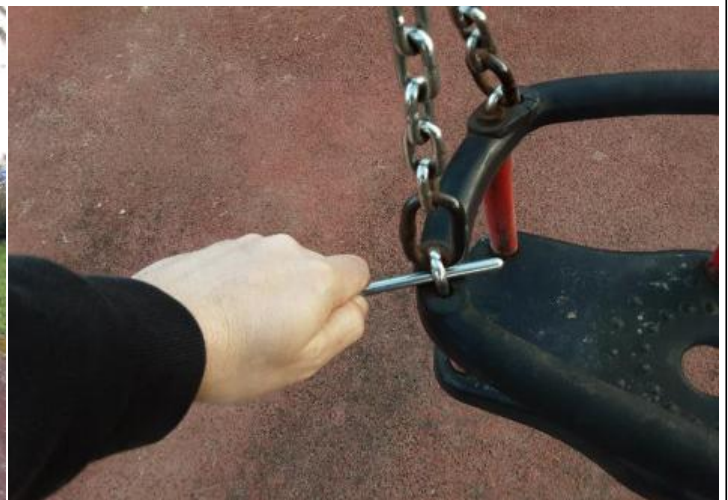
Finding: The connecting links are in excess of 8.6mm and less than 12mm and fail the requirements of BS EN 1176 Part 1; clause 4.2.13, Chains

Action: Monitor - No remedial work recommended

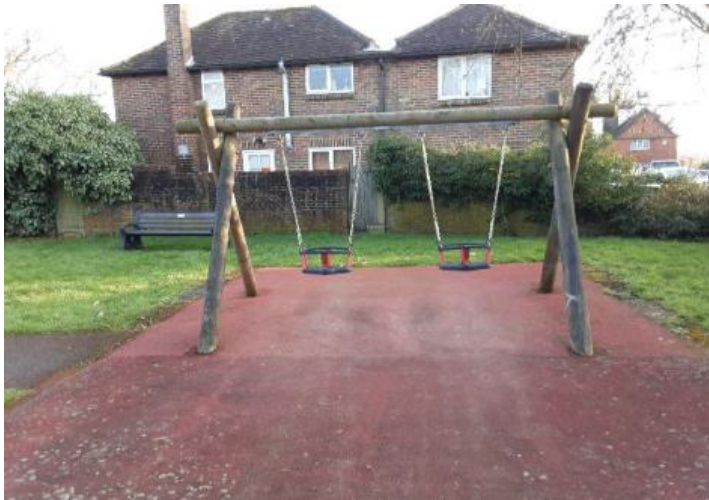
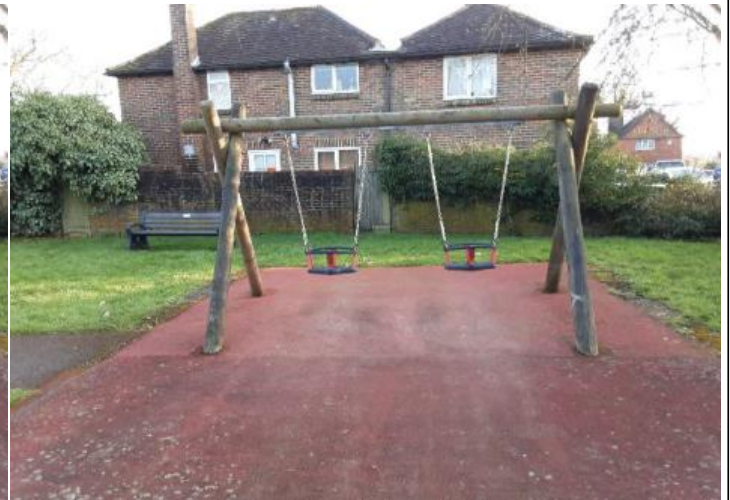
Finding: The bushes are showing signs of wear

Action: Monitor for any further deterioration and replace as required

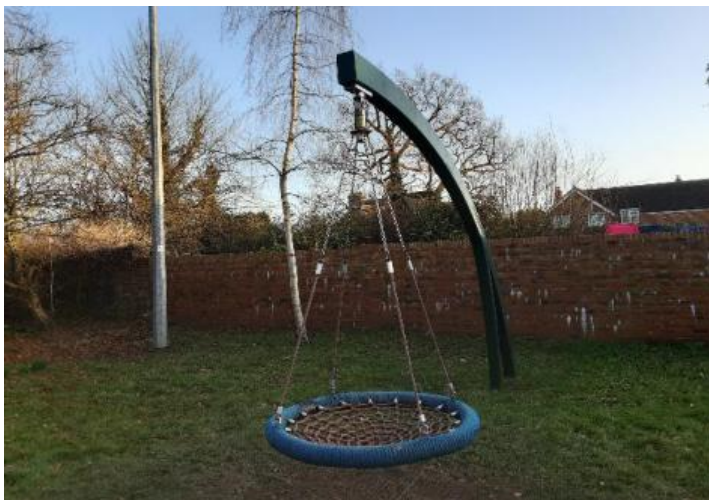
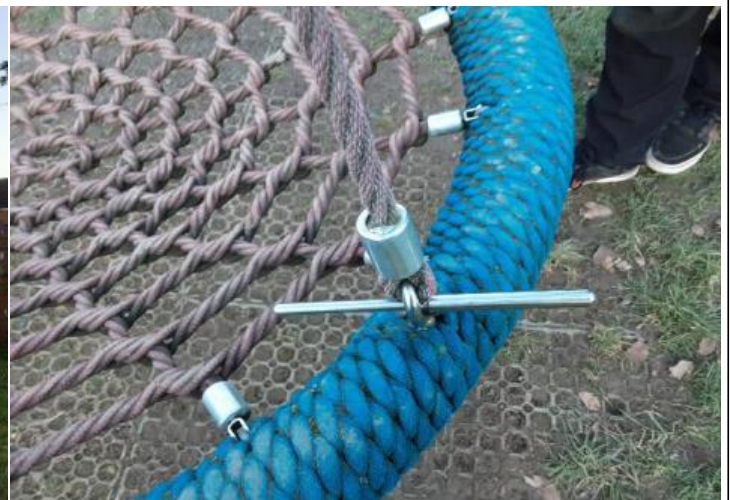
Finding: The connecting links are in excess of 8.6mm and less than 12mm and fail the requirements of BS EN 1176 Part 1; clause 4.2.13, Chains

Action: Monitor - No remedial work recommended

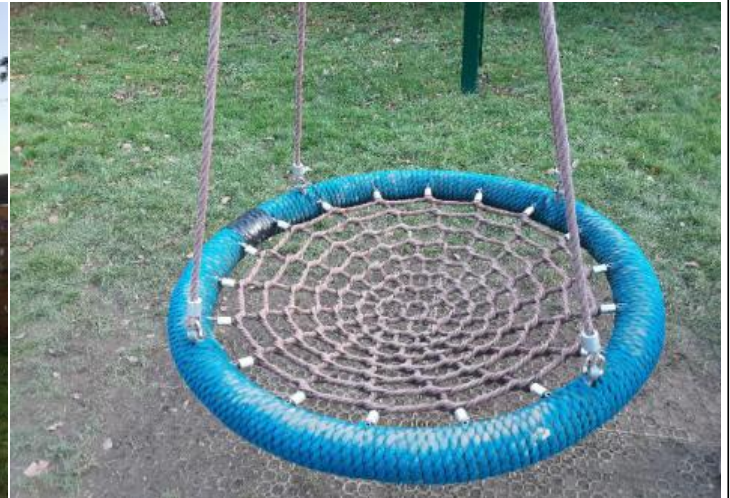
Finding: The incorrect seat design has been installed on this swing; there are unique designs for Type 1 and Type 3 swings that provide differing impact attenuating properties to the leading edges of the seat and/or has incorrectly aligned seat eye fixings which will lead to accelerated wear.

Action: Consider replacing with the correct design seat

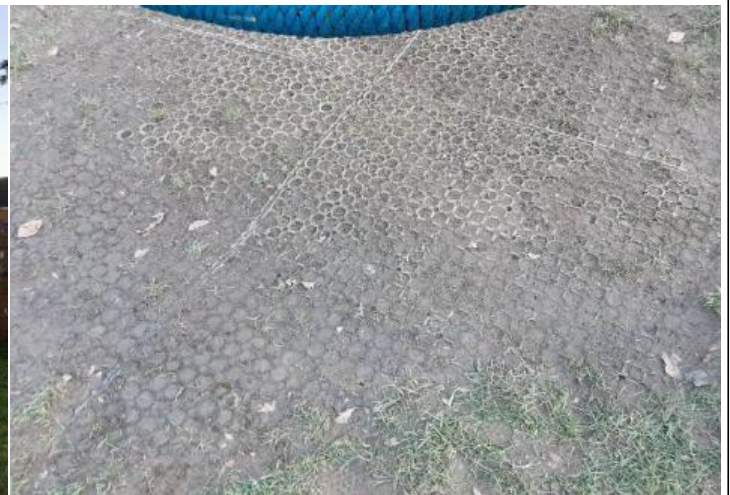
Finding: The grass mats are silted up and the soil is compacted; this may have an effect on the impact absorbing properties of the surface

Action: Consider HIC testing impact absorbing properties to ensure the correct surface qualities are maintained for the equipment and replace as required

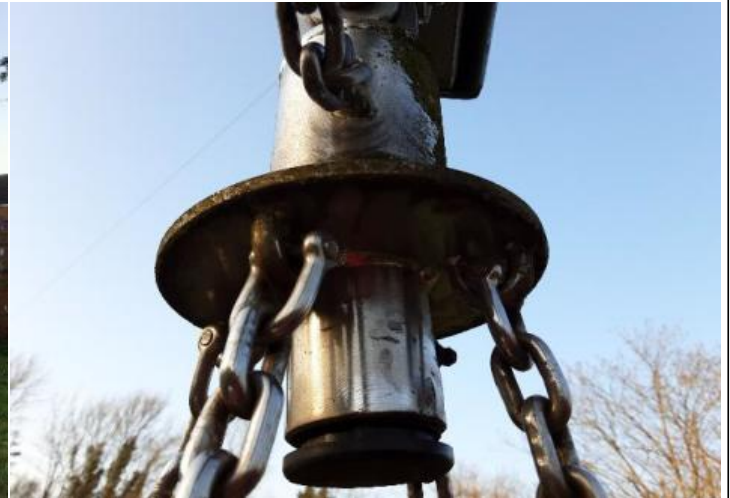
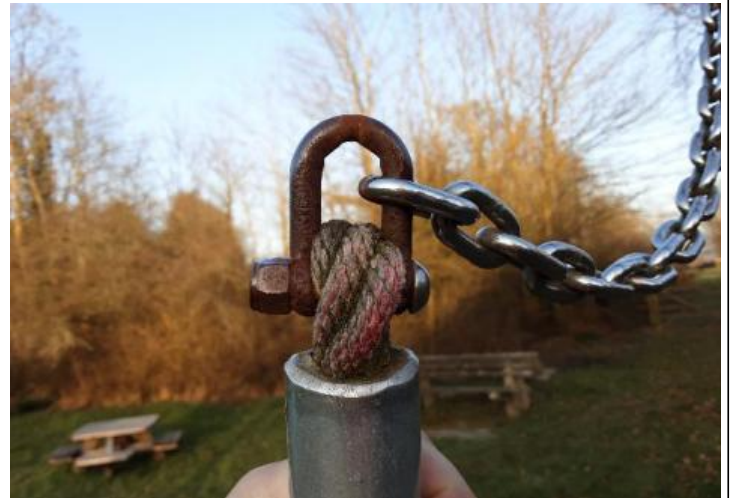
Finding: There is some wear to the shackles.

Action: Monitor for any further deterioration and replace when 40% worn

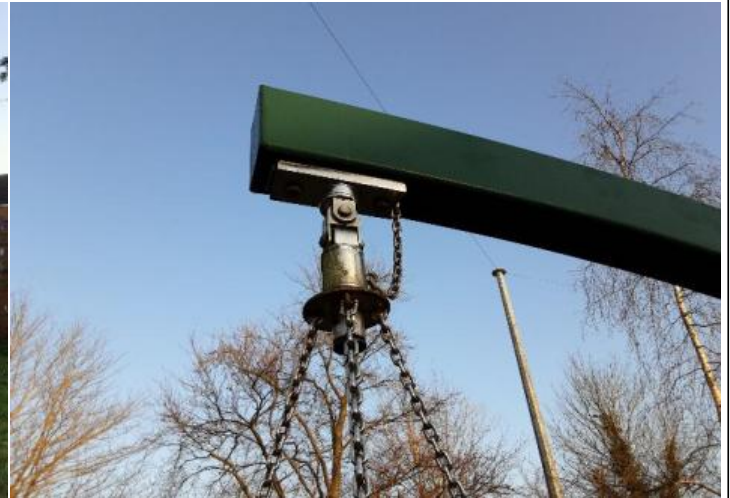
Finding: There is some wear to the universal joint

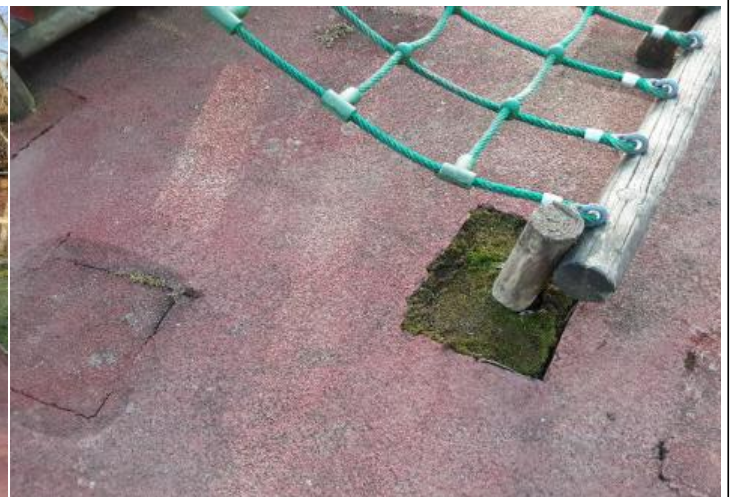
Finding: There is moderate damage to the surface

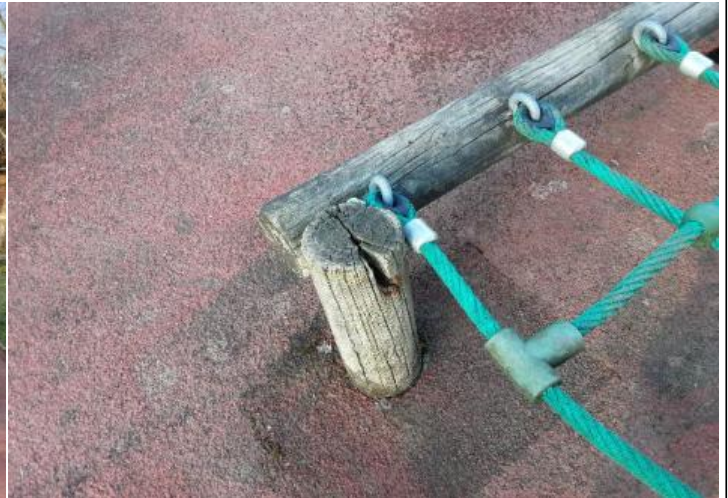
Finding: There are splits in the timber running through fixing points and creating some instability in the structure
Action: Replace all affected timber parts

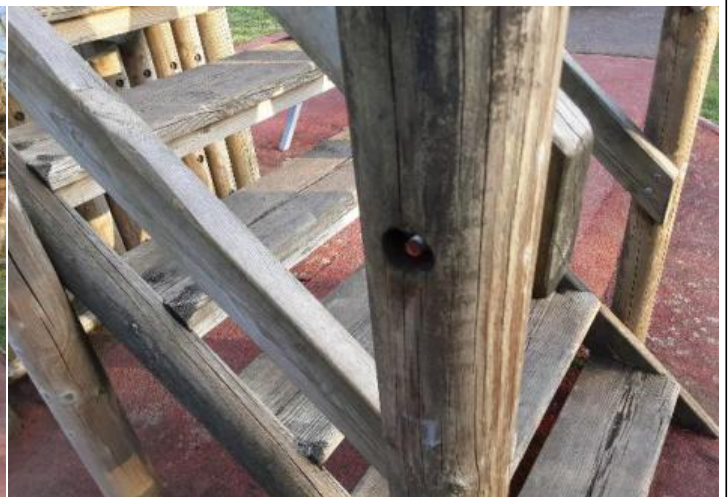
Finding: There is/are bolt cap covers missing or damaged on the item
Action: Replace missing or damaged bolt cap covers

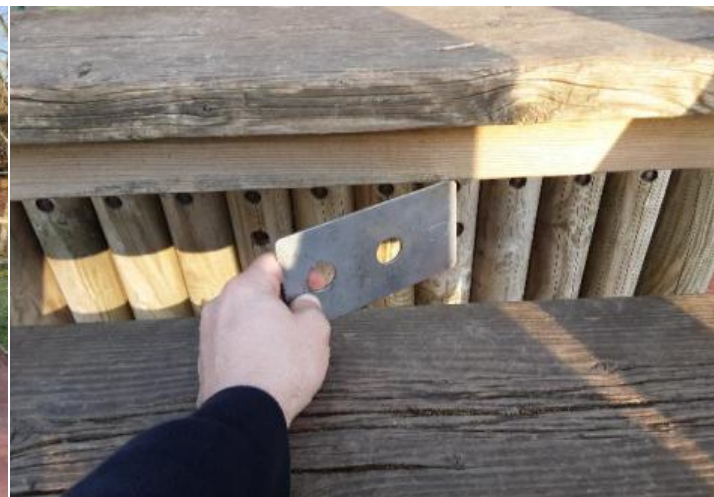
Finding: The item fails to meet the requirements of BS EN 1176 Part 1 4.2.7.2 head and neck entrapment in the barriers and/or steps
