Annual Inspection

Rusper Parish Council

High Street Playground

High Street, Rusper, West Sussex, RH12 4PX

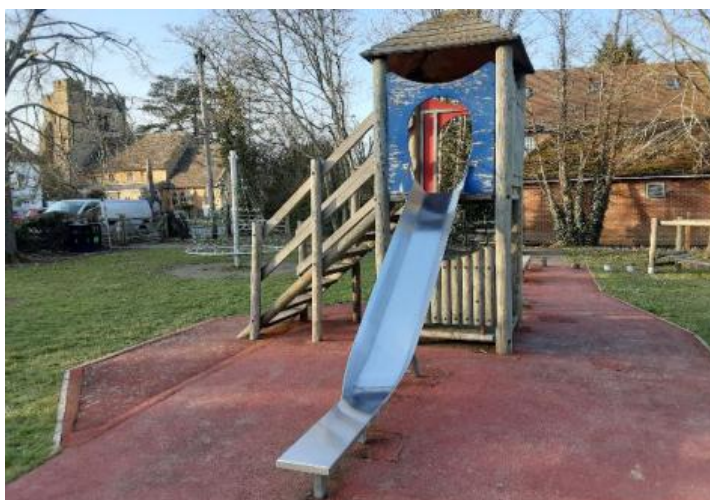
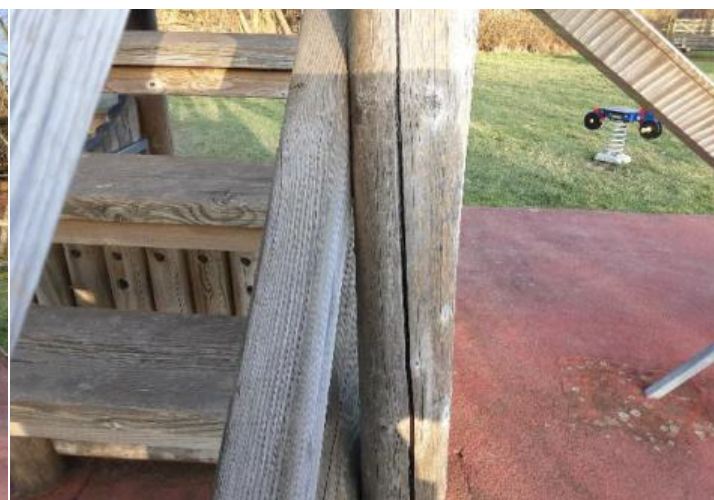
Finding: The timber has a number of splits/shakes or air cracks and this may affect the stability or allow water ingress which will accelerate the rotting process

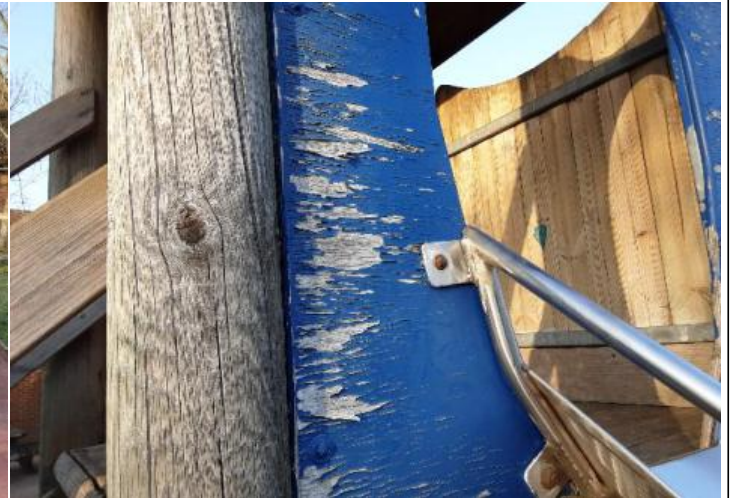
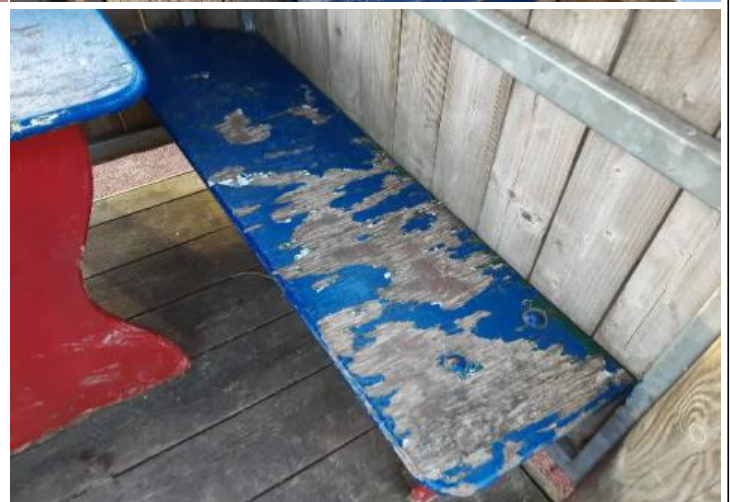
Finding: The timber stain is in poor condition

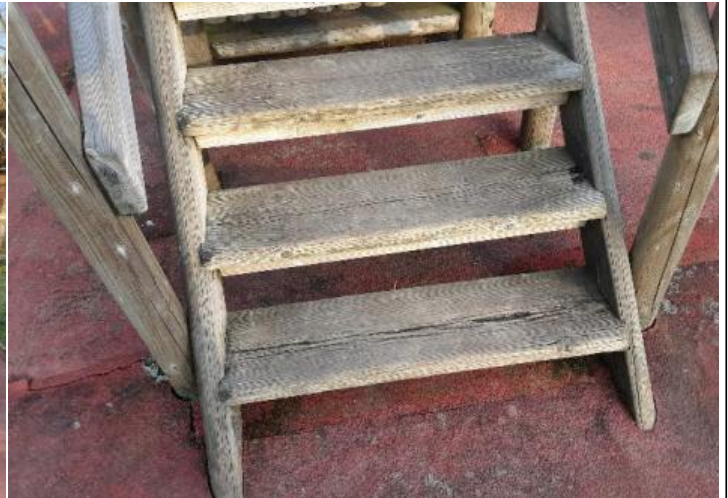
Finding: There is some evidence of rot in the timber

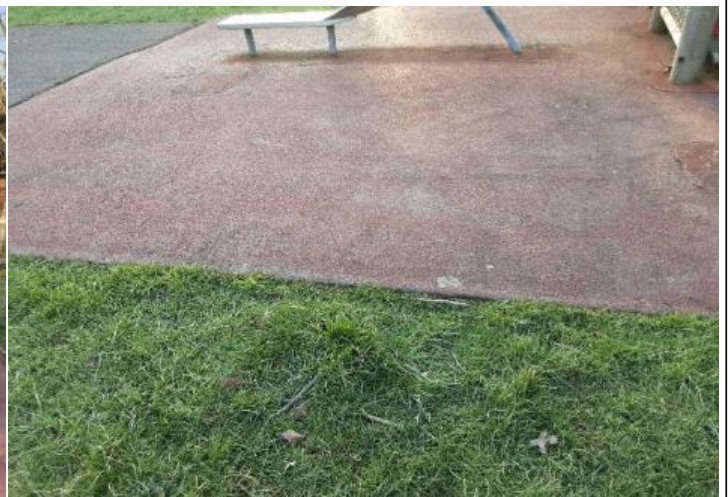
Finding: There are trip hazards at the edges of the surface

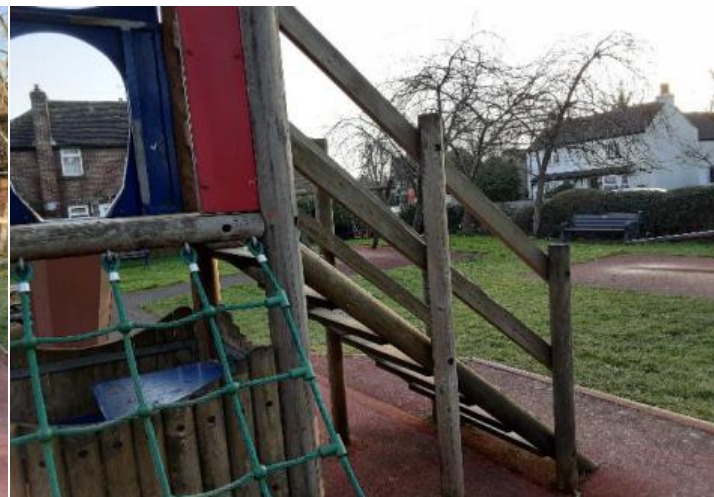
Finding: There is insufficient guarding on the steps leading up to the platform that exceeds 1m in height which contravenes the requirements on BS EN 1176 Part 1

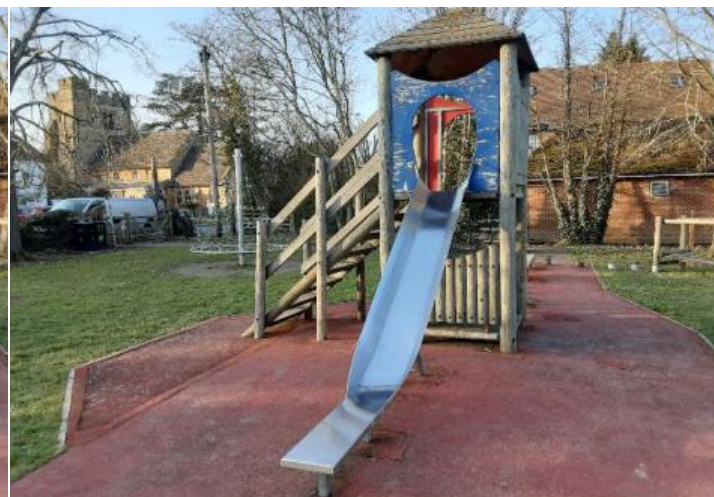
Finding: The slide is predominately south facing and will catch the majority of the sun's heat during the day. Slide surfaces can become very warm during periods of sustained sunny weather

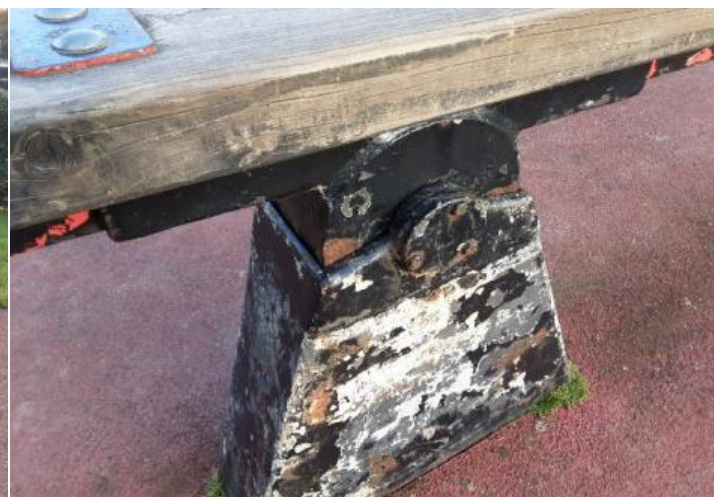
Finding: There is some minor wear to the pivot mechanism

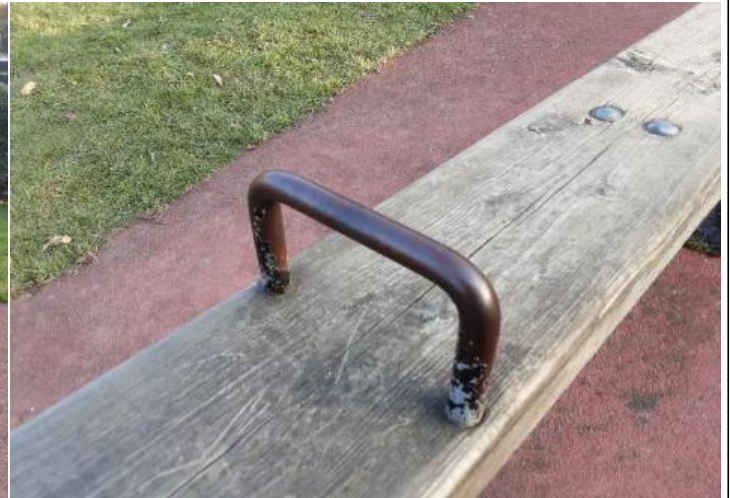
Finding: The paintwork on this item has been damaged or worn exposing the metal underneath which is rusting

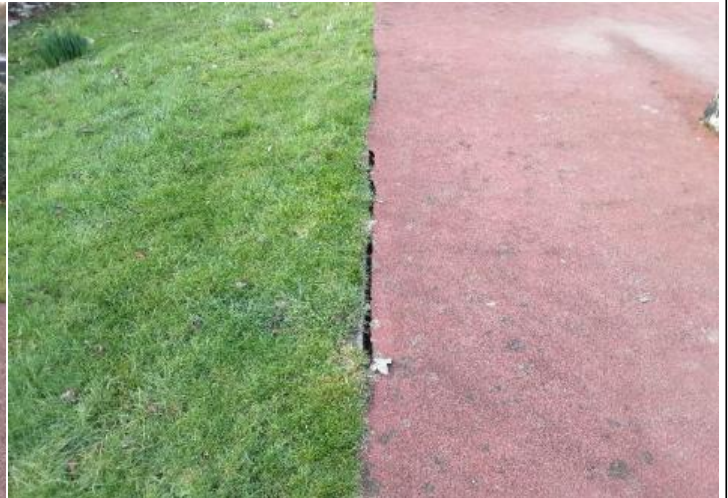
Finding: There are significant gaps (over 30mm) between the surface and the edging or between the joints in the surface; these are large enough for a small foot to enter

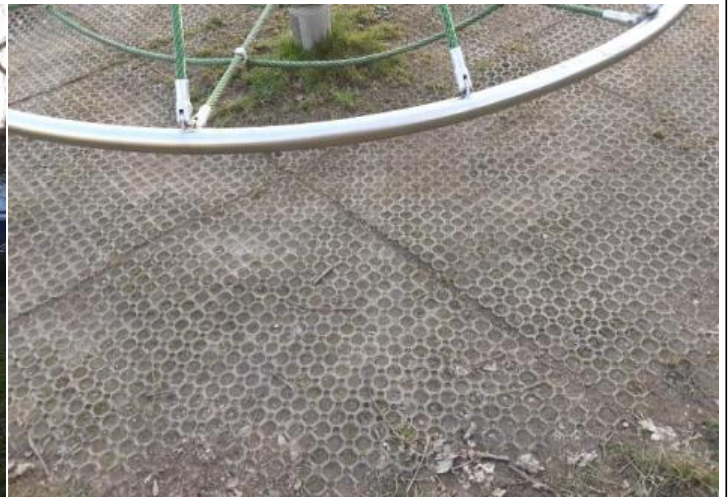
Finding: The grass mats are silted up and the soil is compacted; this may have an effect on the impact absorbing properties of the surface

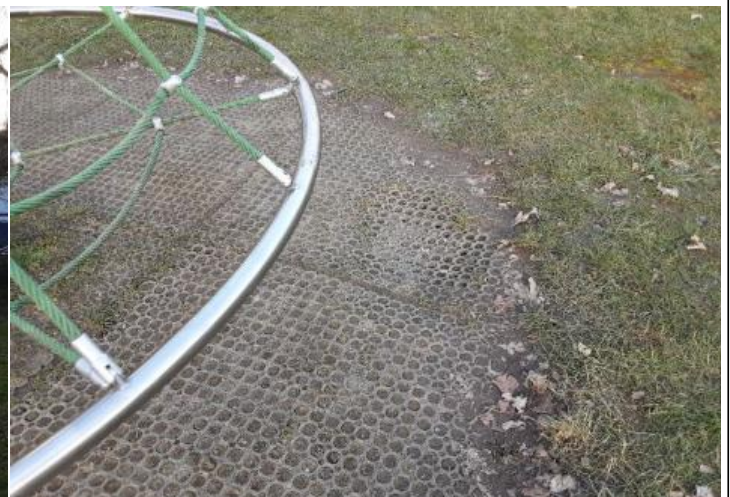
Finding: The surface has subsided in some areas
