Gale Tree Consultancy

Tree Condition Report

Rusper Parish Council

Ref: TCR/619/25

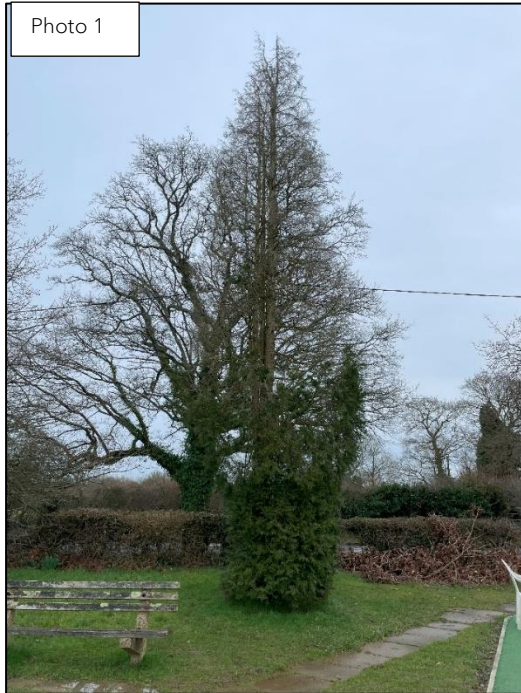
- The upper crown of T6/301 Lawson cypress is dead, with only the lower growth being alive; the cause of the decline is unknown - see Photo 1 in Appendix 4

T6/301 Lawson cypress note the declining upper crown

- A recommendation to reduce the tree down to the new growth has been made, however, equally justifiable is its complete removal
- T8/303 Pedunculate oak has a bark wound on the secondary stem section over Capel Road and adjacent to this is a cavity forming within the wound wood² of an old pruning wound - see Photo 2 in Appendix 4

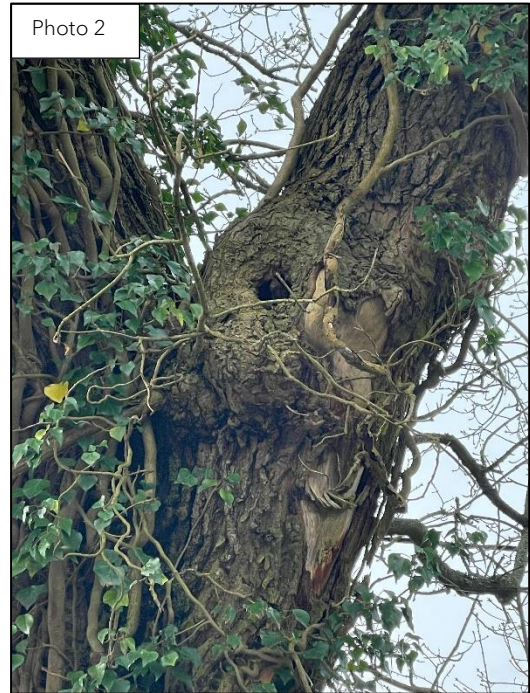
Photo 2

T8/303 Pedunculate oak with bark wound and cavity

- Whilst the arborist is aloft carrying out the prescribed work to this tree, they should assess the cavity noting its depth and overall condition, making their findings known to Gale Tree Consultancy for comment

- Alternatively, Gale Tree Consultancy can undertake this aerial inspection
- T10/305 Pedunculate oak has a large open cavity on its west side from where a burr³ has rotted away - see Photo 3 in Appendix 4

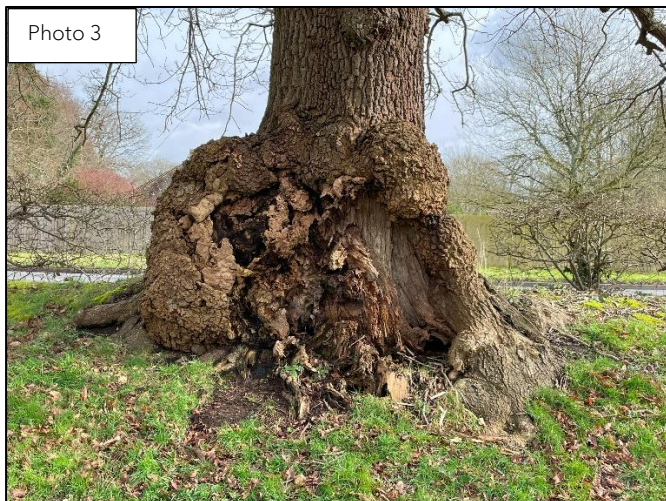
Photo 3

T10/305 Pedunculate oak with large cavity from the failure of a burr - note the green handle of the steel probe in Photo 4

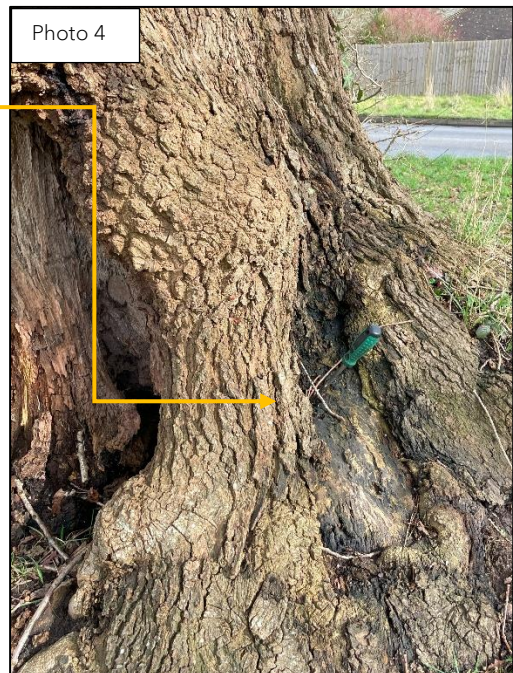
- Decay is also present in the southern buttress root, where the steel probe could be inserted c.20cm into the wood - see Photo 4 in Appendix 4
- To ascertain the condition of the lower stem, and the extent of any decay that may be present, a detailed decay evaluation has been recommended employing the use of sonic and electrical tomography, and a Resi micro drill where applicable - please see Appendix 5 for details of this piece of equipment

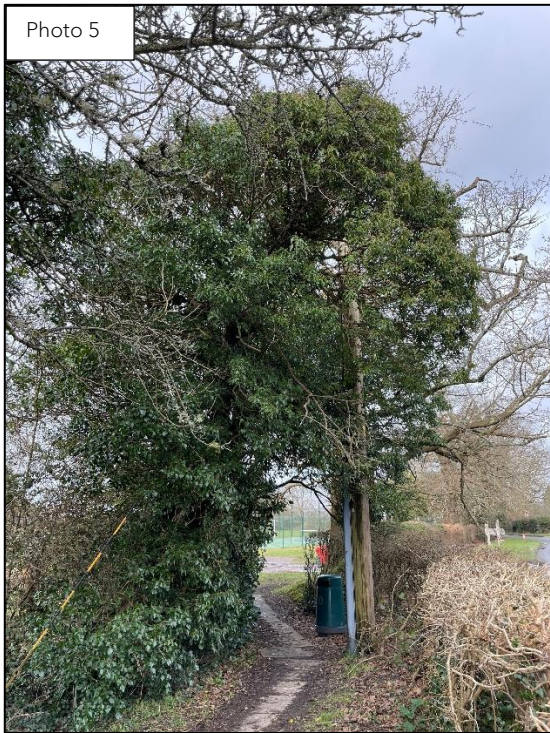
- Ownership of T12/307 Hawthorn is unclear as it appears to straddle the southern boundary line
- It is also completely smothered with ivy making an assessment of its structural and physiological condition impossible - see Photo 5 in Appendix 4

T12/307 Hawthorn almost completely smothered with ivy

- If the tree is under the management of Rusper Parish Council, the ivy should be severed as described and the upper crown assessed in the summer of 2025 for an appraisal of the leaf bearing twigs

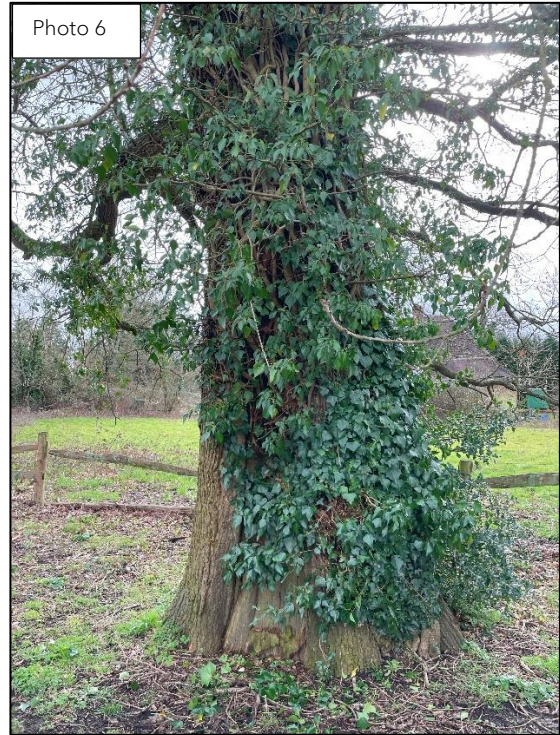
- T13/308 Pedunculate oak has a large wound on its north side, starting from ground level and extending up to c.2m - see Photo 6 in Appendix 4. The immediately adjacent stem area exhibited a dull tone when assessed with a nylon headed mallet

T13/308 Pedunculate oak with large wound on the north side

- A detailed decay evaluation has been recommended to ascertain the extent of any decay that may be present, and inform further management decisions

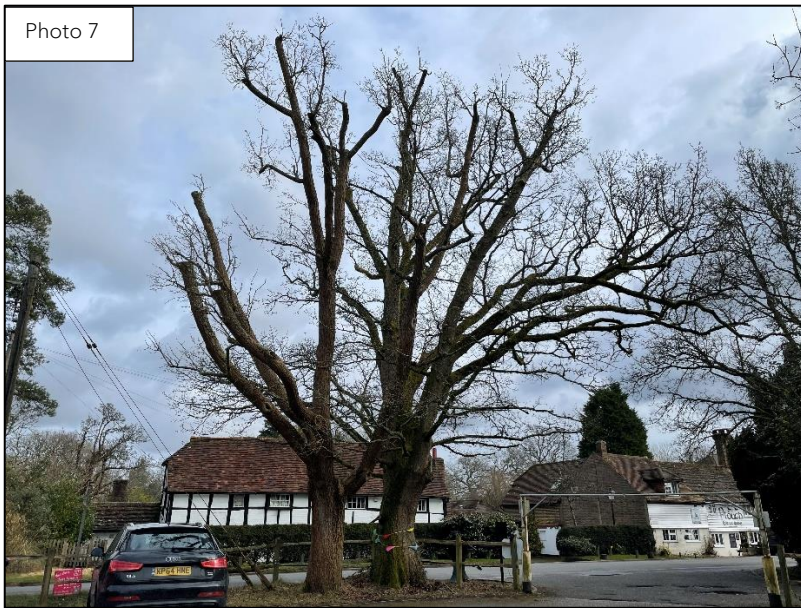
- To the north of the car park entrance are two Pedunculate oak trees growing close together forming one crown shape - T1/310 and T2/311
- Both trees have been reduced, however, T2/311 has been excessively reduced resulting in truncated stem sections with minimal regrowth, some of which have died

T1/310 and T2/311 Pedunculate oak at the entrance to the car park

Note the reduced crowns and the excessively truncated stem sections on T2

- Both trees have been recommended to have the dead and declining branches and stem sections removed back to sound wood
- Although I do not believe T2/311 Pedunculate oak need removing at this time, this may not always be the case. Therefore, I would also recommend the parish council consider planting a replacement tree ahead of this time so it may get established

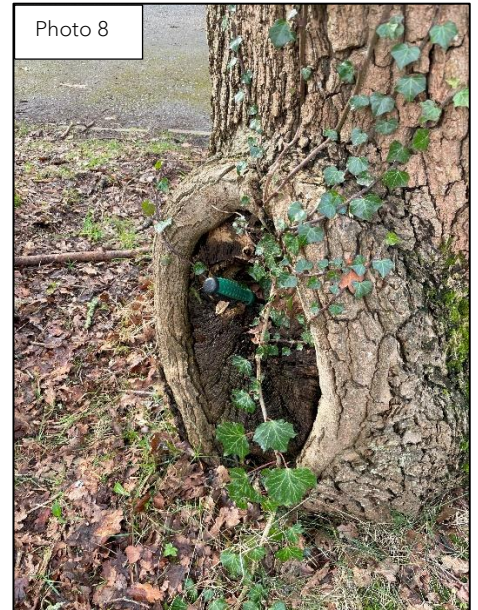
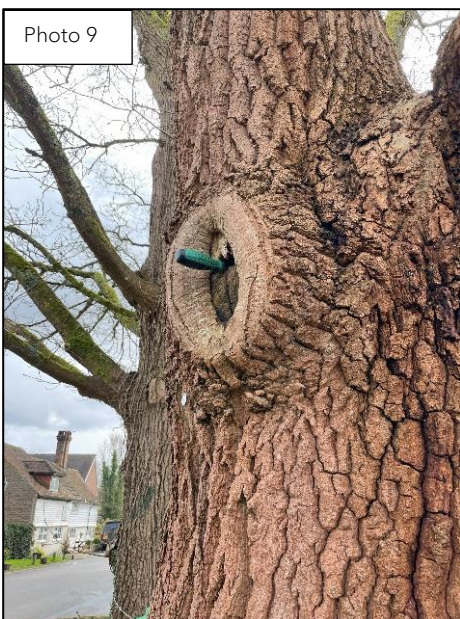
- The tree also has a cavity at ground level on the southeast side of the stem with a depth of c.35cm; wound wood is forming around the outer edge
- There is a further cavity on the north side of the stem at c.2.3m, its depth to is c.35cm - see Photos 7, 8 and 9 in Appendix 4

Photos 8 and 9 showing the cavities on T2 - note the green handle of the steel probed used to assess the cavity depths

- A recommendation has been made to perform an assessment of the cavity at c.2.3m, employing the use of a Resi PD400 micro drill should it be deemed necessary

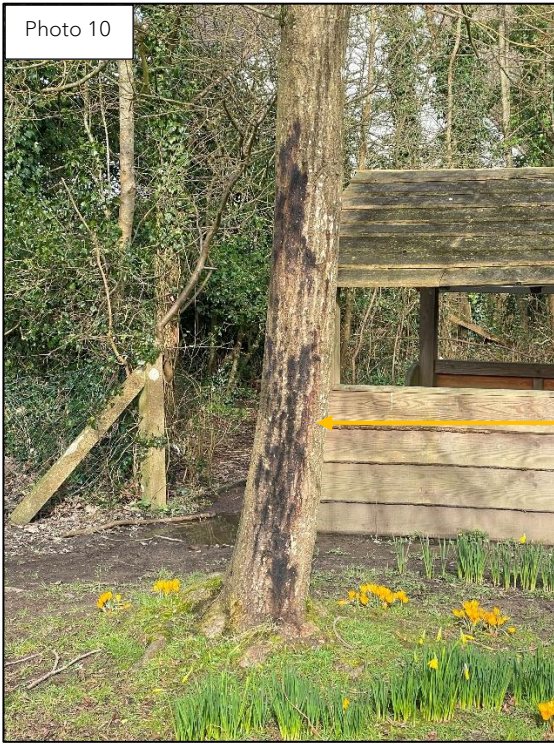
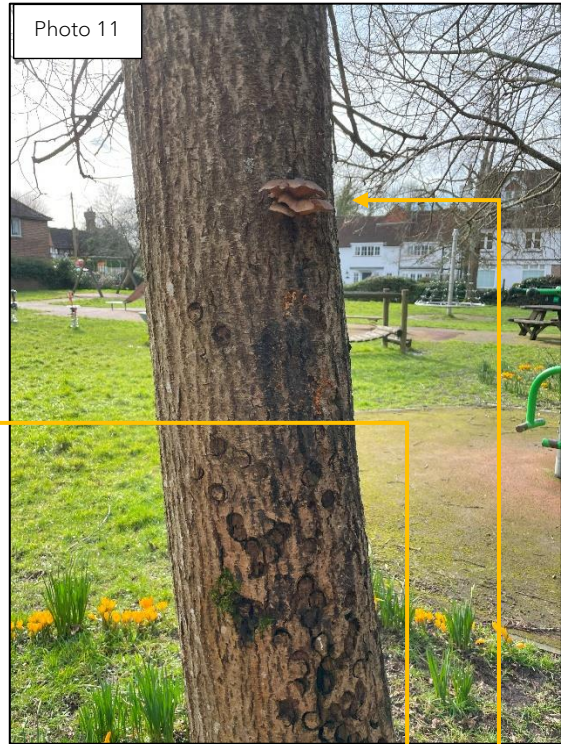
- T5/319 Lime spp. has an area of extensive staining and exudations on its south and west side, consistent with that of a *Phytophthora* spp⁴ – see Photo 10 in Appendix 4

- As the fungus encircles the stem, the tree's vascular system becomes non-functioning resulting in its death
- On the northeast side of the stem are circular bark wounds and a strip of moribund and dead bark with the fruiting body of the decay fungus *Pleurotus ostreatus* (Oyster mushroom) at c.1.5m – see Photo 11 in Appendix 4

- The fungus is associated with a selective white rot, where the cellulose and lignin are degraded simultaneously. In sufficient quantities It can be associated with structurally related problems

T5/319 Lime spp. with staining consistent with a *Phytophthora* fungus
 Bark wounds and the fruiting body of *Pleurotus ostreatus* (Oyster mushroom)

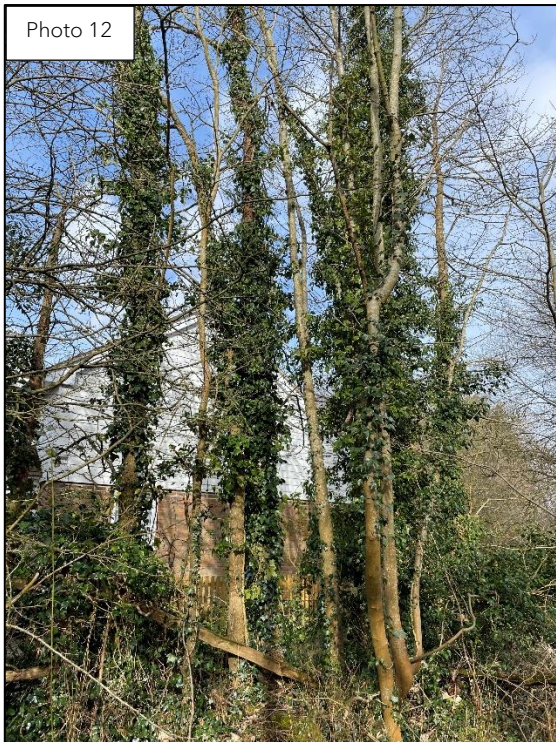
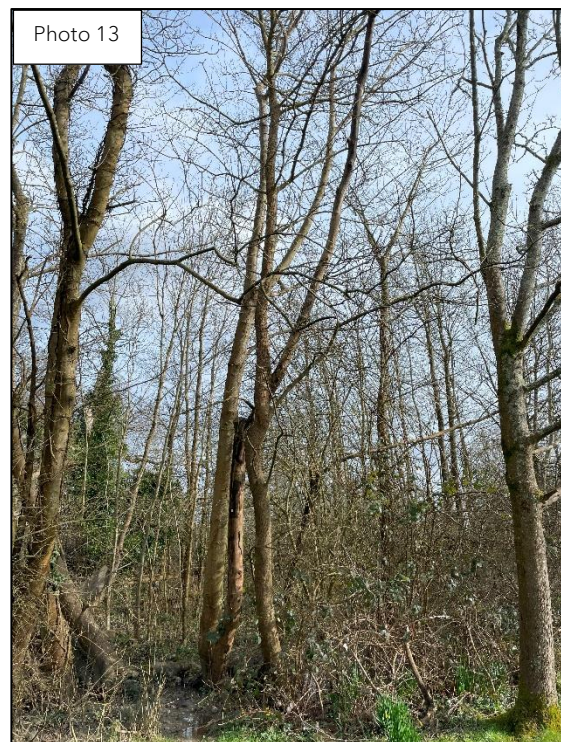
- Along the northeast and east side of the site are a number of dead and declining English elm trees, which have succumbed to the effect of Dutch Elm Disease (DED)⁵

- Some of these are smothered with ivy, making them increasingly liable to fail in strong wind events – see Photos 12 and 13 in Appendix 4
- A recommendation to remove these has been made, along with those which are beginning to fail

G8/322 English elm and T10/324 English elm located in the northeast and east side of the playground

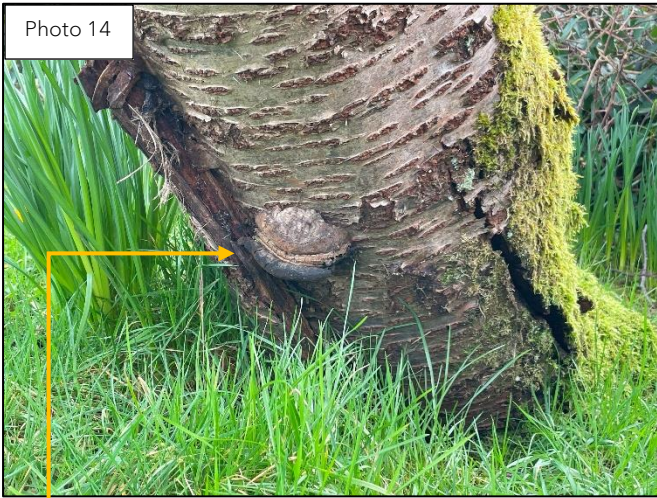
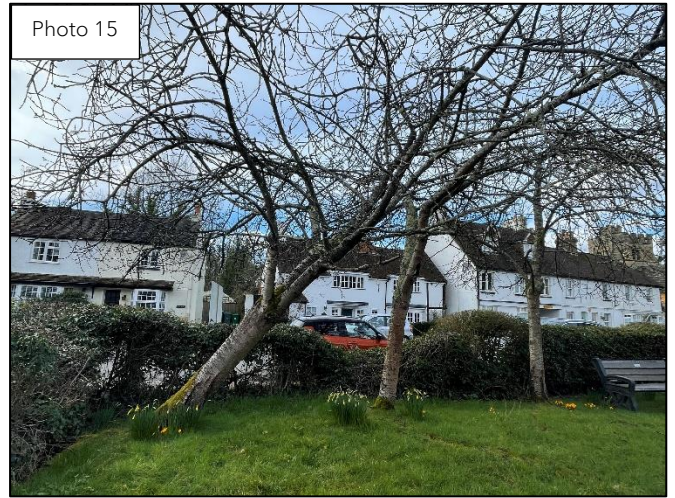
- T12/326 Cherry spp. has a bracket fungus belonging to the genus *Ganoderma* on the north side of the tree close to ground level – see Photo 14 in Appendix 4; an audible change in tone was heard when his area was assessed with the nylon headed mallet

- Generally, the *Ganoderma* spp. of decay fungi cause a localised white rot⁶ to form
- As the decay advances, the lignin is degraded fully leaving the cellulose behind; in extreme cases, the decay can result in windthrow and failure of the stem or root plate

- The tree has partially fallen and is leaning on the neighbouring tree – see Photo 15 in Appendix 4
- No work has been recommended at this time, however that may not always be the case and a recommendation to periodically inspect the tree has been made, especially after extreme weather events such as wind gusts in excess of Force 8 on the Beaufort Scale

T12/326 Cherry spp. partially fallen and leaning against the neighbouring tree with a bracket of a *Ganoderma* fungus on the underside

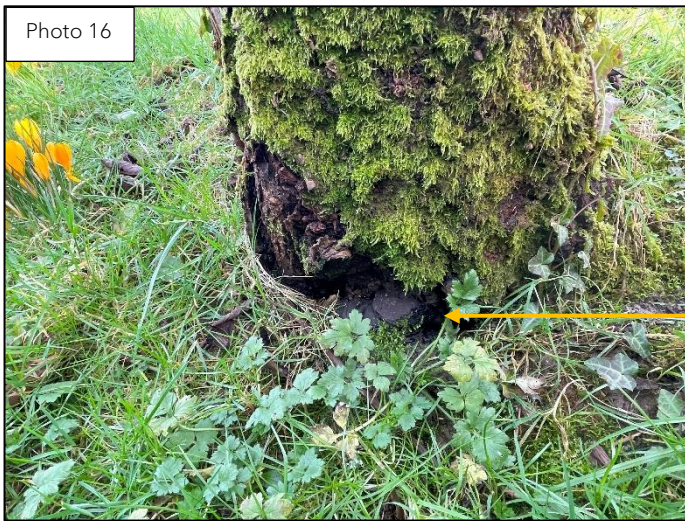
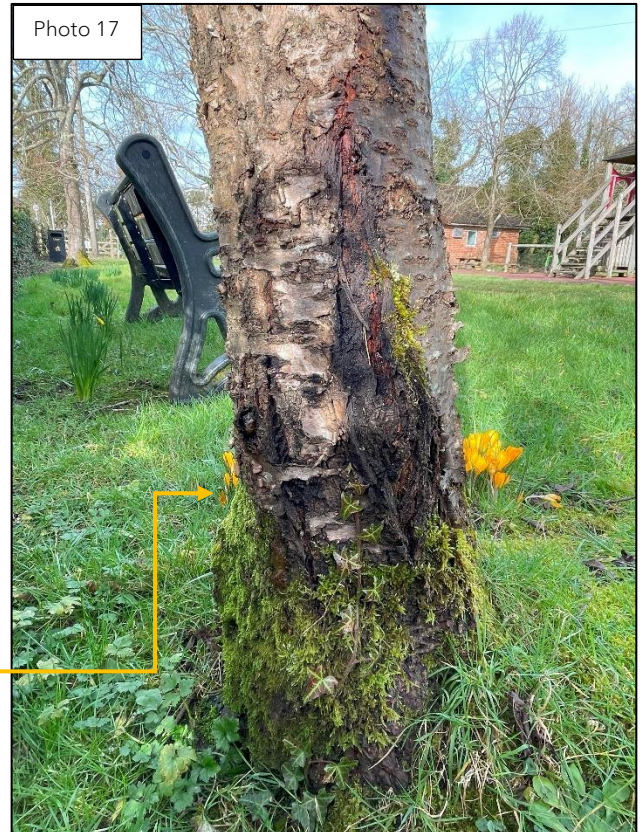
- T13/327 Cherry spp. also has a bracket of the decay fungus *Ganoderma* at ground level on the west side of the stem – see Photo 16 in Appendix 4
- The lower stem also has bark deformity/swelling suggesting the tree has compartmentalised the area of decay by placing adaptive growth around the affected area – see Photo 17 in Appendix 4

T13/327 Cherry spp. with a bracket of a *Ganoderma* fungus on its west side and swelling around the lower stem

- No further action required at this time, but periodically inspect until the next assessment, especially after extreme weather events such as wind gusts in excess of Force 8 on the Beaufort Scale
