Annual Inspection

Rusper Parish Council

High Street Playground

High Street, Rusper, West Sussex, RH12 4PX

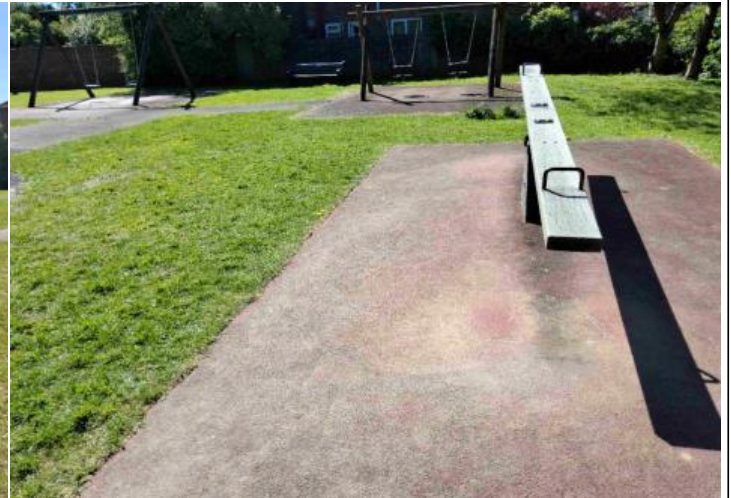
Item: Ancillary Items - Site General
Manufacturer: Owner/Operator

Finding: The safety surface is beginning to wear

Action: Monitor for any further deterioration and repair as required

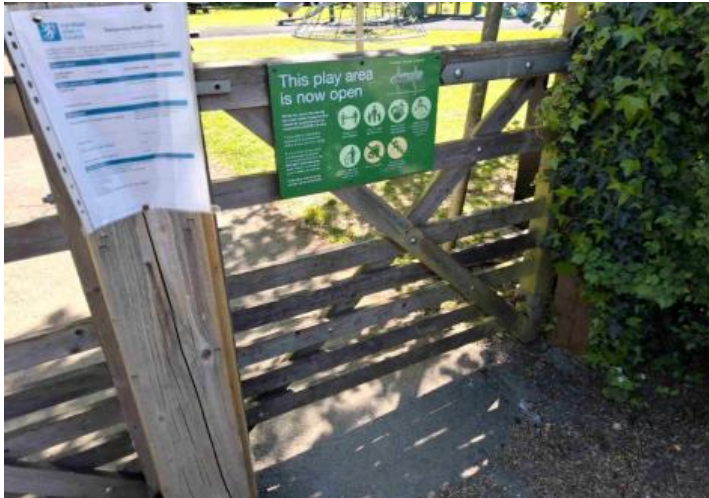
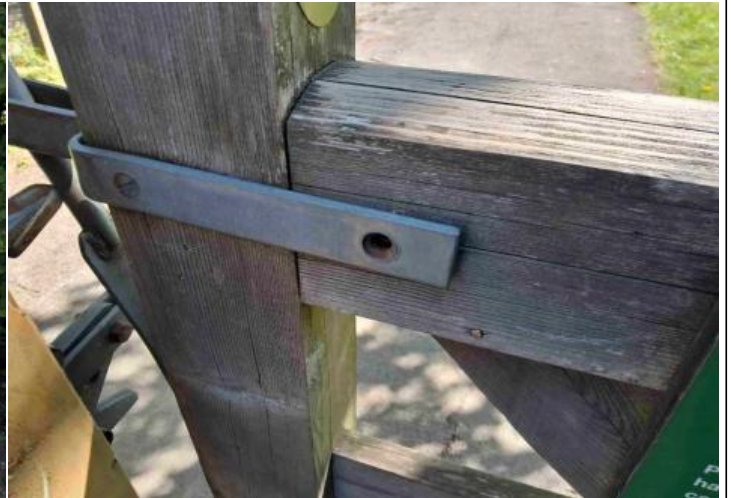
Item: Gates - Gate
Manufacturer: Not Identified

Finding: There is or are fixings missing on the item

Action: Replace all missing fixings

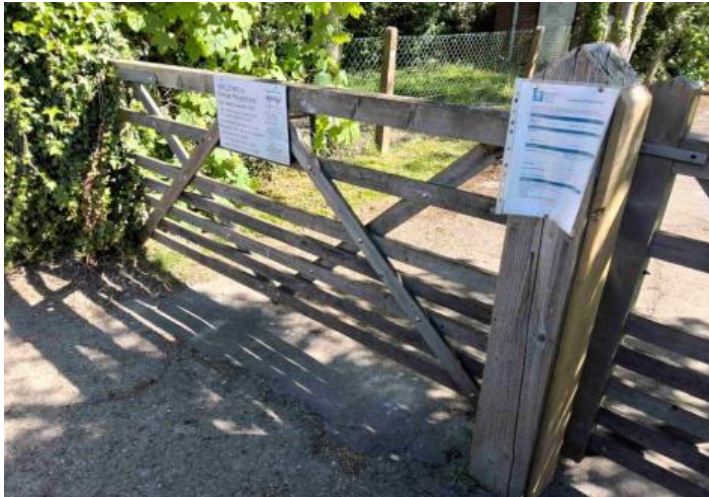
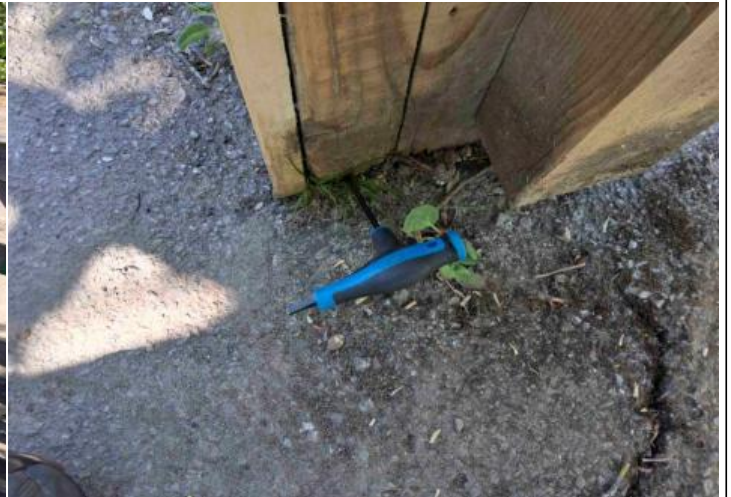
Item: Gates - Gate - Maintenance
Manufacturer: Not Identified

Finding: There is some evidence of rot in the timber

Action: Monitor for any further deterioration and replace as required

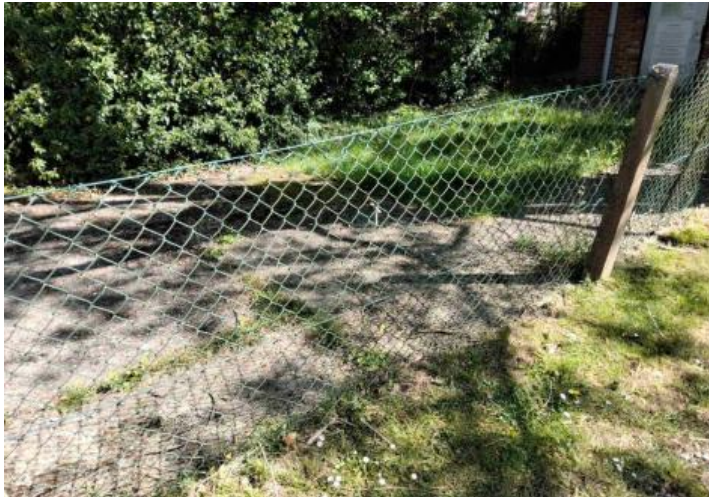
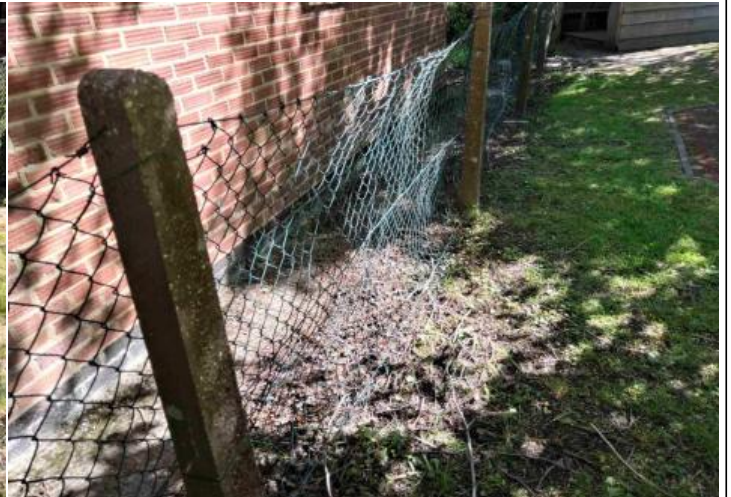
Item: Fences - Fence - Chainlink
Manufacturer: Not Identified

Finding: There is some damage to the fence sections

Action: Monitor for any further deterioration and repair as required

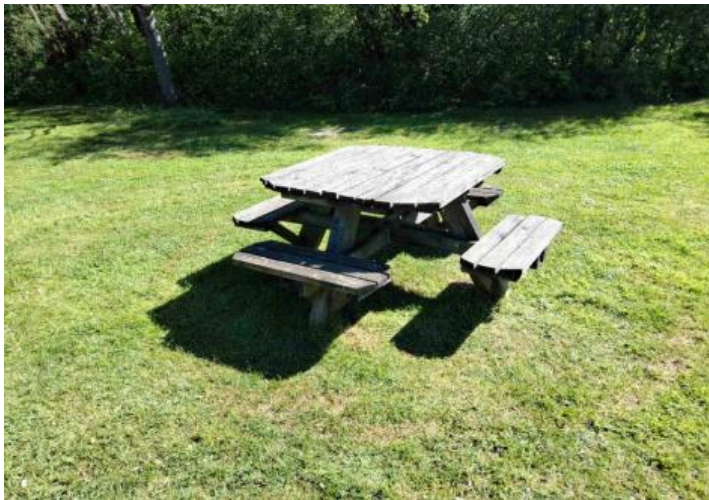
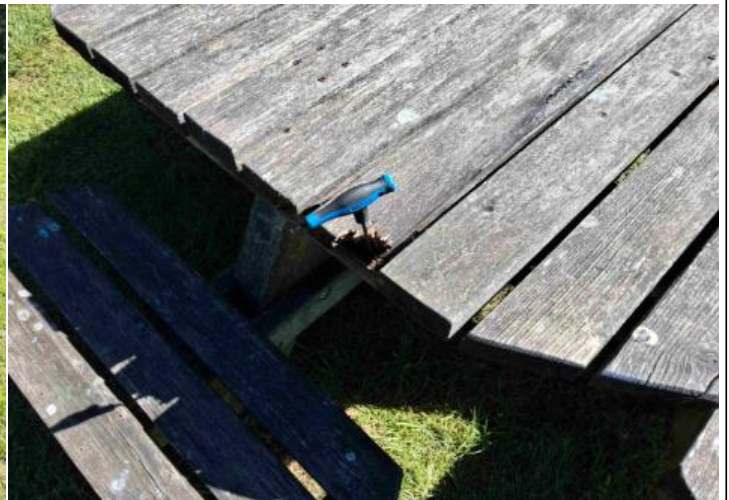
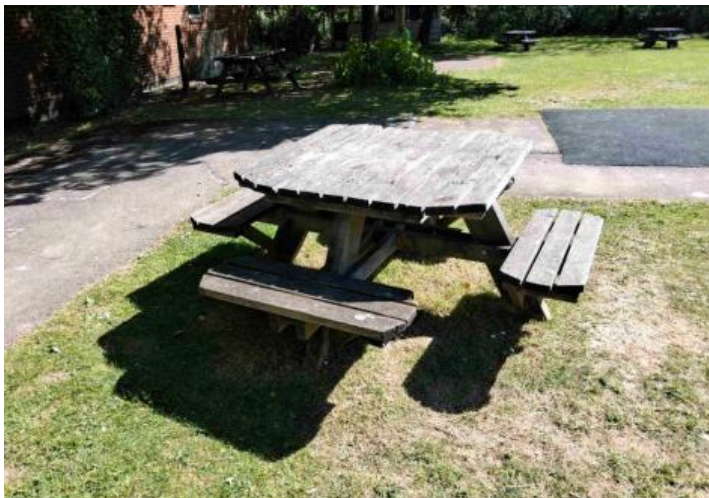
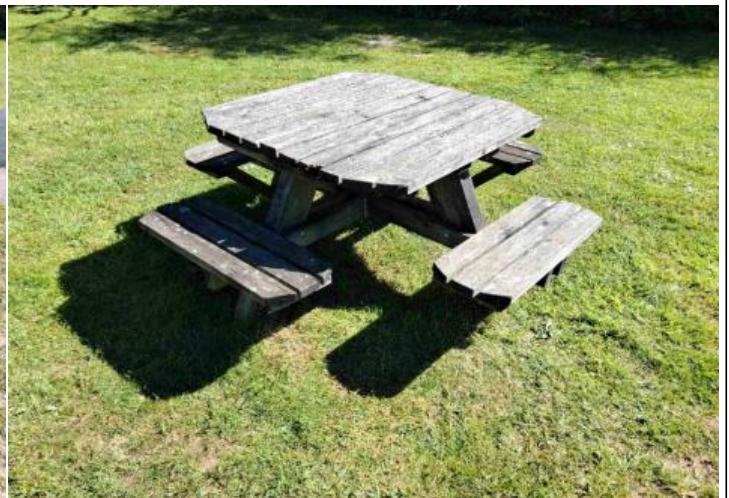
Item: Ancillary Items - Picnic Table
Manufacturer: Not Identified

Finding: There are areas or parts of the timber on the structure that have rotted

Action: Replace all affected timbers

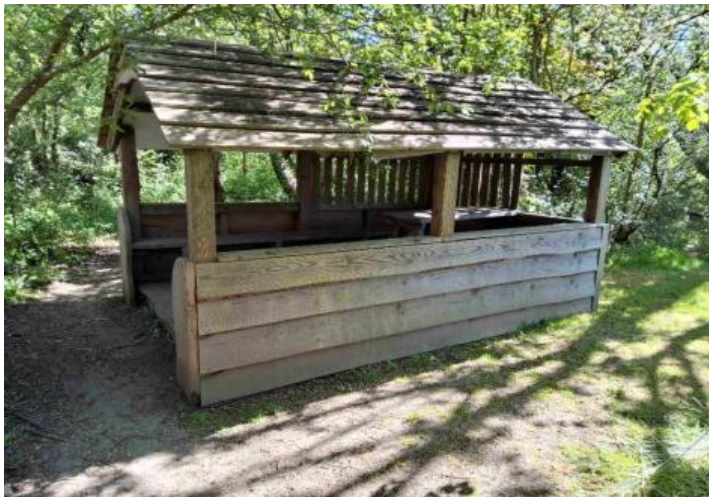
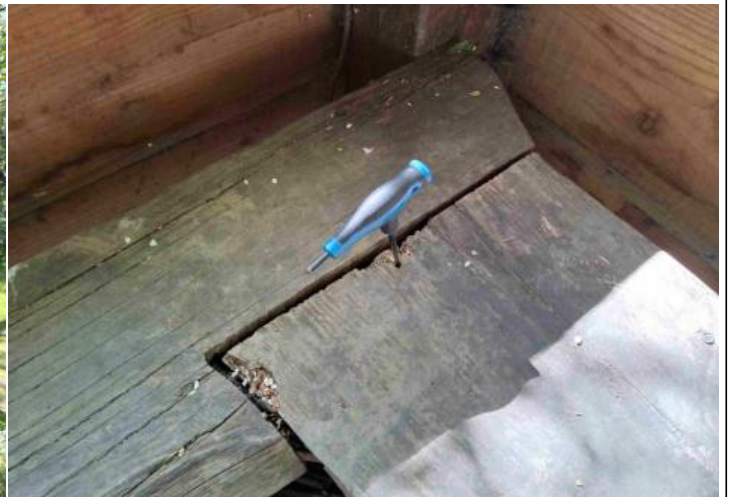
Item: Ancillary Items - Shelter
Manufacturer: Not Identified

Finding: There is some evidence of rot in the timber

Action: Monitor for any further deterioration and replace as required

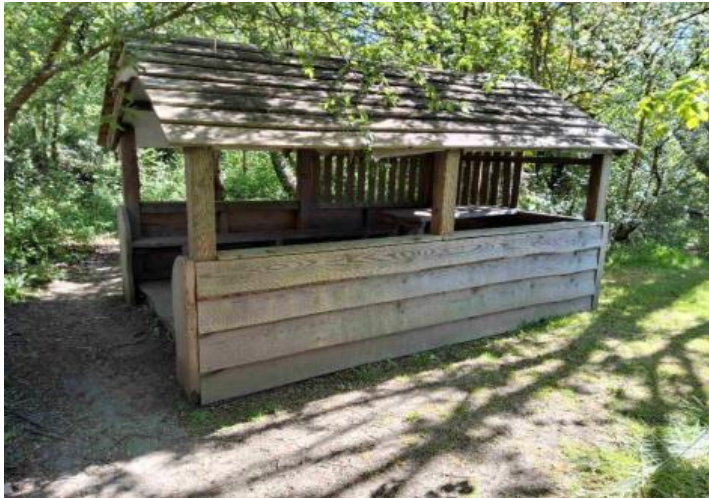
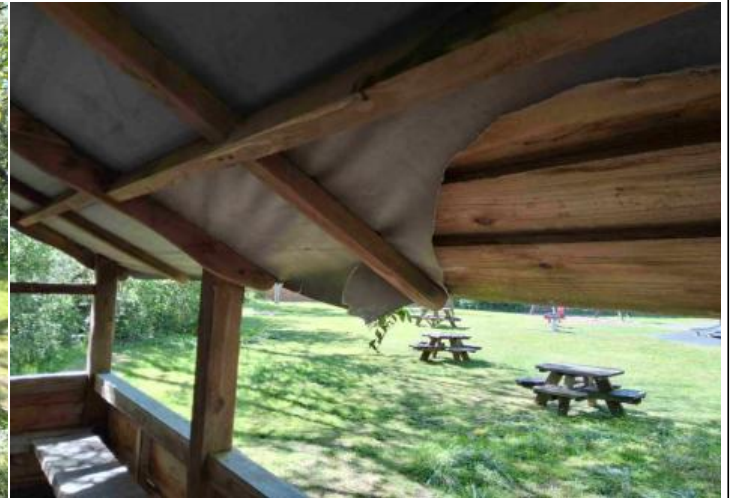
Item: Ancillary Items - Shelter
Manufacturer: Not Identified

Finding: The roof lining is damaged

Action: Replace

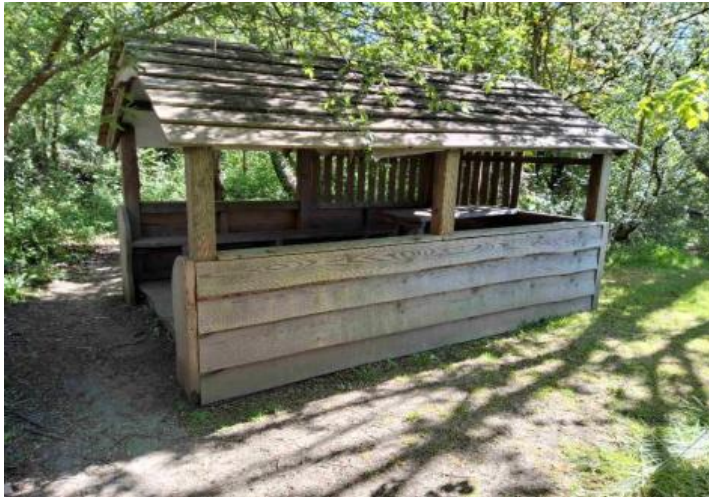
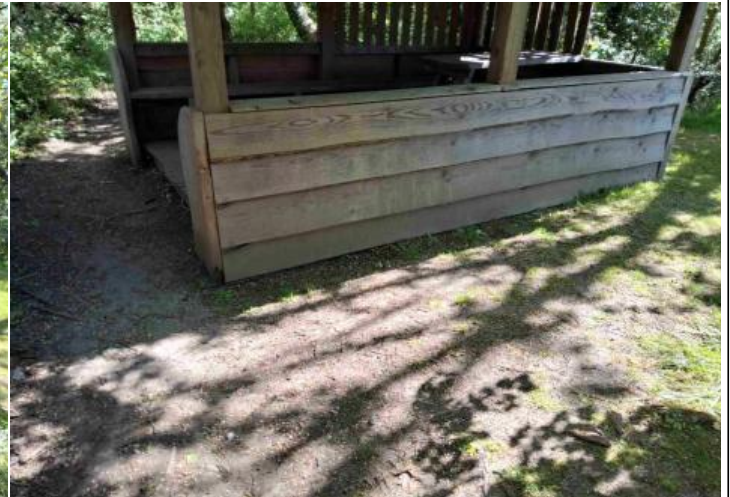
Item: Ancillary Items - Shelter
Manufacturer: Not Identified

Finding: The surface has eroded in some areas and may be slippery in wet conditions

Action: Reinstate the surface

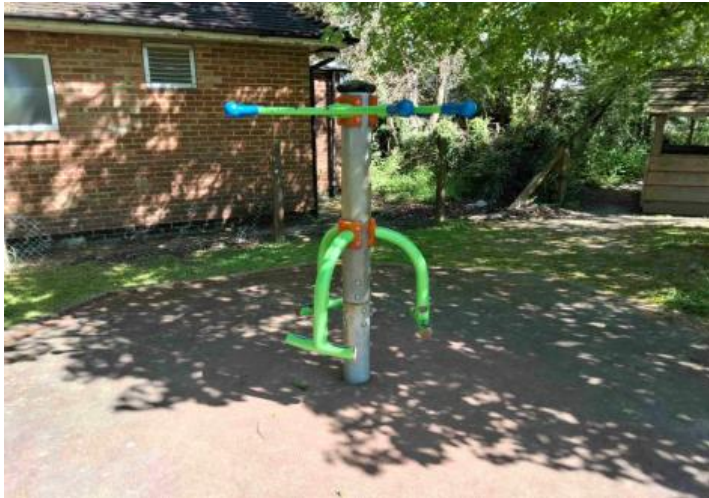
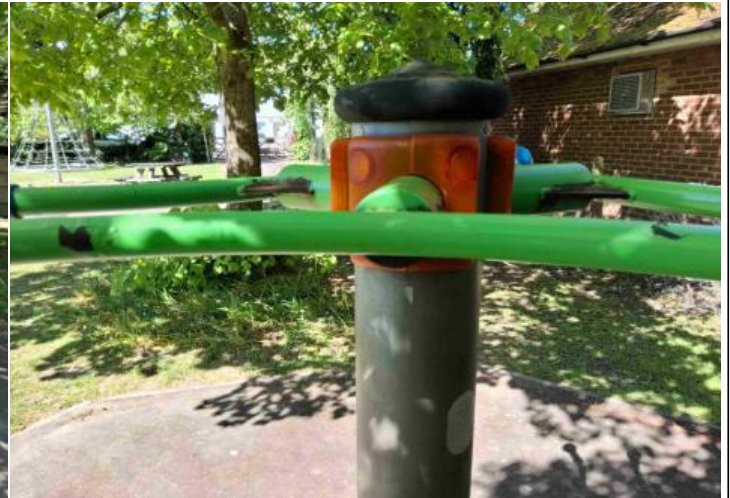
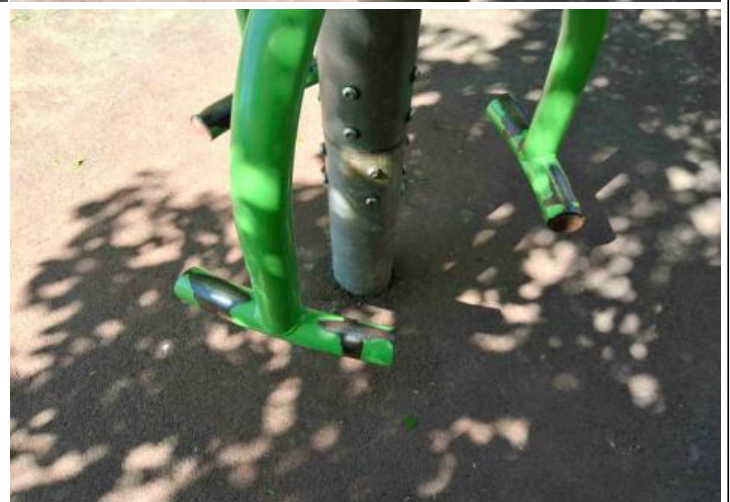
Item: Rotor Play - Low Rotator
Manufacturer: Sutcliffe Play Limited

Finding: The paintwork on this item has been damaged or worn exposing the metal underneath which is rusting / corroding

Action: Treat affected areas and repaint

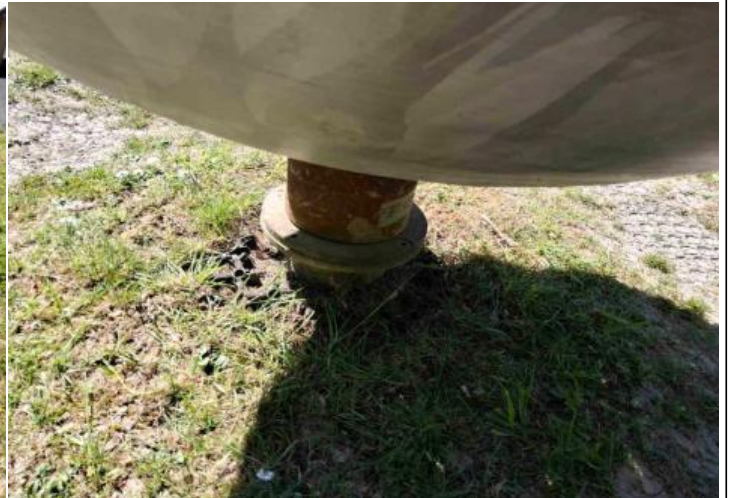
Item: Rotor Play - Dish Roundabout
Manufacturer: Sutcliffe Play Limited

Finding: There is surface corrosion / rust present on the item

Action: Consider treating the item

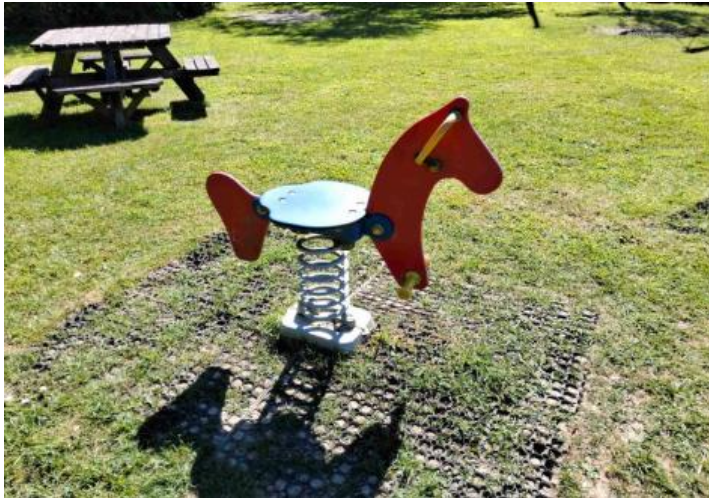
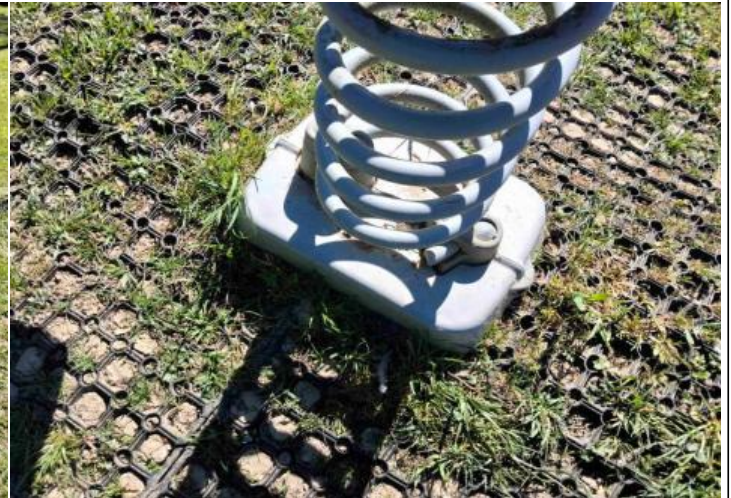
Item: Rocking Equipment - Spring Horse
Manufacturer: Ledon

Finding: The spring clamps are showing signs of wear

Action: Monitor for any further deterioration and replace as required

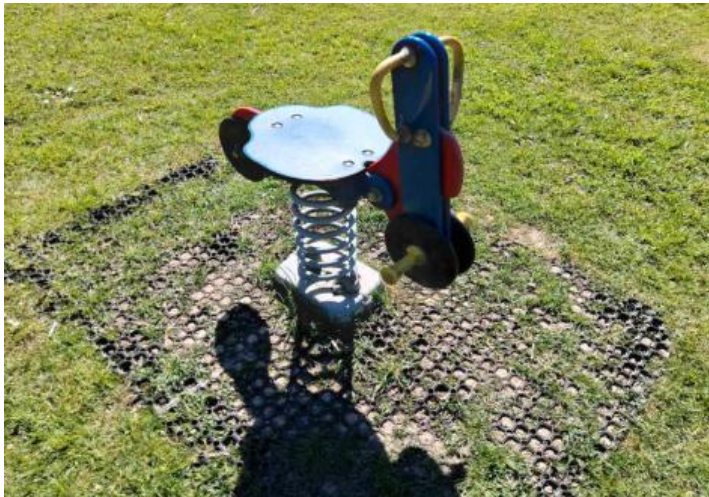
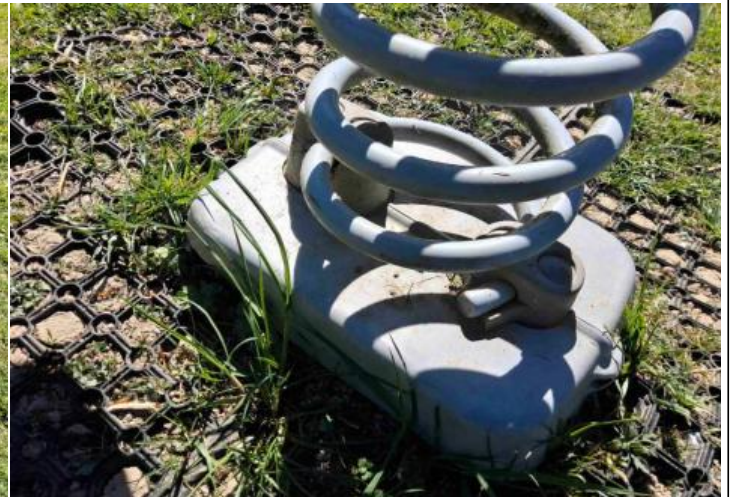
Item: Rocking Equipment - Spring Motorbike
Manufacturer: Ledon

Finding: The spring clamps are showing signs of wear

Action: Monitor for any further deterioration and replace as required

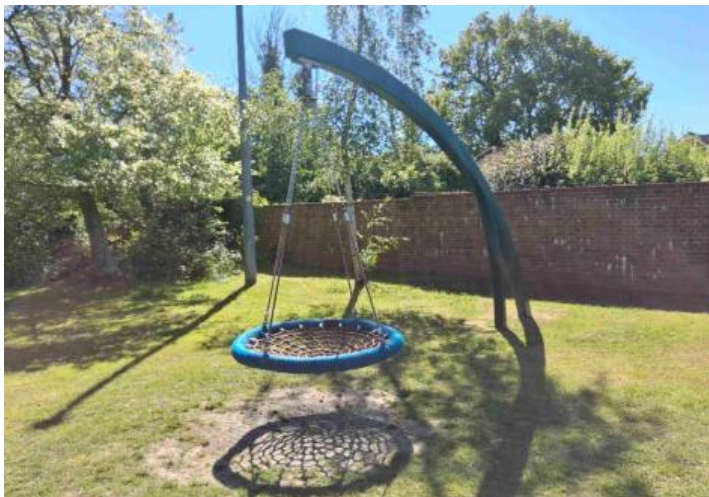
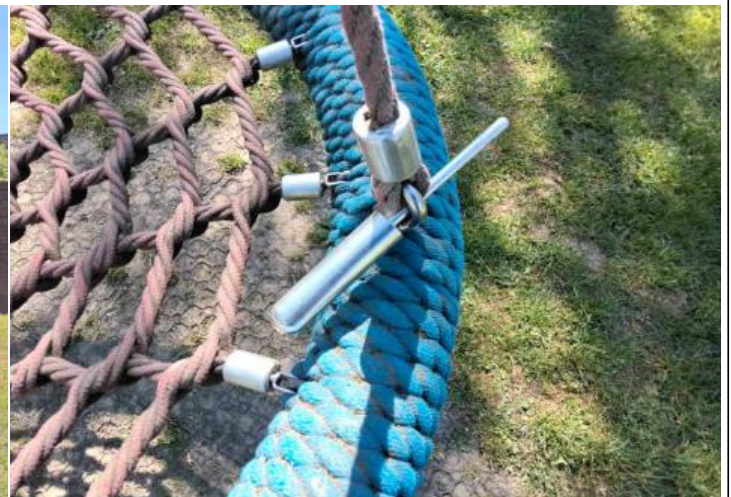
Item: Swings - Cantilever Swing - Type 3
Manufacturer: Not Identified

Finding: There is/are finger entrapment/s between shackle and rope and the item fails to meet the requirements of BS EN 1176 Part 1 4.2.7.6 Entrapment of fingers

Action: Monitor - No action given the risk assessment

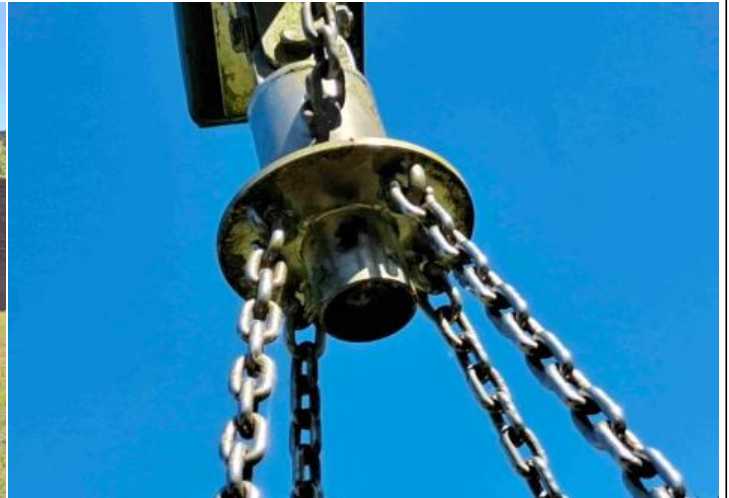
Item: Swings - Cantilever Swing - Type 3
Manufacturer: Not Identified

Finding: There are missing end caps

Action: Replace

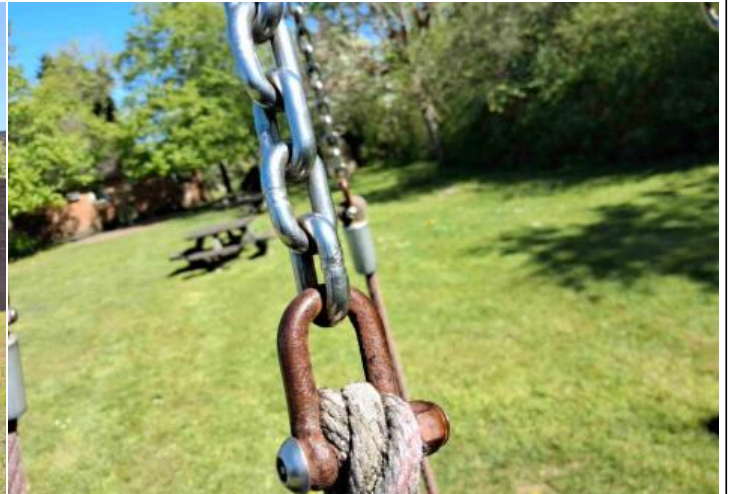
Item: Swings - Cantilever Swing - Type 3
Manufacturer: Not Identified

Finding: There is some wear to the shackles.

Action: Monitor for any further deterioration and replace when 40% worn

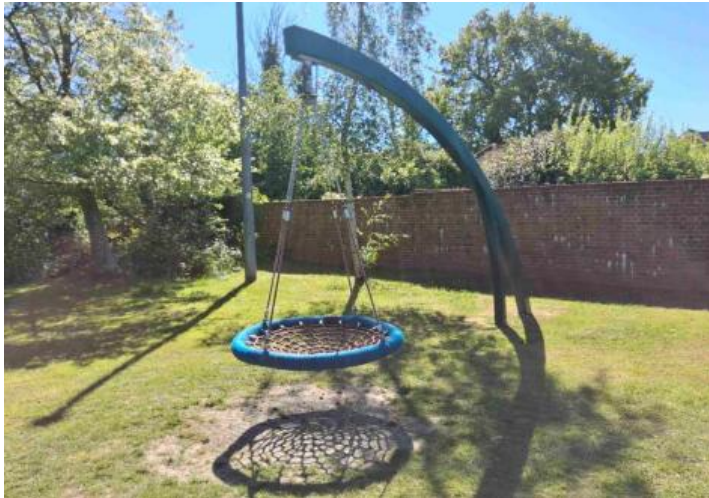
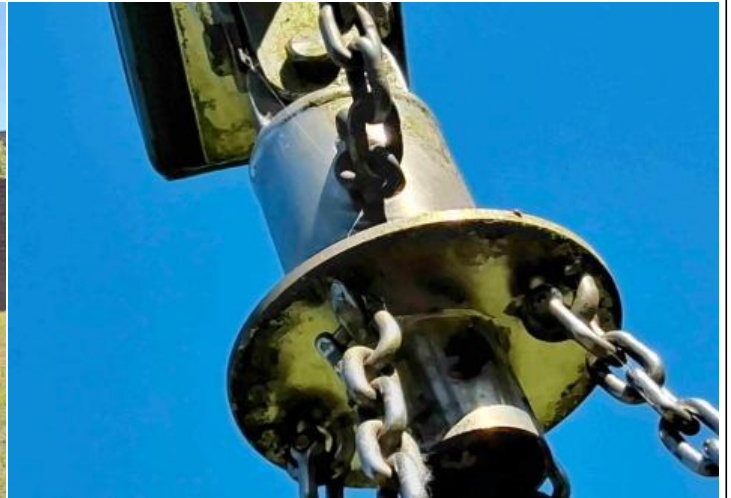
Item: Swings - Cantilever Swing - Type 3
Manufacturer: Not Identified

Finding: There is some notable evidence of chain wear

Action: Monitor for any further deterioration and replace when 40% worn

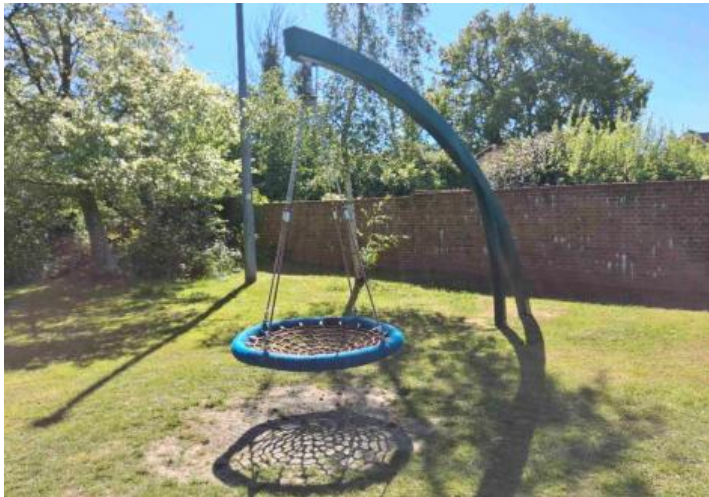
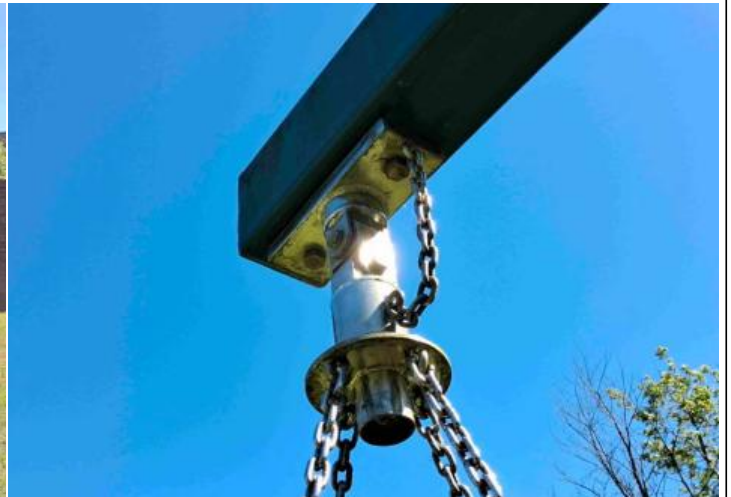
Item: Swings - Cantilever Swing - Type 3
Manufacturer: Not Identified

Finding: The universal joint is showing signs of wear

Action: Monitor for any further deterioration and repair / replace as required

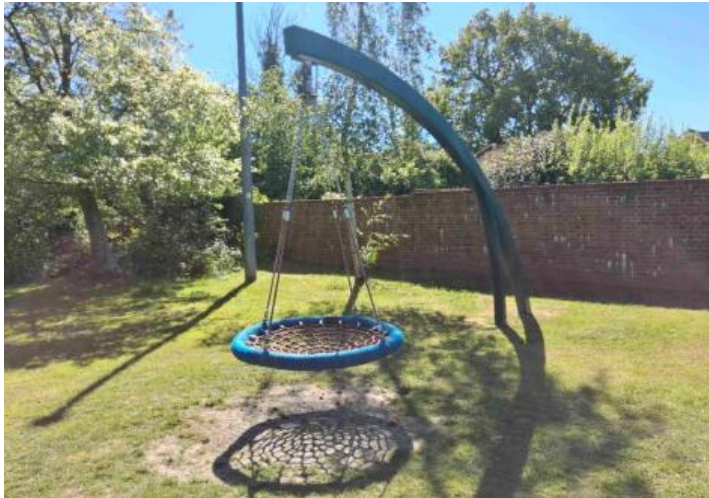
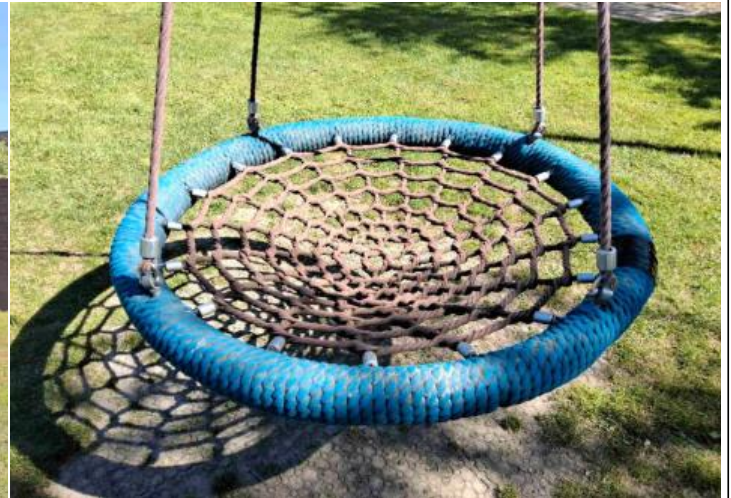
Item: Swings - Cantilever Swing - Type 3
Manufacturer: Not Identified

Finding: The incorrect seat design has been installed on this swing; there are unique designs for Type 1 and Type 3 swings that provide differing impact attenuating properties to the leading edges of the seat and/or has incorrectly aligned seat eye fixings which will lead to accelerated wear.

Action: Consider replacing with the correct design seat

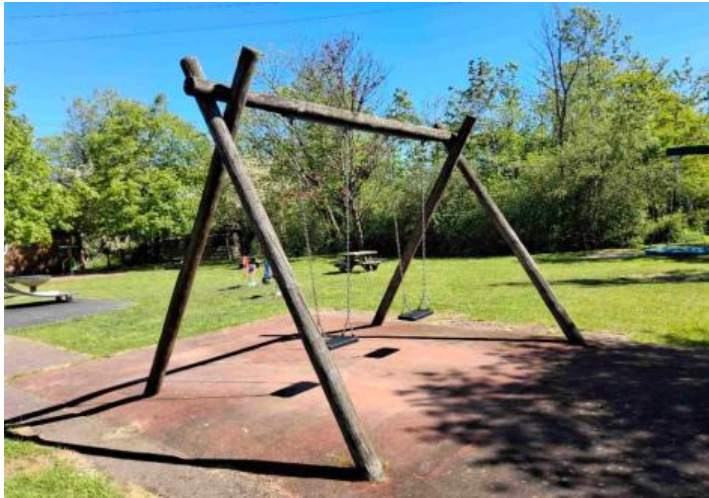
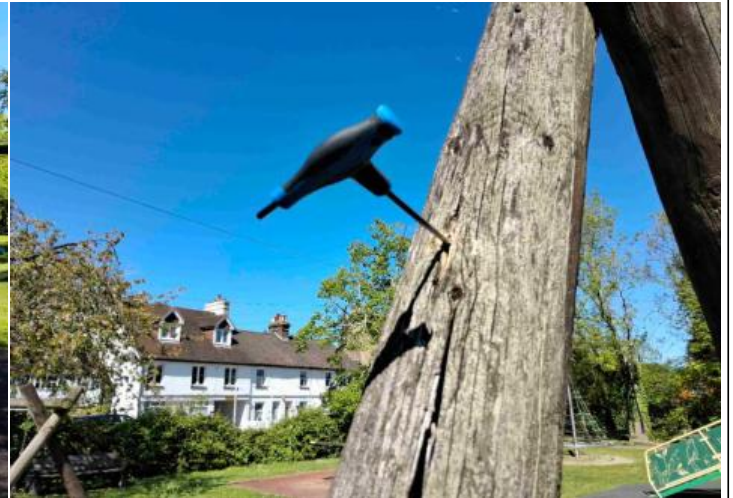
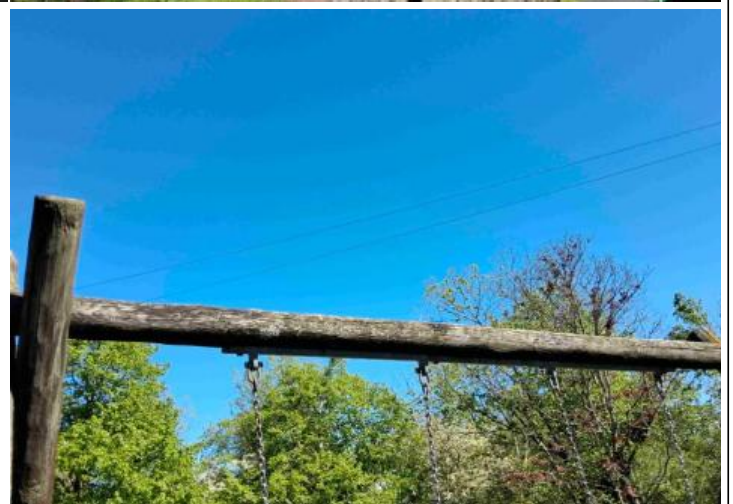
Item: Swings - 1 Bay 2 Seat (Flat)
Manufacturer: Playdale Playgrounds Ltd

Finding: There is some evidence of rot in the timber

Action: Monitor for any further deterioration and replace as required

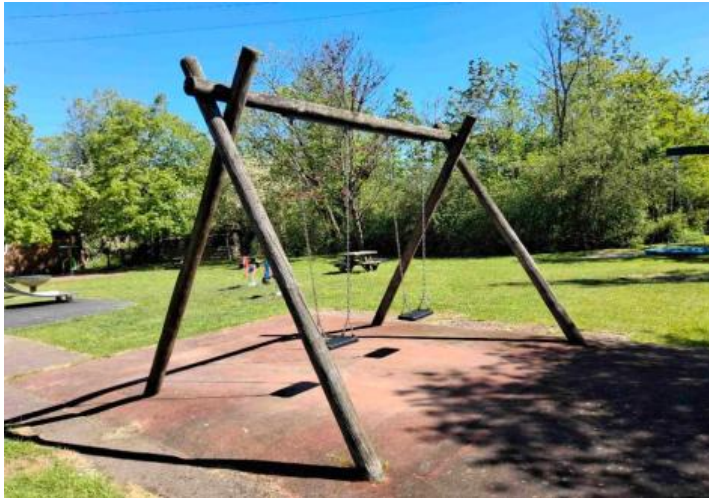
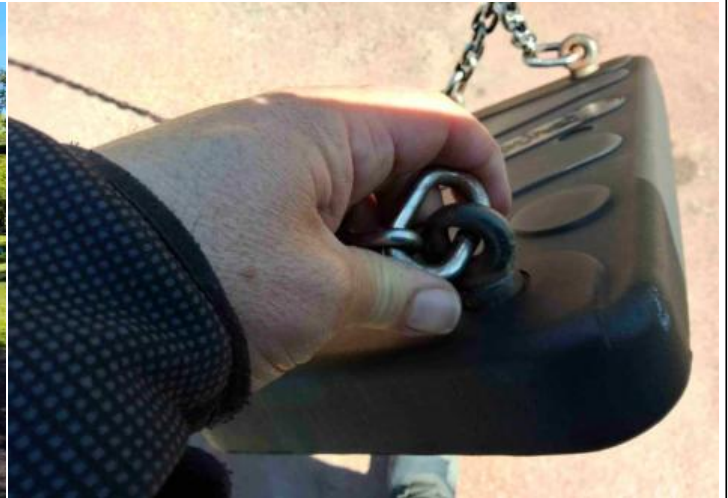
Item: Swings - 1 Bay 2 Seat (Flat)
Manufacturer: Playdale Playgrounds Ltd

Finding: There is some wear to the connecting links

Action: Monitor for any further deterioration and replace when 40% worn

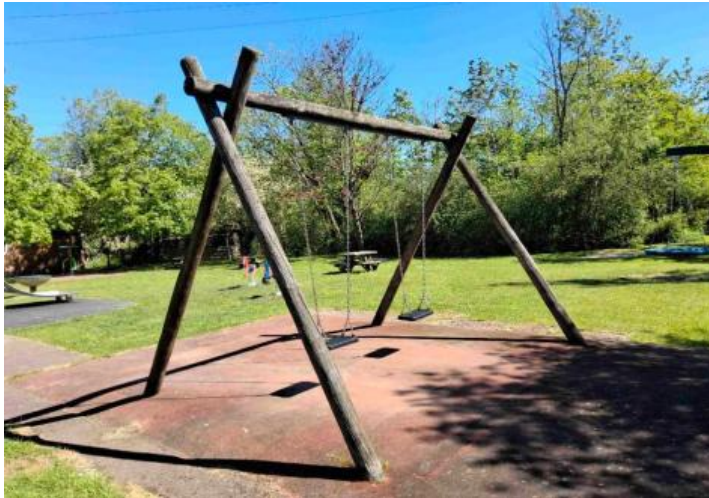
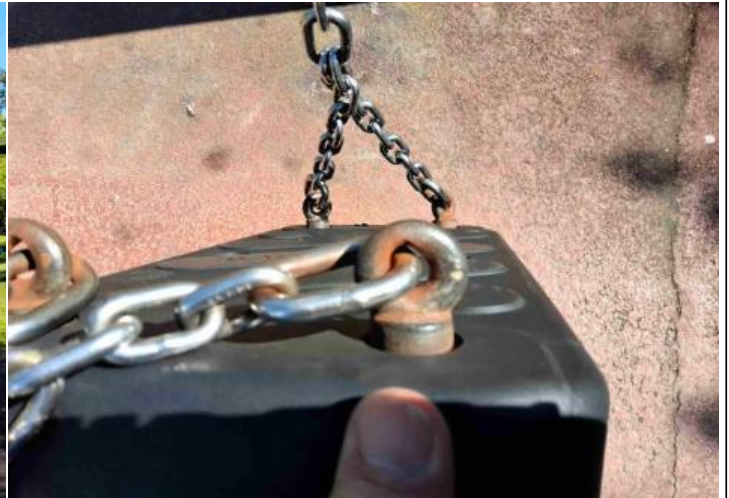
Item: Swings - 1 Bay 2 Seat (Flat)
Manufacturer: Playdale Playgrounds Ltd

Finding: The swing seat connectors have some wear present

Action: Monitor for further deterioration and replace when 40% worn

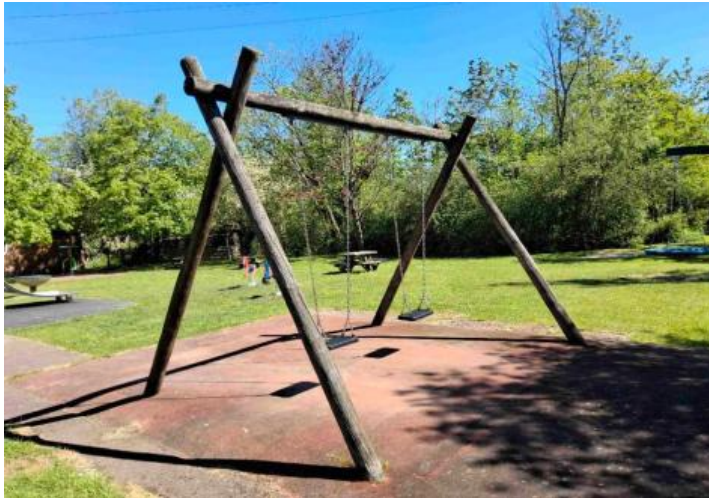
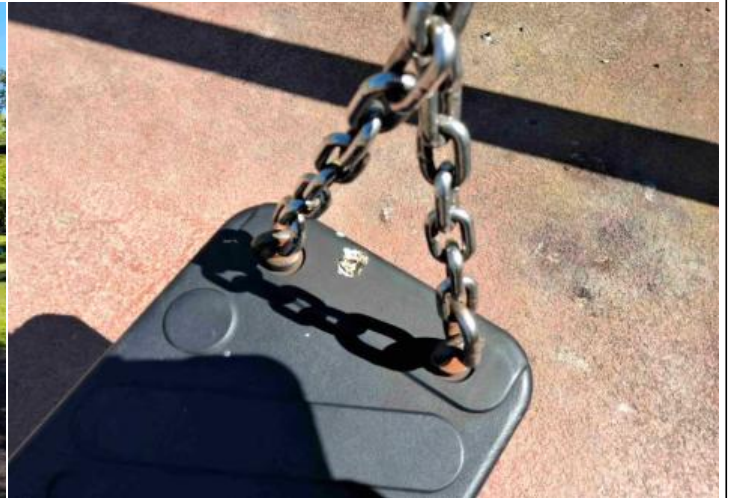
Item: Swings - 1 Bay 2 Seat (Flat)
Manufacturer: Playdale Playgrounds Ltd

Finding: The swing seat connectors are loose

Action: Tighten to secure

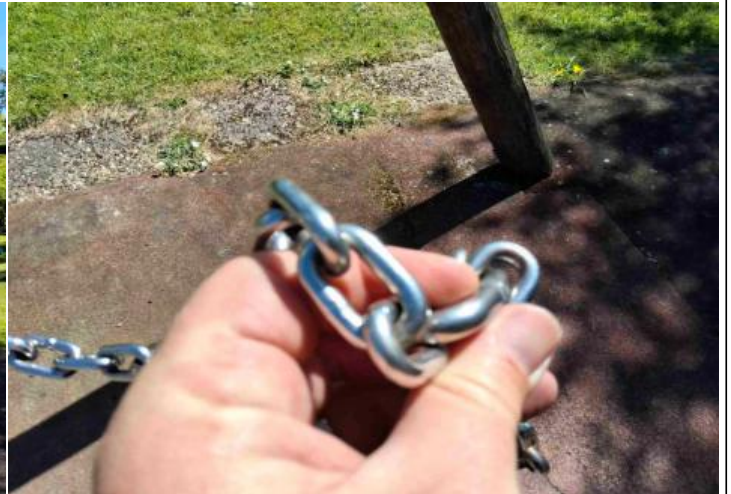
Item: Swings - 1 Bay 2 Seat (Flat)
Manufacturer: Playdale Playgrounds Ltd

Finding: There is some notable evidence of chain wear

Action: Monitor for any further deterioration and replace when 40% worn

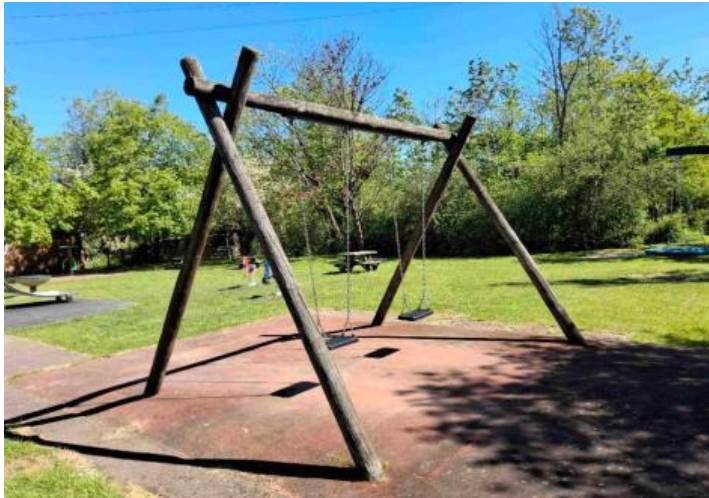
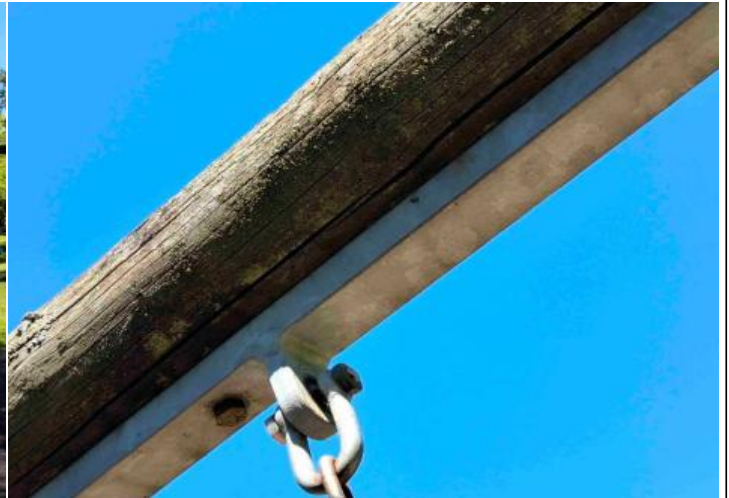
Item: Swings - 1 Bay 2 Seat (Flat)
Manufacturer: Playdale Playgrounds Ltd

Finding: The bush / bushes is / are showing signs of wear

Action: Monitor for any further deterioration and replace as required

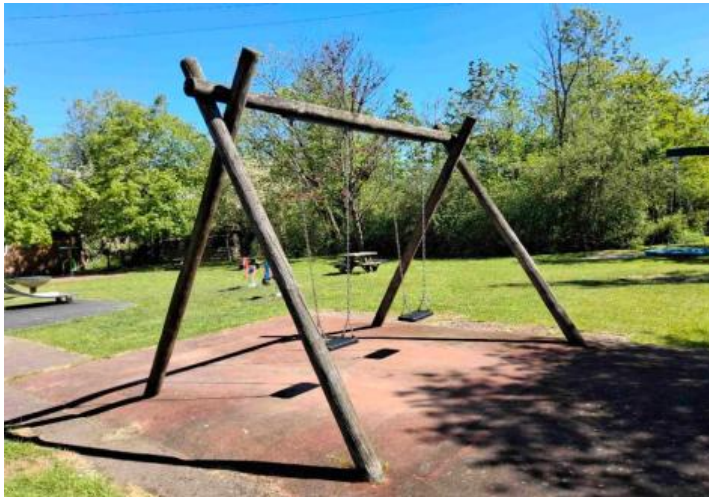
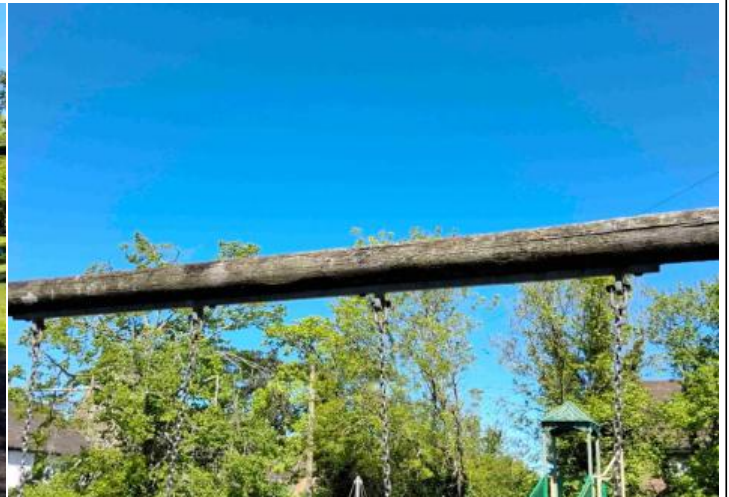
Item: Swings - 1 Bay 2 Seat (Flat)
Manufacturer: Playdale Playgrounds Ltd

Finding: There is algae or moss on the surface of the equipment that can lead to the onset of rot

Action: Monitor condition of the timbers (rot), clean and treat appropriately

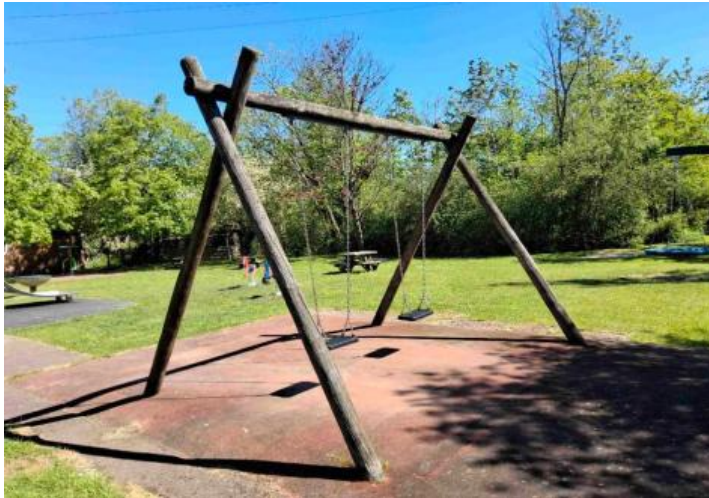
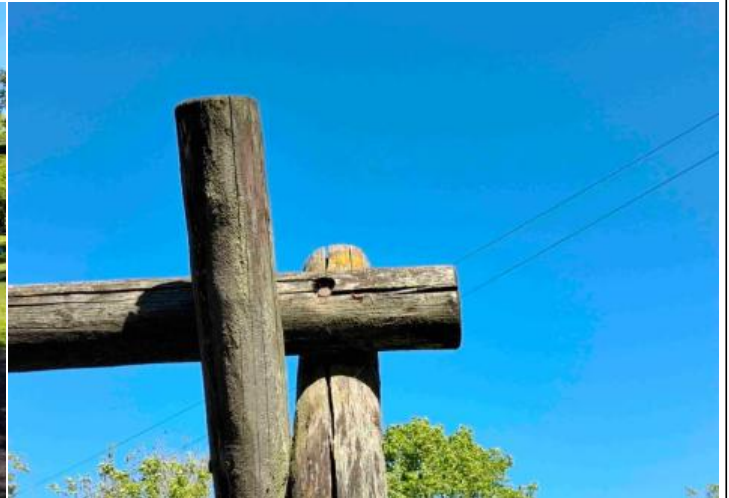
Item: Swings - 1 Bay 2 Seat (Flat)
Manufacturer: Playdale Playgrounds Ltd

Finding: Bolt cap cover/s missing or damaged

Action: Replace

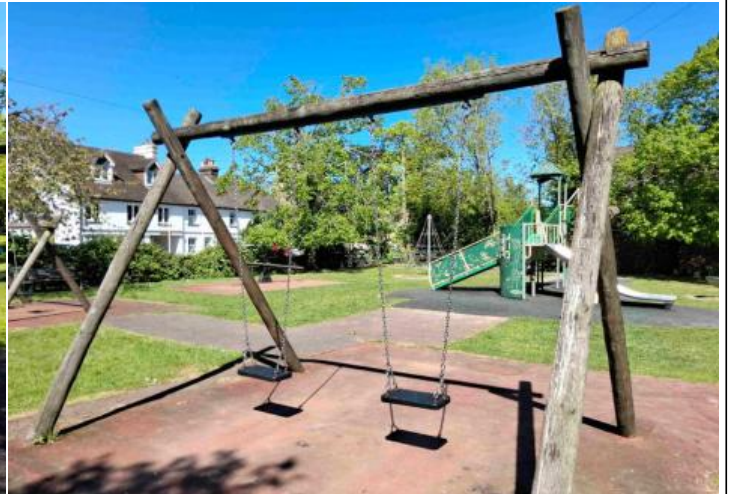
Item: Swings - 1 Bay 2 Seat (Flat)
Manufacturer: Playdale Playgrounds Ltd

Finding: The timber stain is in poor condition

Action: Prepare all affected parts and re-stain with an appropriate preservative

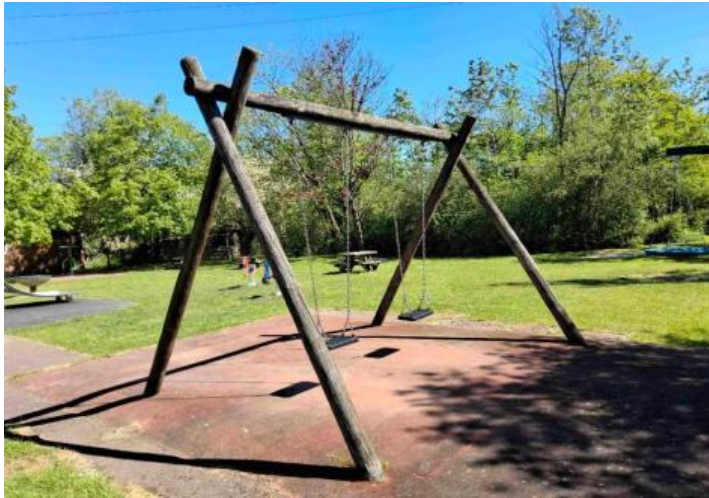
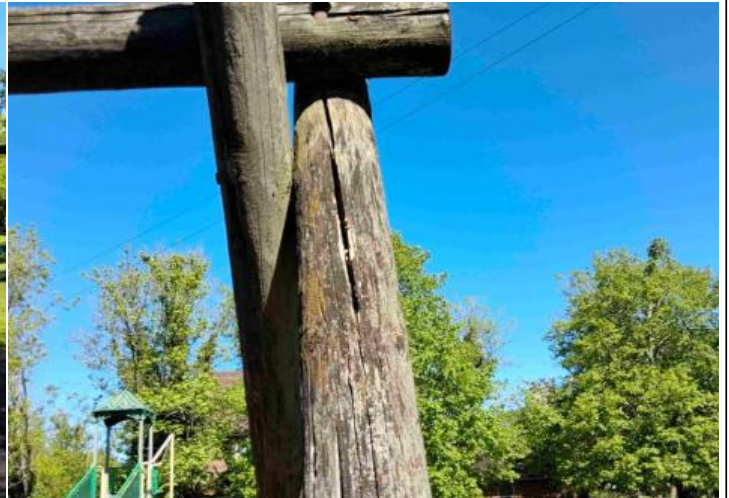
Item: Swings - 1 Bay 2 Seat (Flat)
Manufacturer: Playdale Playgrounds Ltd

Finding: The timber has a number of splits/shakes or air cracks and this may affect the stability or allow water ingress which will accelerate the rotting process. Timber splits may also create rough / splintering edges.

Action: Monitor, sand down any rough edges and ensure the splits do not cross through fixing points of the structure and/or cause any instability

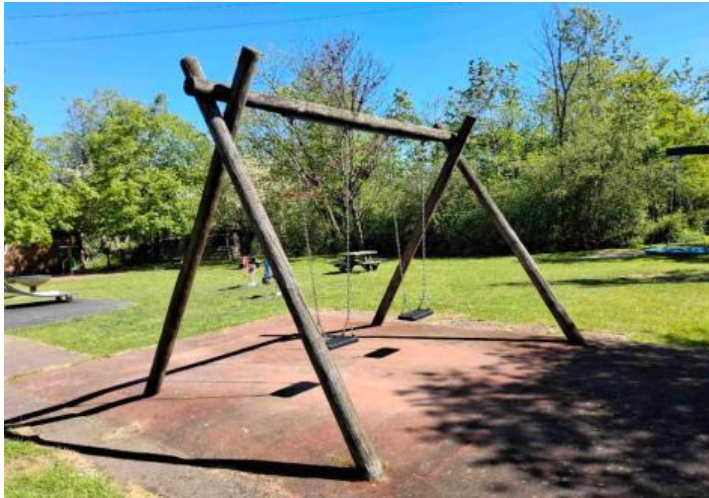
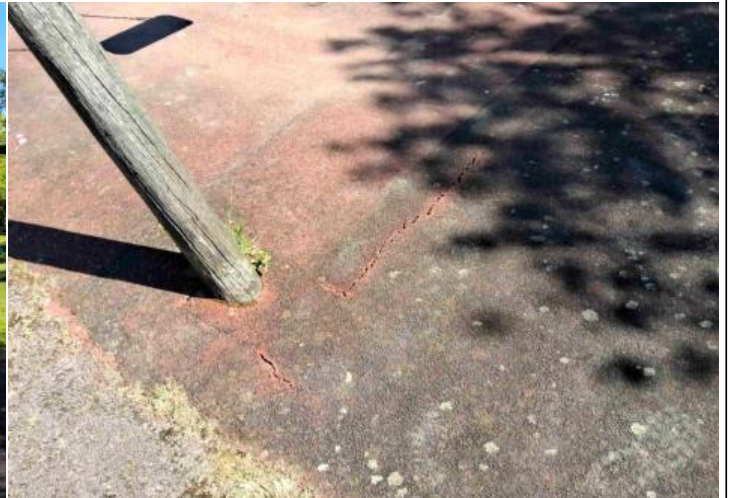
Item: Swings - 1 Bay 2 Seat (Flat)
Manufacturer: Playdale Playgrounds Ltd

Finding: There is moderate damage to the surface

Action: Repair the damaged areas of surfacing

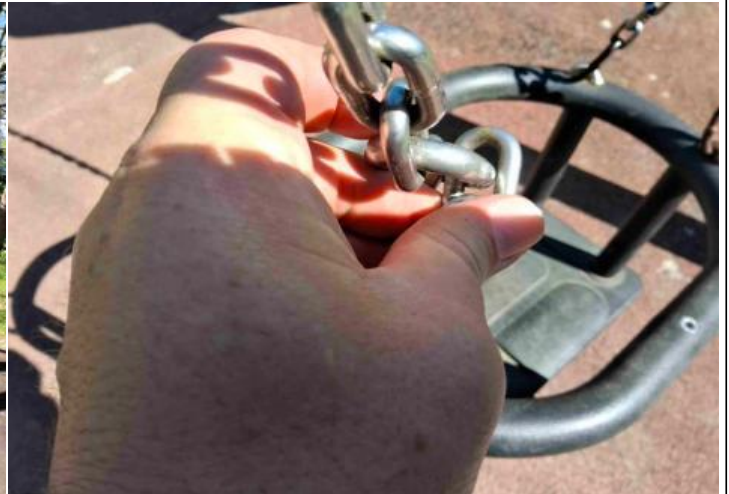
Item: Swings - 1 Bay 2 Seat (Cradle)
Manufacturer: Playdale Playgrounds Ltd

Finding: There is some notable evidence of chain wear

Action: Monitor for any further deterioration and replace when 40% worn

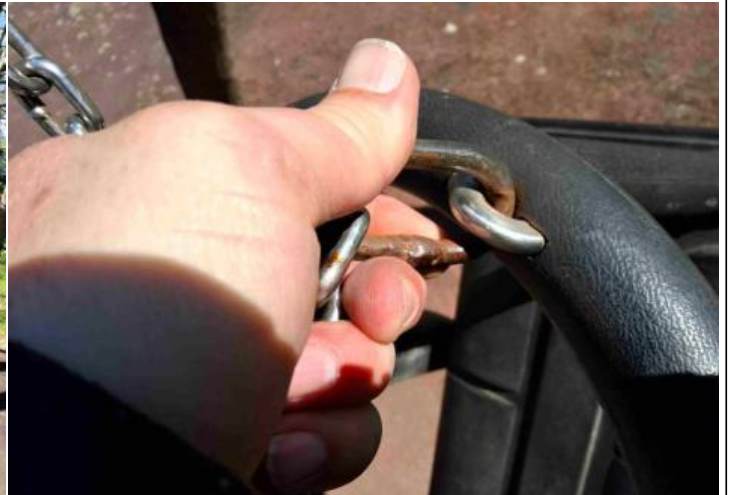
Item: Swings - 1 Bay 2 Seat (Cradle)
Manufacturer: Playdale Playgrounds Ltd

Finding: There is some wear to the connecting links

Action: Monitor for any further deterioration and replace when 40% worn

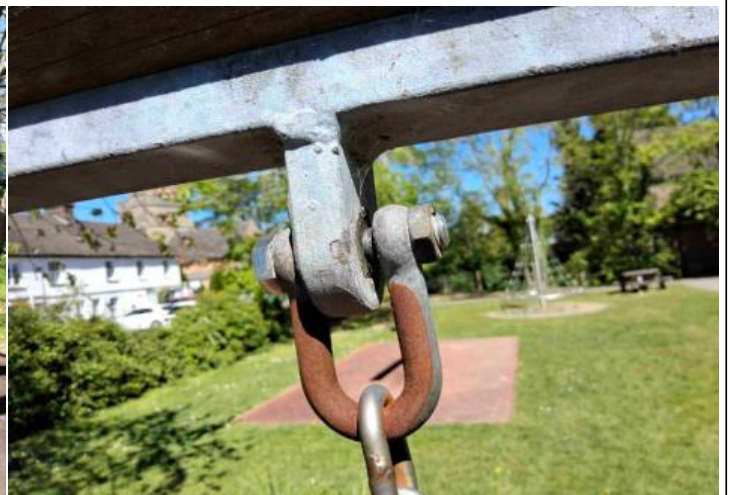
Item: Swings - 1 Bay 2 Seat (Cradle)
Manufacturer: Playdale Playgrounds Ltd

Finding: The bush / bushes is / are showing signs of wear

Action: Monitor for any further deterioration and replace as required
