Annual Inspection

Rusper Parish Council

High Street Playground

High Street, Rusper, West Sussex, RH12 4PX

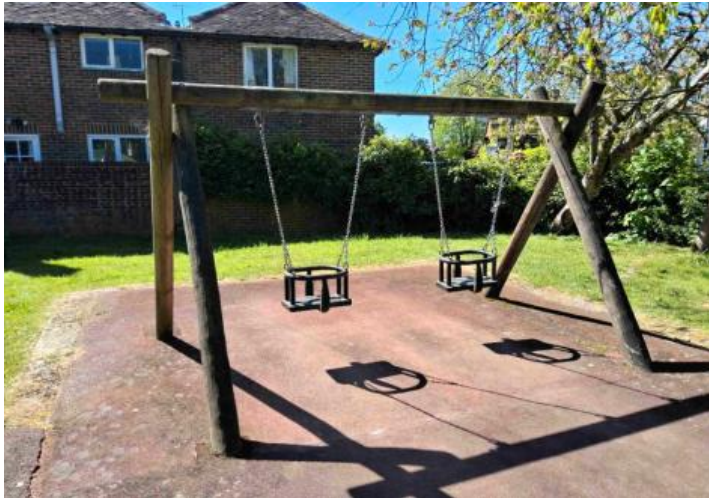
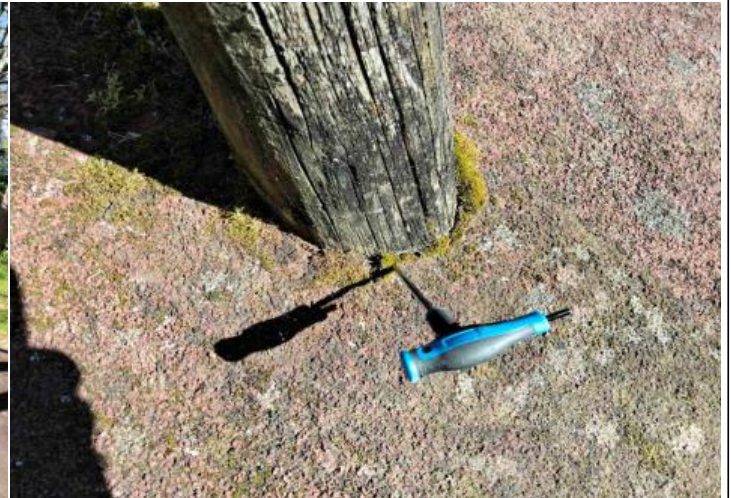
Item: Swings - 1 Bay 2 Seat (Cradle)
Manufacturer: Playdale Playgrounds Ltd

Finding: There is some evidence of rot in the timber

Action: Monitor for any further deterioration and replace as required

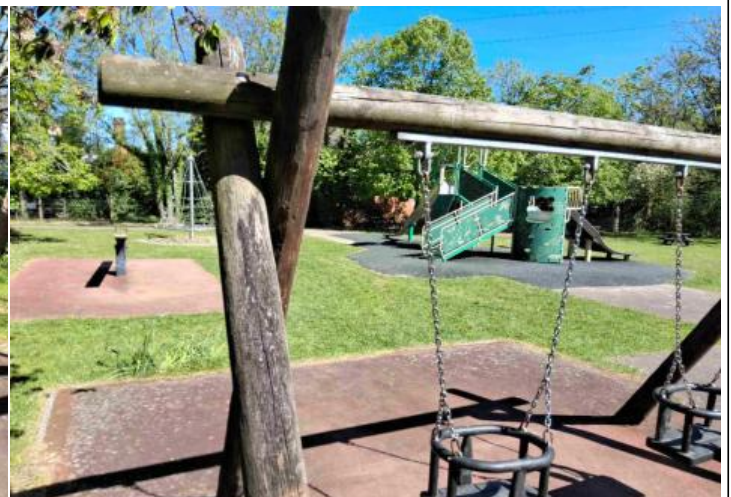
Item: Swings - 1 Bay 2 Seat (Cradle)
Manufacturer: Playdale Playgrounds Ltd

Finding: The timber stain is in poor condition

Action: Prepare all affected parts and re-stain with an appropriate preservative

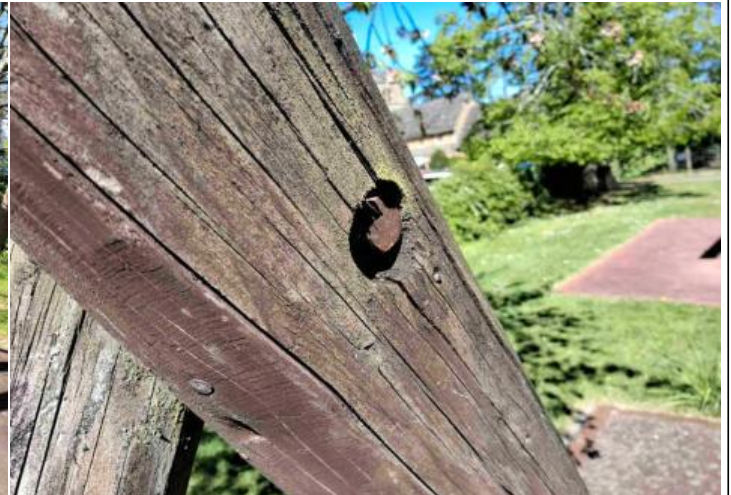
Item: Swings - 1 Bay 2 Seat (Cradle)
Manufacturer: Playdale Playgrounds Ltd

Finding: Bolt cap cover/s missing or damaged

Action: Replace

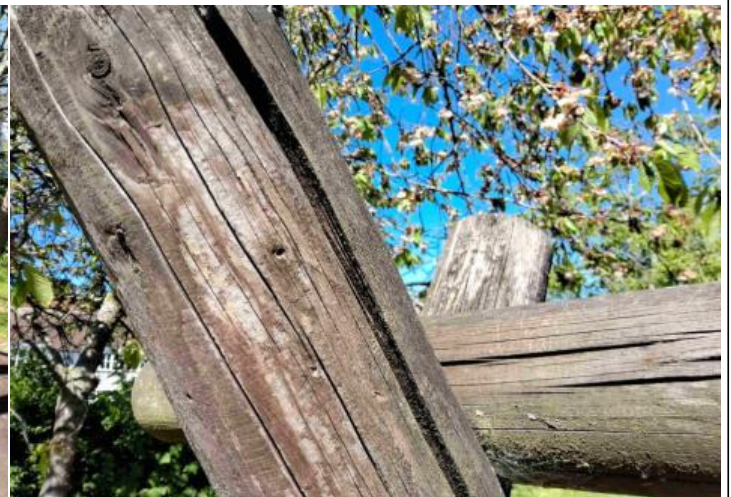
Item: Swings - 1 Bay 2 Seat (Cradle)
Manufacturer: Playdale Playgrounds Ltd

Finding: The timber has a number of splits/shakes or air cracks and this may affect the stability or allow water ingress which will accelerate the rotting process. Timber splits may also create rough / splintering edges.

Action: Monitor, sand down any rough edges and ensure the splits do not cross through fixing points of the structure and/or cause any instability

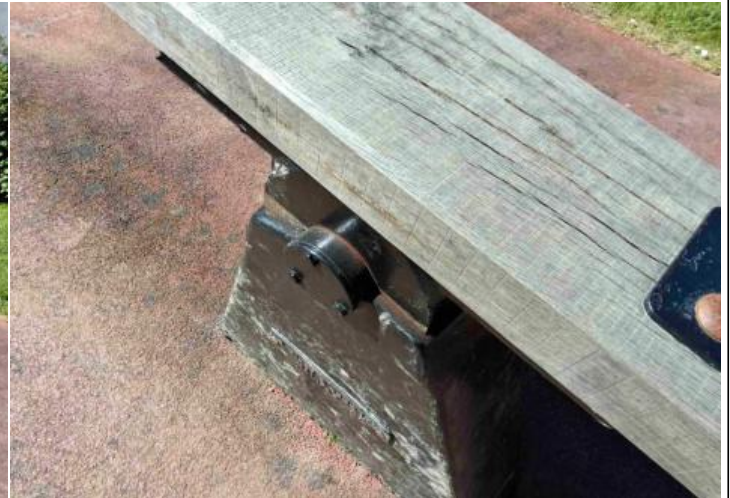
Item: Rocking Equipment - See Saw
Manufacturer: Hirst & Sons Ltd

Finding: There is some play within the pivot mechanism

Action: Monitor for any further deterioration and repair as required

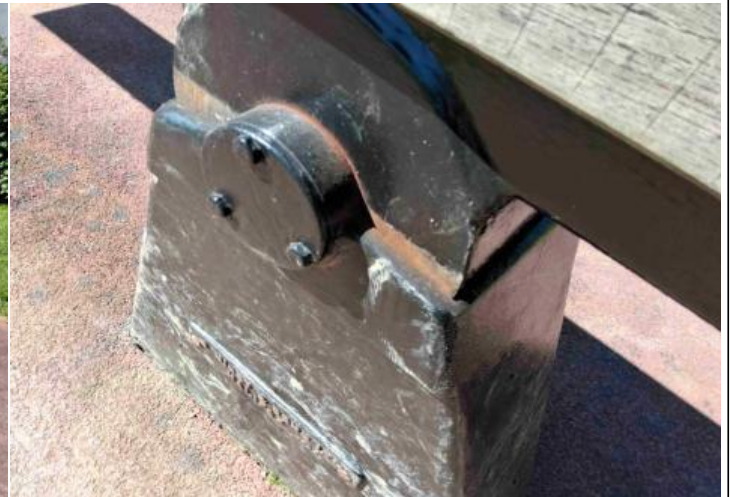
Item: Rocking Equipment - See Saw
Manufacturer: Hirst & Sons Ltd

Finding: The paintwork on this item has been damaged or worn exposing the metal underneath which is rusting / corroding

Action: Treat affected areas and repaint

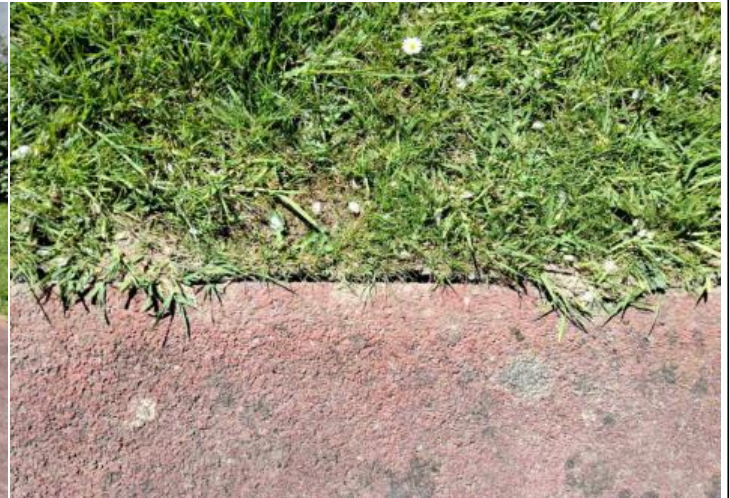
Item: Rocking Equipment - See Saw
Manufacturer: Hirst & Sons Ltd
Risk Level: L - Low Risk
Surface: Wet Pour

Finding: There are gaps opening between the surfacing and the edging surround or between the joints in the surfacing
Action: Monitor for any further deterioration and repair as required

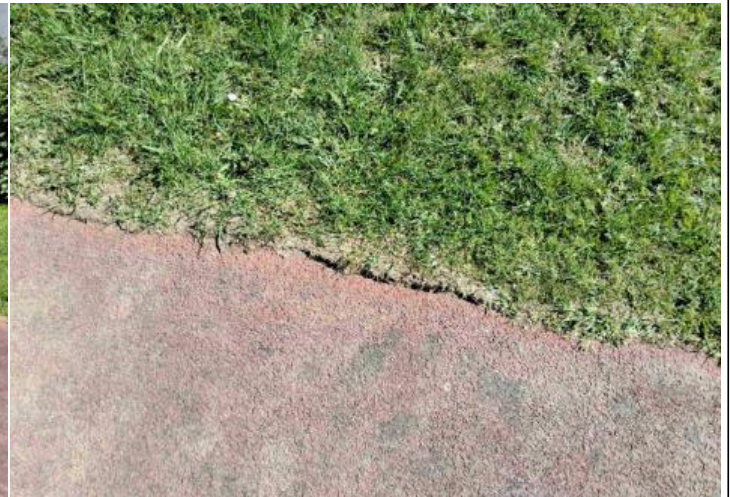
Item: Rocking Equipment - See Saw
Manufacturer: Hirst & Sons Ltd
Risk Level: L - Low Risk
Surface: Wet Pour

Finding: There is some damage to the surface
Action: Monitor for any further deterioration and repair as required

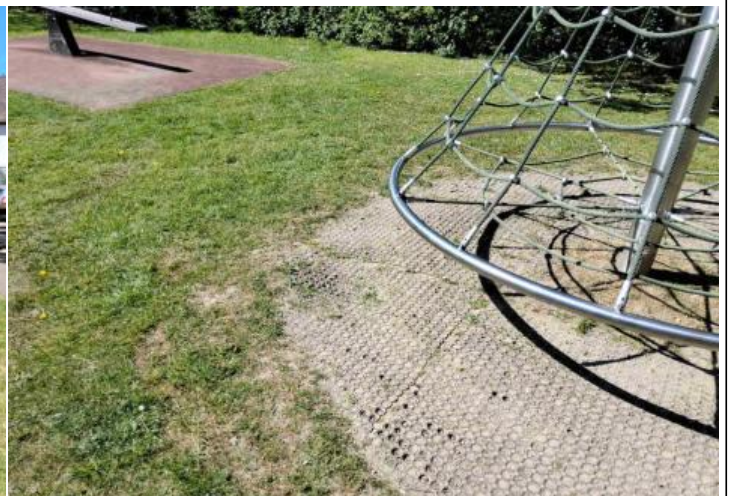
Finding: The grass mat surface is notably uneven in places and may cause users to trip or roll ankles

Action: Level the surface if possible and infill any voids

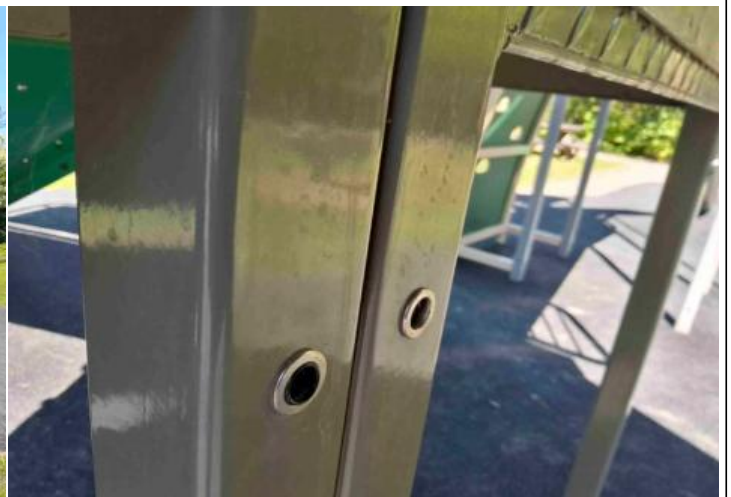
Finding: Insert/s missing or damaged

Action: Replace
