Annual Inspection

Rusper Parish Council

High Street Playground

High Street, Rusper, West Sussex, RH12 4PX

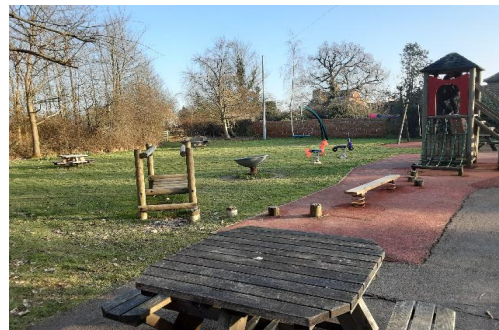
Item: Site General
Manufacturer: Not Applicable
Surface Type: N/A
Item Quantity: 1
Equipment Compliance: N/A
Surface Area Compliance: N/A

There is moderate damage to the surface - Repair the damaged areas of surfacing

There is algae, silt or moss growth on the surface resulting in slippery conditions - Clean and treat appropriately

The safety surface around the area is beginning to wear - Monitor for any further deterioration and repair as required

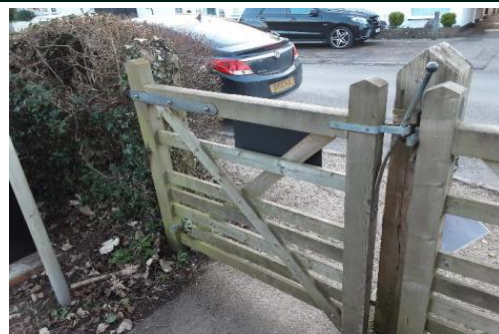
Item: Gate
Manufacturer: Owner/Operator
Surface Type: N/A
Item Quantity: 1
Equipment Compliance: N/A
Surface Area Compliance: N/A

The gate is not operating correctly - Take effective action to ensure the gate closes between 4 and 8 seconds

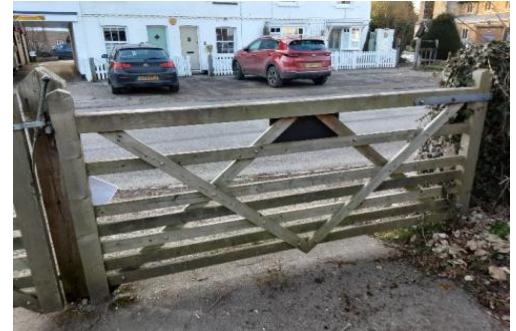
Item: Gate - Maintenance
Manufacturer: Owner/Operator
Surface Type: N/A
Item Quantity: 1
Equipment Compliance: N/A
Surface Area Compliance: N/A

There is no padlock on the maintenance gate - Provide a padlock to secure the gate

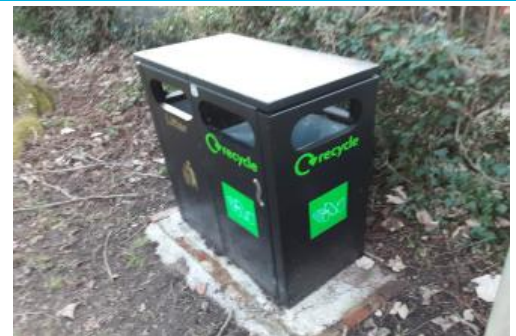
Item: Litter Bin
Manufacturer: Owner/Operator
Surface Type: N/A
Item Quantity: 1
Equipment Compliance: N/A
Surface Area Compliance: N/A

This item is satisfactory - no work required -

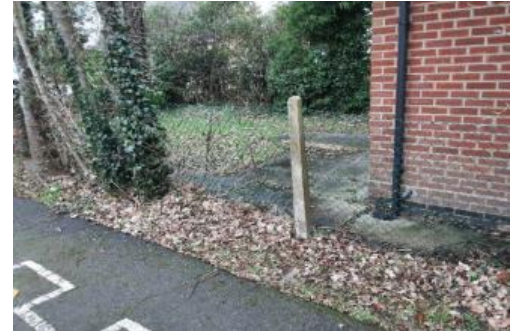
Item: Fence - Chainlink
Manufacturer: Owner/Operator
Surface Type: N/A
Item Quantity: 1
Equipment Compliance: N/A
Surface Area Compliance: N/A

This item is satisfactory - no work required -

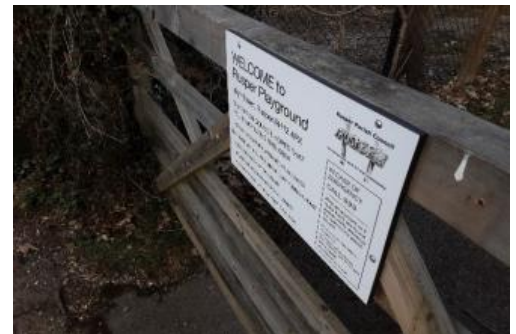
Item: Sign
Manufacturer: Owner/Operator
Surface Type: N/A
Item Quantity: 1
Equipment Compliance: N/A
Surface Area Compliance: N/A

This item is satisfactory - no work required -

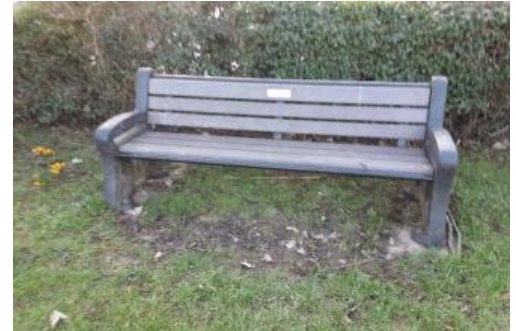
Item: Bench
Manufacturer: Owner/Operator
Surface Type: Grass
Item Quantity: 2
Equipment Compliance: N/A
Surface Area Compliance: N/A

This item is satisfactory - no work required -

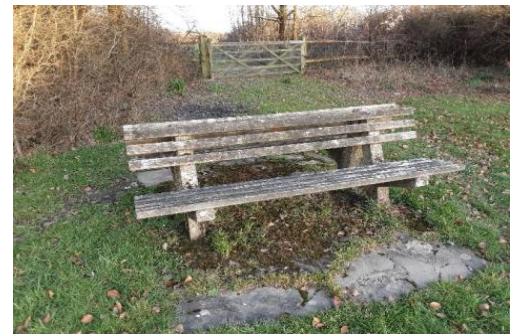
Item: Bench
Manufacturer: Owner/Operator
Surface Type: N/A
Item Part Number:
Item Quantity: 3
Equipment Compliance: N/A
Surface Area Compliance: N/A
Total Findings: 3

There is weed / vegetation growth on, between, or around the edges of the surfacing - Remove weed / vegetation growth

There is some evidence of rot in the timber - Monitor for any further deterioration and replace as required

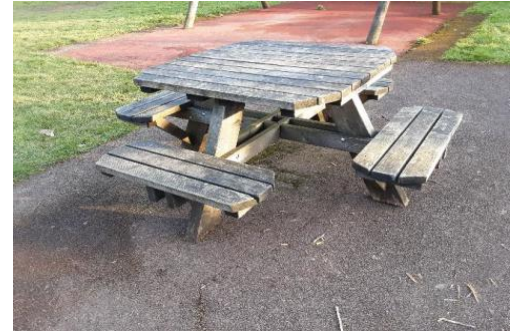
Item: Picnic Table
Manufacturer: Owner/Operator
Surface Type: N/A
Item Part Number:
Item Quantity: 6
Equipment Compliance: N/A
Surface Area Compliance: N/A
Total Findings: 1

The table/s is/are not secured to the ground and there is some potential for the item/s to be moved within falling spaces of equipment - Secure to the ground

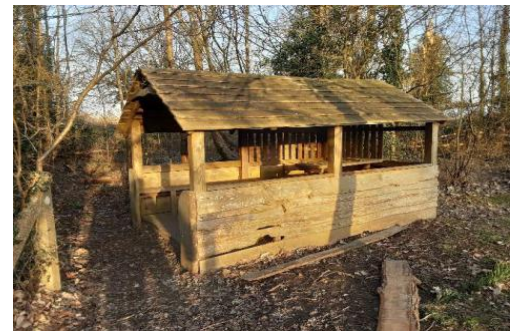
Item: Shelter
Manufacturer: Owner/Operator
Surface Type: N/A
Item Quantity: 1
Equipment Compliance: N/A
Surface Area Compliance: N/A
Total Findings: 2

There are areas or parts of the timber on the structure that have rotted - Replace all affected timbers

The item has been damaged and there are planks of wood scattered around the area - Remove all loose timber and repair the item

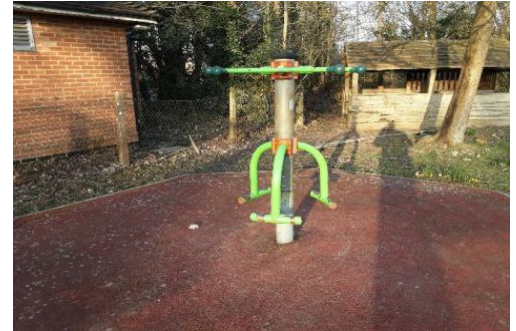
Item: Low Rotator
Manufacturer: Sutcliffe Play Limited
Surface Type: Wet Pour
Item Quantity: 1
Equipment Compliance: Yes
Surface Area Compliance: Yes

The paintwork on this item has been damaged or worn exposing the metal underneath which is rusting - Treat any rusting components and repaint

There are gaps opening between the surfacing and the edging surround or between the joints in the surfacing - Monitor for any further deterioration and repair as required

There is some damage to the handgrips - Replace all affected components

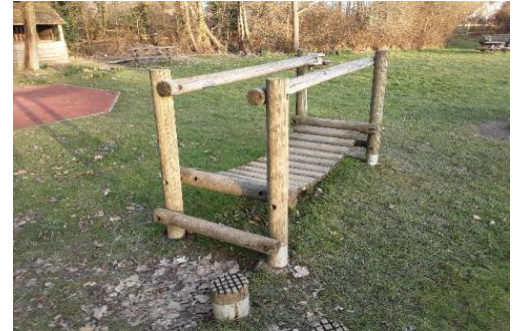
Item: Activity Trail
Manufacturer: Playahead
Surface Type: Wet Pour
Item Quantity: 1
Equipment Compliance: No
Surface Area Compliance: No

The adjacent log beam forms a hard object within the falling space of the equipment in contravention of the requirements of BS EN 1176 Part 1 - Monitor - No remedial work recommended

The surfacing dimensions are short and do not meet with the requirements of the current applicable standard - Monitor - no remedial action recommended

The paintwork on the spring has been damaged or worn exposing the metal underneath which is rusting - Treat any rusting components and repaint

The timber has a number of splits/shakes or air cracks and this may affect the stability or allow water ingress which will accelerate the rotting process - Monitor to ensure the splits do not cross through fixing points of the structure and/or cause any instability

There is/are bolt cap covers missing or damaged on the item - Replace missing or damaged bolt cap covers

There is some evidence of rot in the timber - Monitor for any further deterioration and replace as required

There is some damage to the timber - Monitor for any further deterioration and repair as required

There is some minor damage to the surface - Monitor for any further deterioration and repair as required

The rope connectors are showing signs of corrosion - Monitor for any further deterioration and replace as required

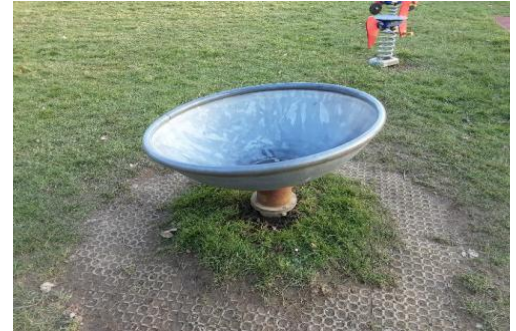
Item: Spinner Bowl
Manufacturer: Sutcliffe Play Limited
Surface Type: Grass Matrix Tiles
Item Quantity: 1
Equipment Compliance: Yes
Surface Area Compliance: Yes

The grass mats are silted up and the soil is compacted; this may have an effect on the impact absorbing properties of the surface - Consider HIC testing impact absorbing properties to ensure the correct surface qualities are maintained for the equipment and replace as required

The paintwork on this item has been damaged or worn exposing the metal underneath which is rusting - Treat any rusting components and repaint

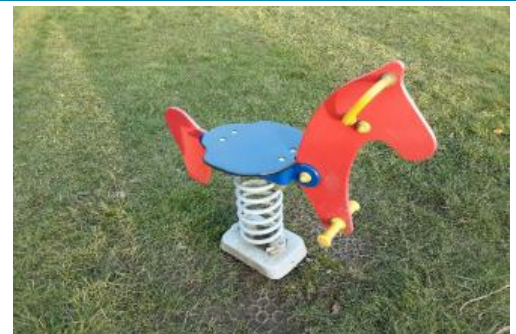
Item: Spring Horse
Manufacturer: Ledon
Surface Type: Grass Matrix Tiles
Item Quantity: 1
Equipment Compliance: Yes
Surface Area Compliance: Yes

This item is satisfactory - no work required -

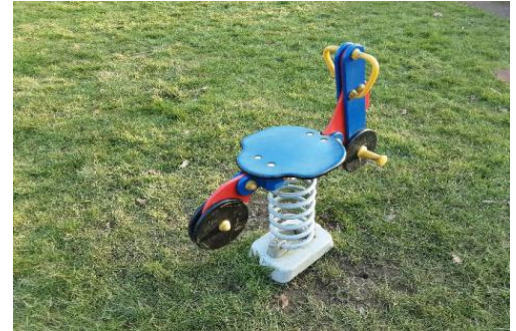
Item: Spring Motorbike
Manufacturer: Ledon
Surface Type: Grass Matrix Tiles
Item Quantity: 1
Equipment Compliance: Yes
Surface Area Compliance: Yes

There is some graffiti present - Remove the graffiti

The spring clamps are loose - Tighten all loose fixings

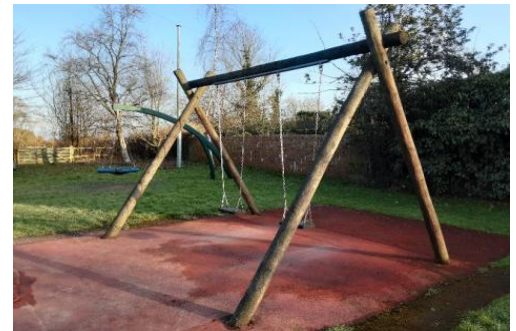
Item: 1 Bay 2 Seat (Flat)
Manufacturer: Playdale Playgrounds Ltd
Surface Type: Wet Pour
Item Quantity: 1
Equipment Compliance: Yes
Surface Area Compliance: Yes

The timber has a number of splits/shakes or air cracks and this may affect the stability or allow water ingress which will accelerate the rotting process - Monitor to ensure the splits do not cross through fixing points of the structure and/or cause any instability

The bushes are showing signs of wear - Monitor for any further deterioration and replace as required

The seat has minor damage or wear - Monitor for any further deterioration and replace as required

There is some notable evidence of chain wear - Monitor for any further deterioration and replace when 40% worn

There is moderate damage to the surface - Repair the damaged areas of surfacing

There is some evidence of rot in the timber - Monitor for any further deterioration and replace as required

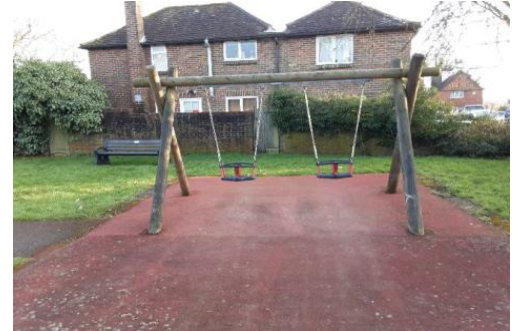
Item: 1 Bay 2 Seat (Cradle)
Manufacturer: Playdale Playgrounds Ltd
Surface Type: Wet Pour
Item Quantity: 1
Equipment Compliance: No
Surface Area Compliance: Yes

The timber has a number of splits/shakes or air cracks and this may affect the stability or allow water ingress which will accelerate the rotting process - Monitor to ensure the splits do not cross through fixing points of the structure and/or cause any instability

There is some evidence of rot in the timber - Monitor for any further deterioration and replace as required

There is some notable evidence of chain wear - Monitor for any further deterioration and replace when 40% worn

The swing seat frames are corroding - Monitor for any further deterioration and replace as required

The bushes are showing signs of wear - Monitor for any further deterioration and replace as required

There is/are bolt cap covers missing or damaged on the item - Replace missing or damaged bolt cap covers

The seat has minor damage or wear - Monitor for any further deterioration and replace as required

One of the seat connectors is loose - Secure all loose connections

The connecting links are in excess of 8.6mm and less than 12mm and fail the requirements of BS EN 1176 Part 1; clause 4.2.13, Chains - Monitor - No remedial work recommended

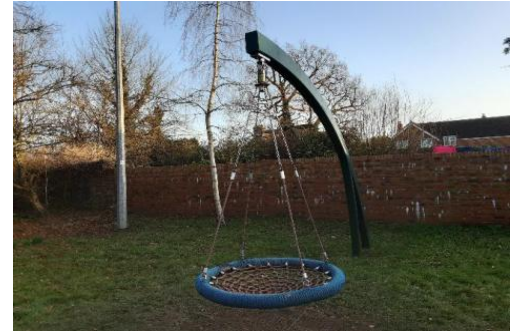
Item: Cantilever Swing - Type 3
Manufacturer: Not Identified
Surface Type: Grass Matrix Tiles
Item Quantity: 1
Equipment Compliance: No
Surface Area Compliance: Yes

The connecting links are in excess of 8.6mm and less than 12mm and fail the requirements of BS EN 1176 Part 1; clause 4.2.13, Chains - Monitor - No remedial work recommended

The incorrect seat design has been installed on this swing; there are unique designs for Type 1 and Type 3 swings that provide differing impact attenuating properties to the leading edges of the seat and/or has incorrectly aligned seat eye fixings which will lead to accelerated wear. - Consider replacing with the correct design seat

The grass mats are silted up and the soil is compacted; this may have an effect on the impact absorbing properties of the surface - Consider HIC testing impact absorbing properties to ensure the correct surface qualities are maintained for the equipment and replace as required

There is some wear to the shackles. - Monitor for any further deterioration and replace when 40% worn

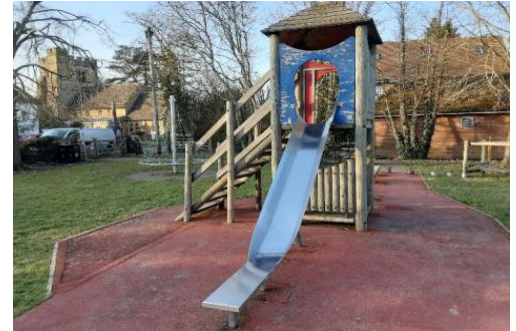
Item: Multi Play (Junior)
Manufacturer: Playdale Playgrounds Ltd
Surface Type: Wet Pour
Item Quantity: 1
Equipment Compliance: No
Surface Area Compliance: Yes

There is moderate damage to the surface - Repair the damaged areas of surfacing

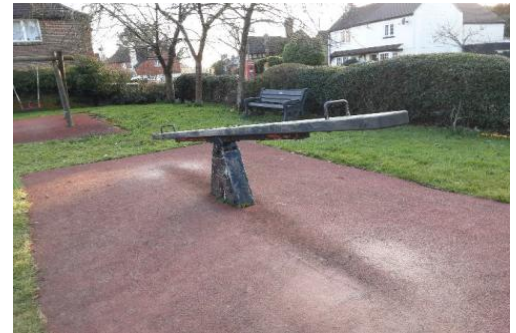
Item: See Saw
Manufacturer: Hirst & Sons Ltd
Surface Type: Wet Pour
Item Quantity: 1
Equipment Compliance: Yes
Surface Area Compliance: Yes

There is some minor wear to the pivot mechanism - Monitor for any further deterioration and repair as required

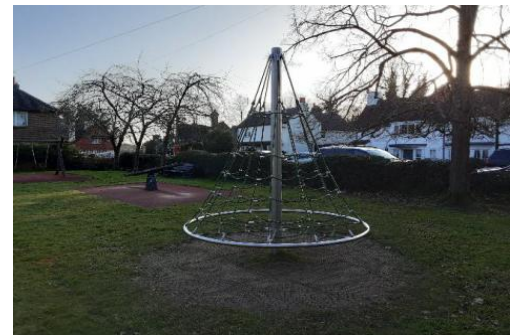
Item: Cone Climber
Manufacturer: Tayplay Ltd
Surface Type: Grass Matrix Tiles
Item Quantity: 1
Equipment Compliance: Yes
Surface Area Compliance: Yes

The grass mats are silted up and the soil is compacted; this may have an effect on the impact absorbing properties of the surface - Consider HIC testing impact absorbing properties to ensure the correct surface qualities are maintained for the equipment and replace as required

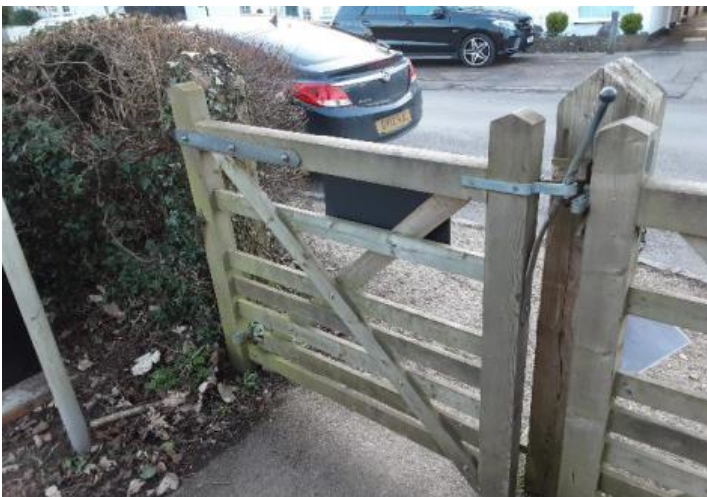
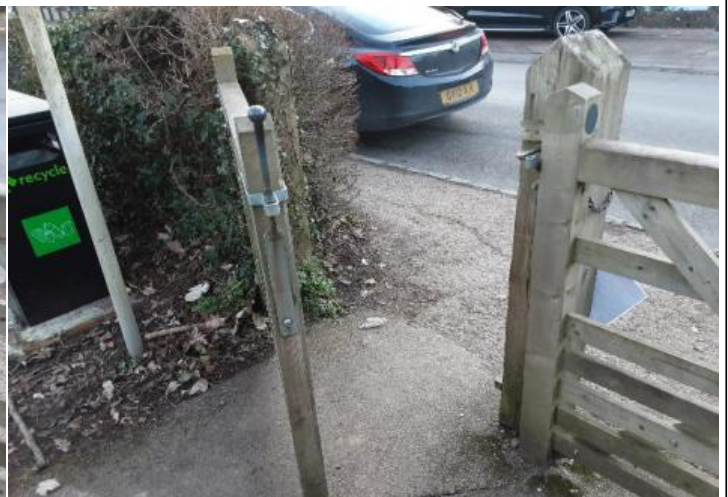
Item: Gates - Gate
Manufacturer: Owner/Operator

Finding: The gate is not operating correctly

Action: Take effective action to ensure the gate closes between 4 and 8 seconds

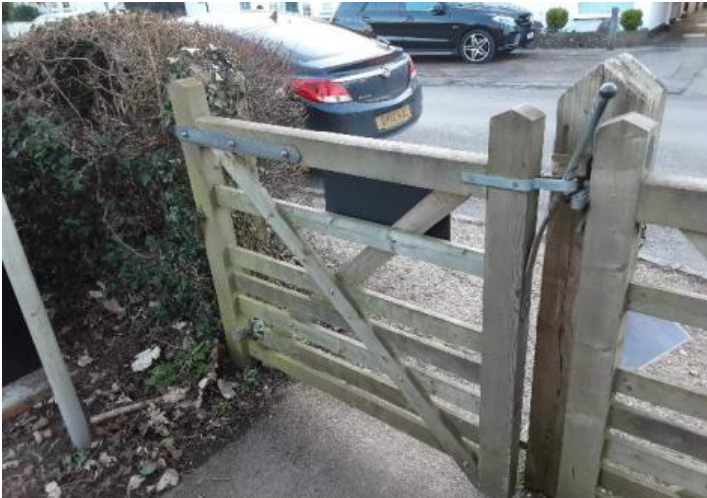
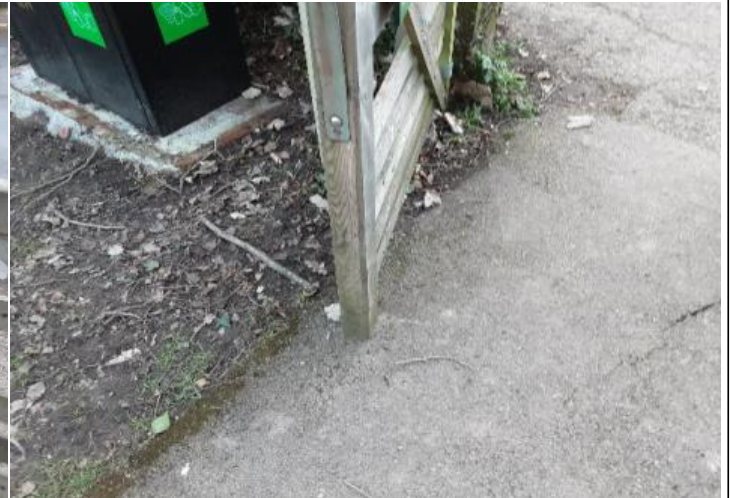
Item: Gates - Gate
Manufacturer: Owner/Operator

Finding: The gate is snagging on the surrounding surface preventing it from closing correctly

Action: Carry out remedial works to ensure the gate closes correctly

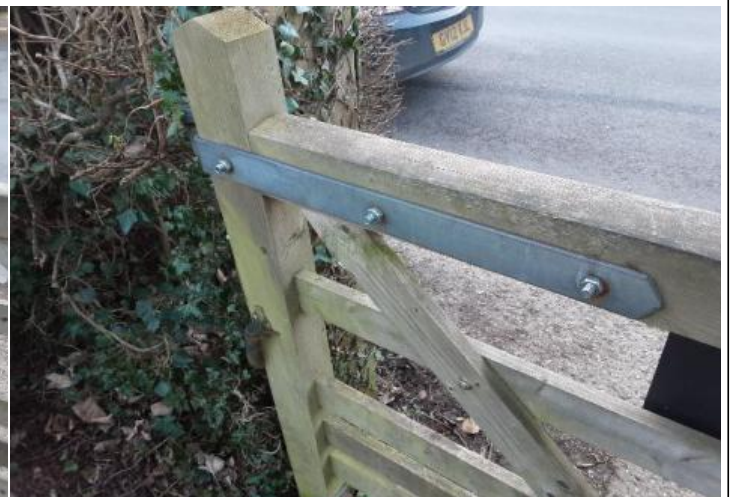
Item: Gates - Gate
Manufacturer: Owner/Operator

Finding: There are projecting bolt thread(s) present

Action: Remove excess thread length and deburr or provide cap

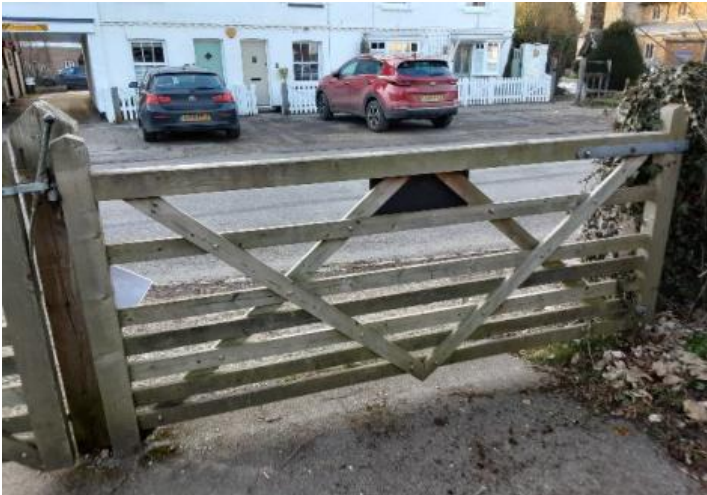
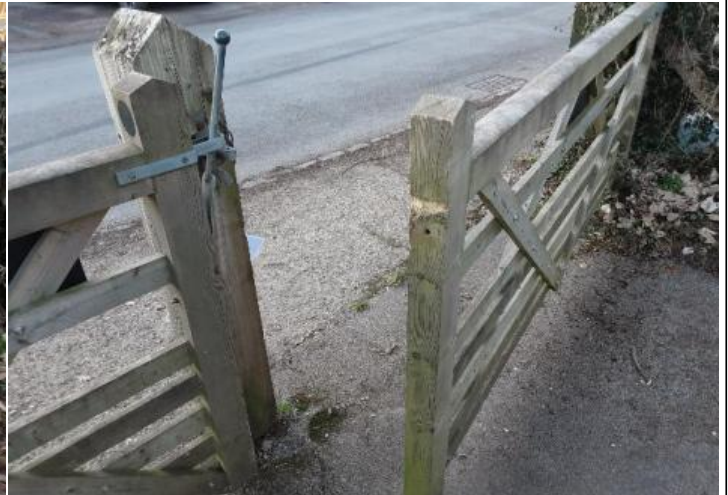
Item: Gates - Gate - Maintenance
Manufacturer: Owner/Operator

Finding: There is no padlock on the maintenance gate

Action: Provide a padlock to secure the gate

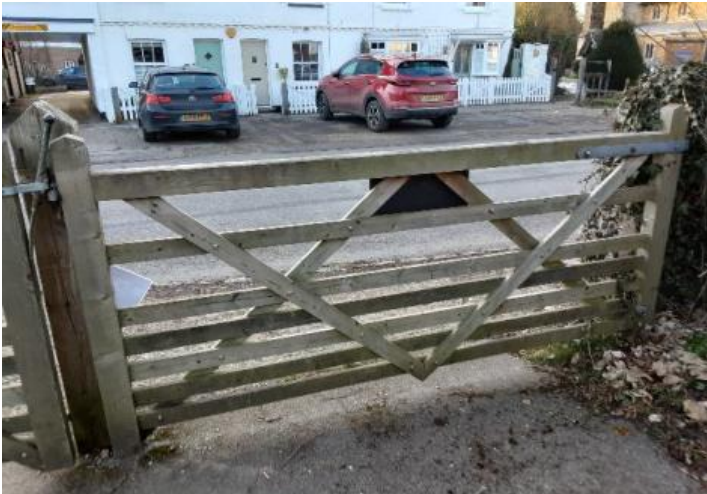
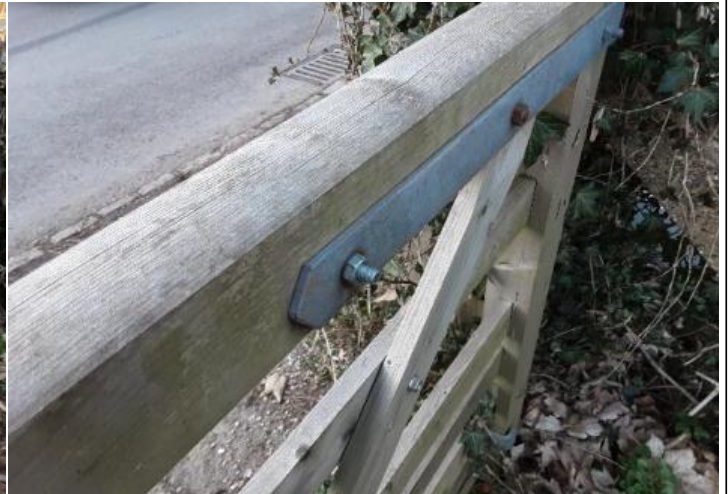
Item: Gates - Gate - Maintenance
Manufacturer: Owner/Operator

Finding: There are projecting bolt thread(s) present

Action: Remove excess thread length and deburr or provide cap

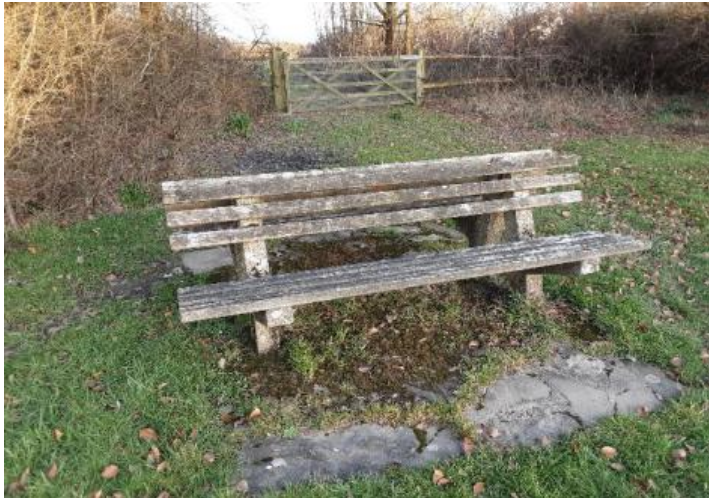
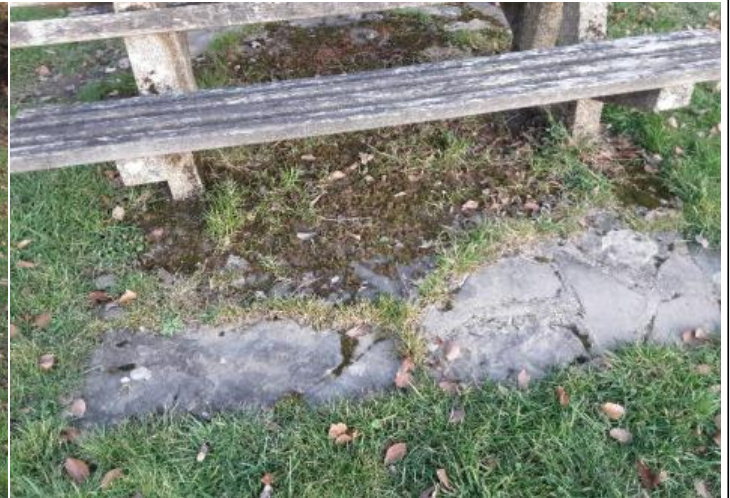
Item: Ancillary Items - Bench
Manufacturer: Owner/Operator

Finding: There is weed / vegetation growth on, between, or around the edges of the surfacing
Action: Remove weed / vegetation growth

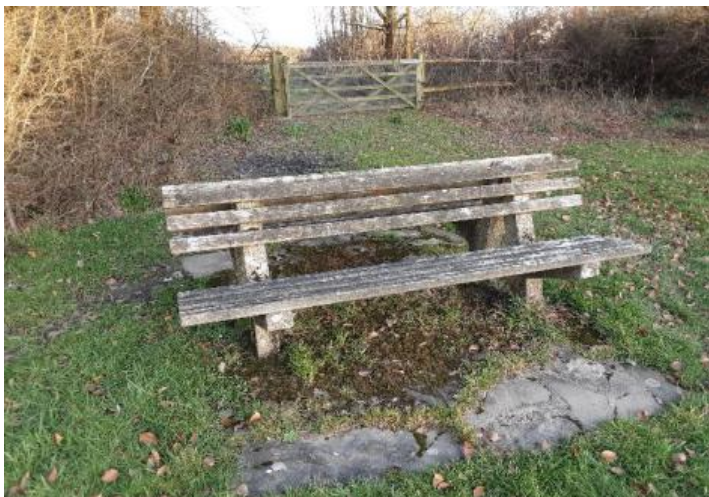
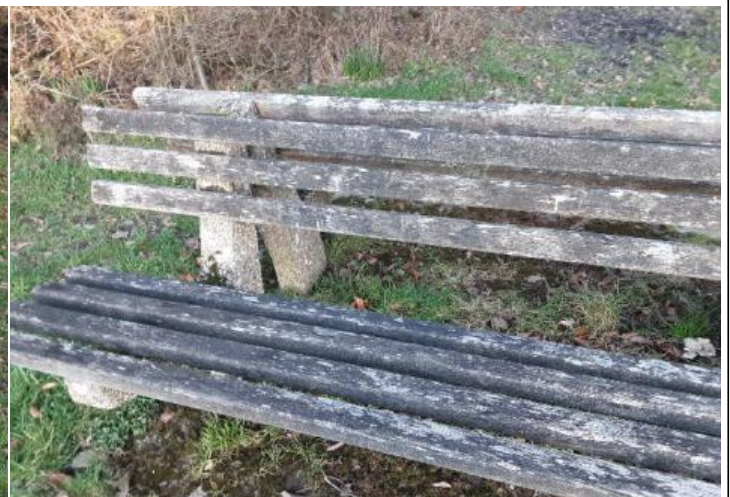
Item: Ancillary Items - Bench
Manufacturer: Owner/Operator

Finding: There is algae or moss on the surface of the equipment
Action: Clean and treat appropriately

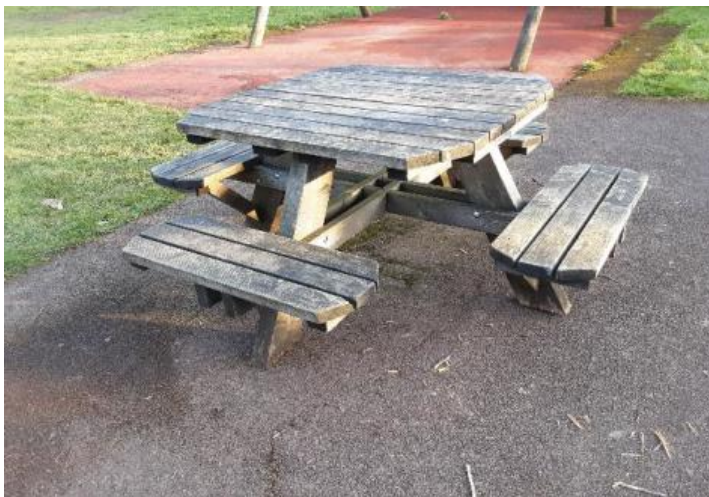
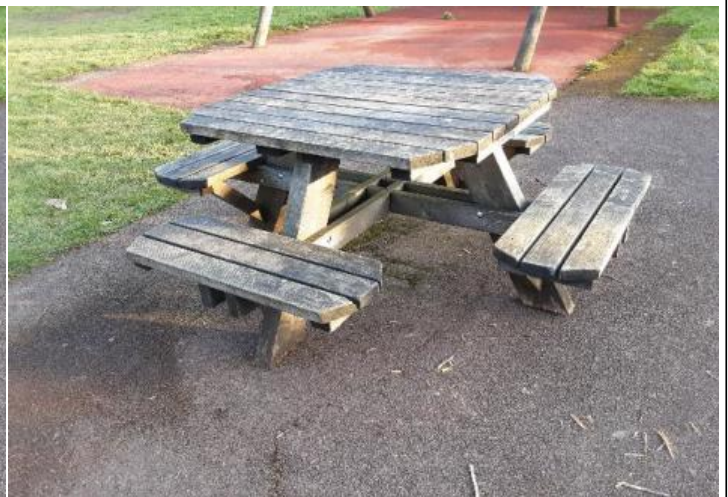
Item: Ancillary Items - Picnic Table
Manufacturer: Owner/Operator

Finding: The table/s is/are not secured to the ground and there is some potential for the item/s to be moved within falling spaces of equipment

Action: Secure to the ground

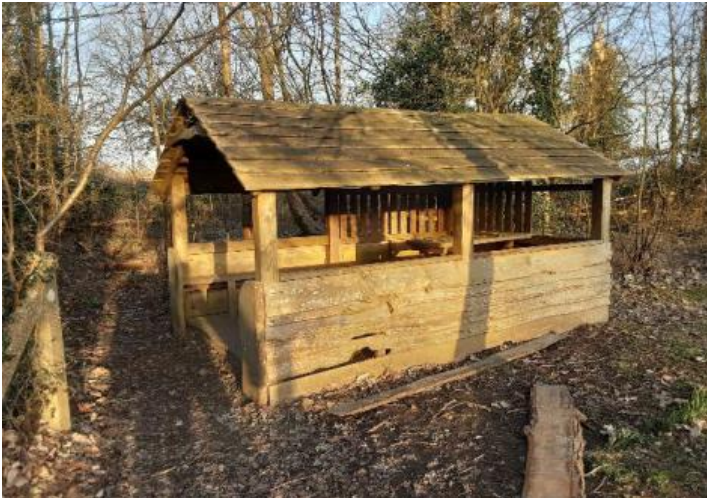
Item: Ancillary Items - Shelter
Manufacturer: Owner/Operator

Finding: There are areas or parts of the timber on the structure that have rotted

Action: Replace all affected timbers

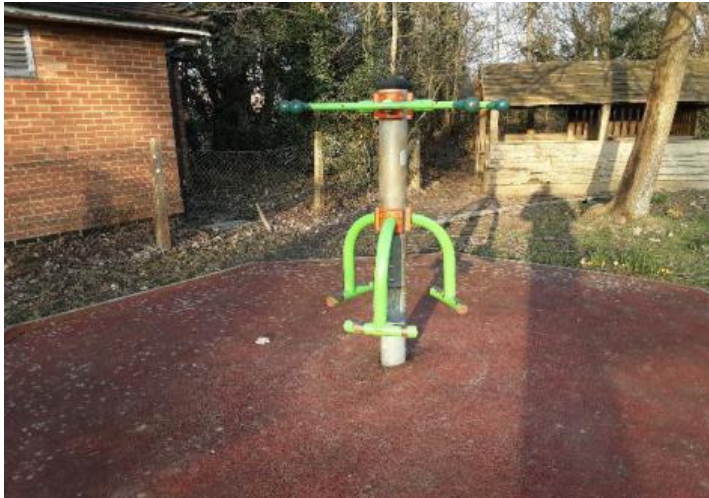
Item: Rotor Play - Low Rotator
Manufacturer: Sutcliffe Play Limited

Finding: The paintwork on this item has been damaged or worn exposing the metal underneath which is rusting

Action: Treat any rusting components and repaint

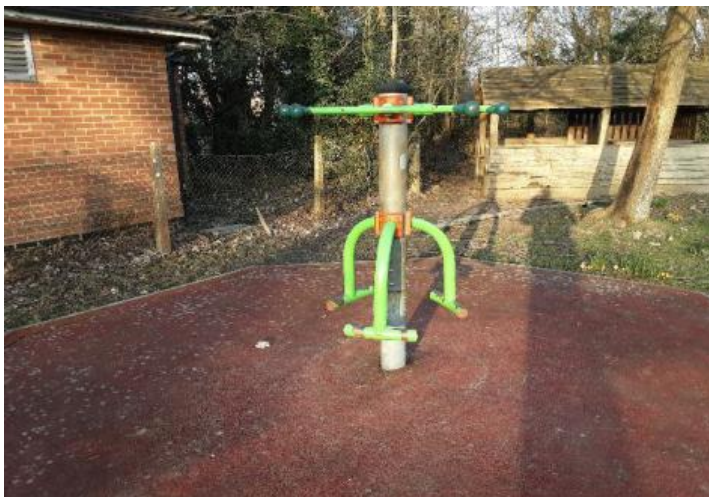
Item: Rotor Play - Low Rotator
Manufacturer: Sutcliffe Play Limited

Finding: There is some damage to the handgrips

Action: Replace all affected components

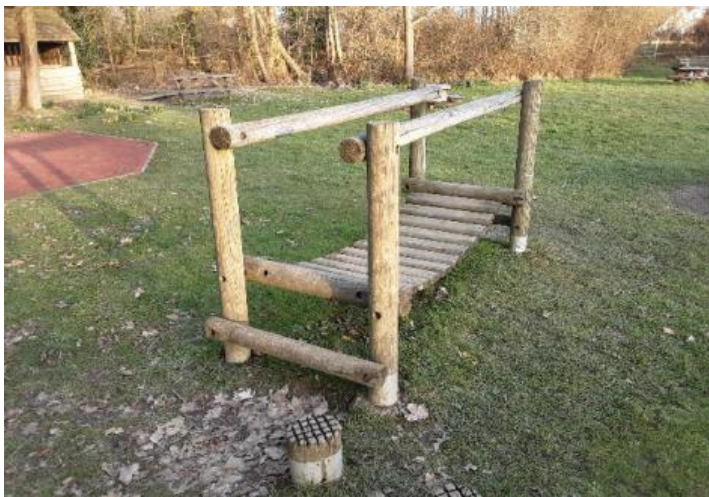
Item: Activity Equipment - Activity Trail
Manufacturer: Playahead

Finding: The adjacent log beam forms a hard object within the falling space of the equipment in contravention of the requirements of BS EN 1176 Part 1
Action: Monitor - No remedial work recommended

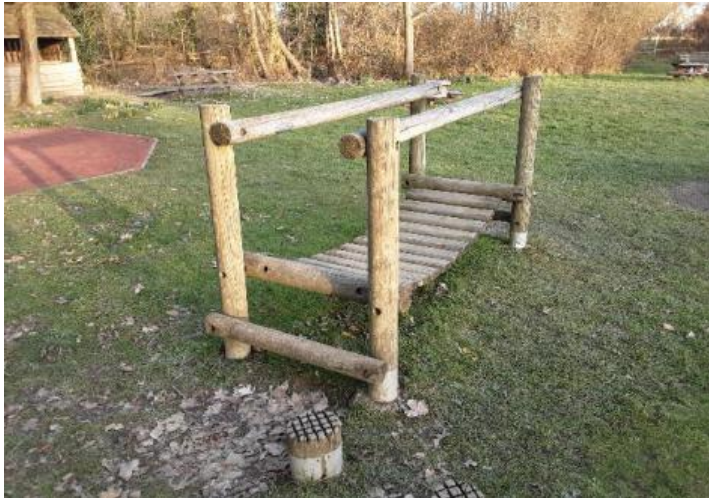
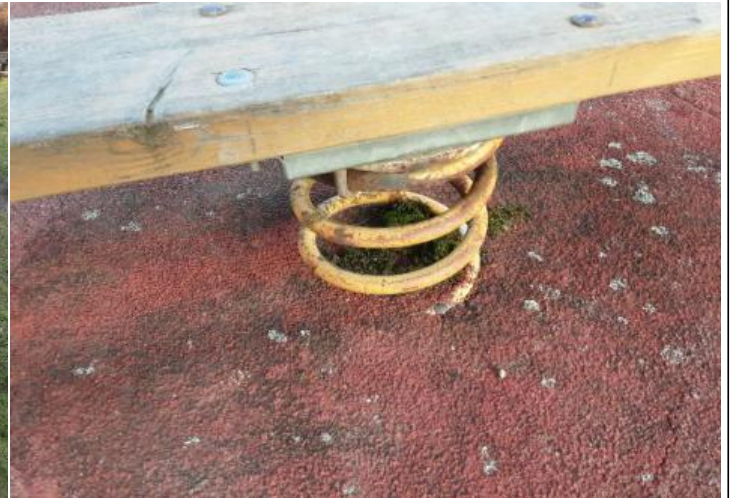
Item: Activity Equipment - Activity Trail
Manufacturer: Playahead

Finding: There are projecting bolt thread(s) present

Action: Remove excess thread length and deburr or provide cap

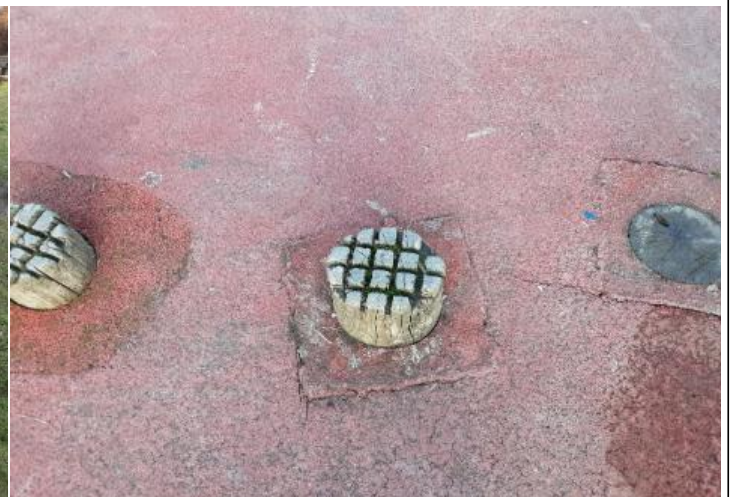
Item: Activity Equipment - Activity Trail
Manufacturer: Playahead

Finding: There is algae or moss on the surface of the equipment

Action: Clean and treat appropriately

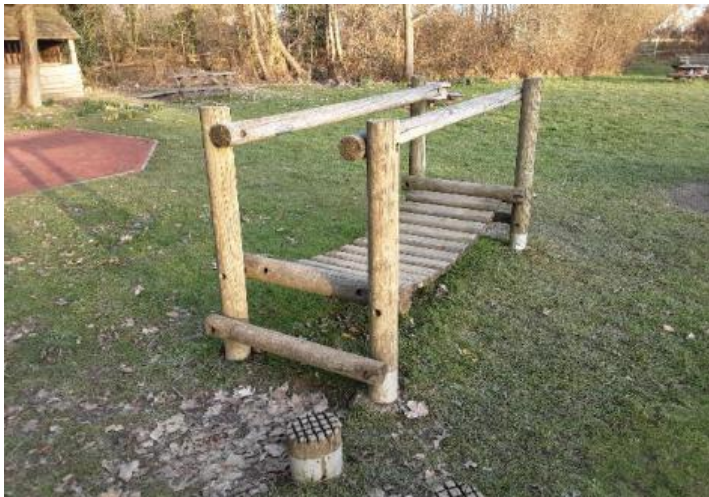
Item: Activity Equipment - Activity Trail
Manufacturer: Playahead

Finding: There is/are bolt cap covers missing or damaged on the item
Action: Replace missing or damaged bolt cap covers

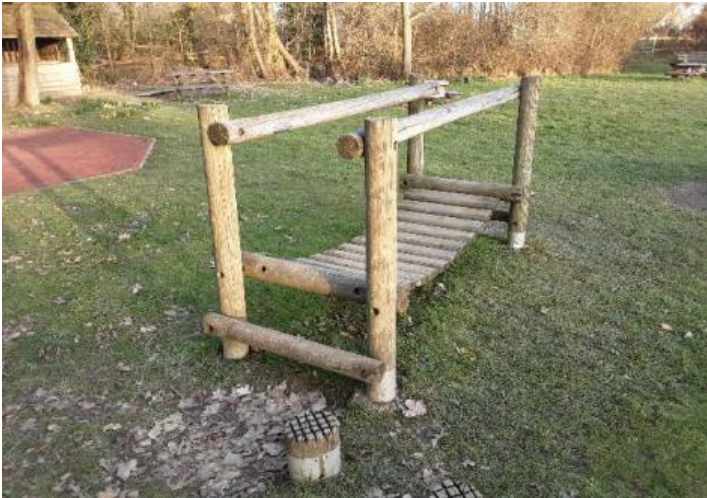
Item: Activity Equipment - Activity Trail
Manufacturer: Playahead

Finding: There is some evidence of rot in the timber

Action: Monitor for any further deterioration and replace as required

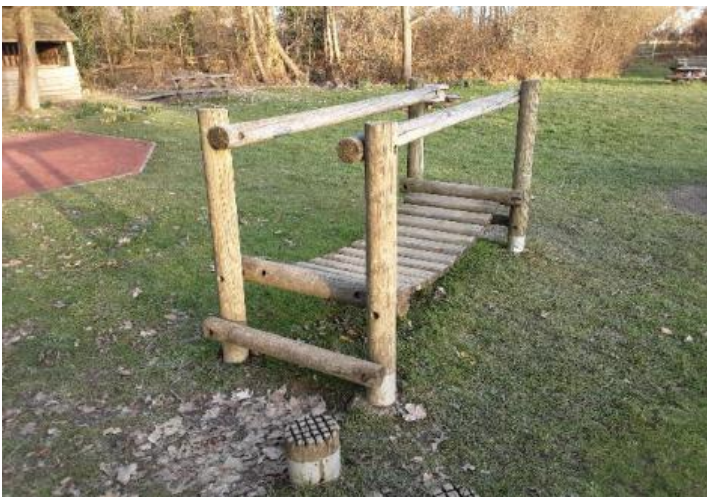
Item: Activity Equipment - Activity Trail
Manufacturer: Playahead

Finding: There is some damage to the timber

Action: Monitor for any further deterioration and repair as required

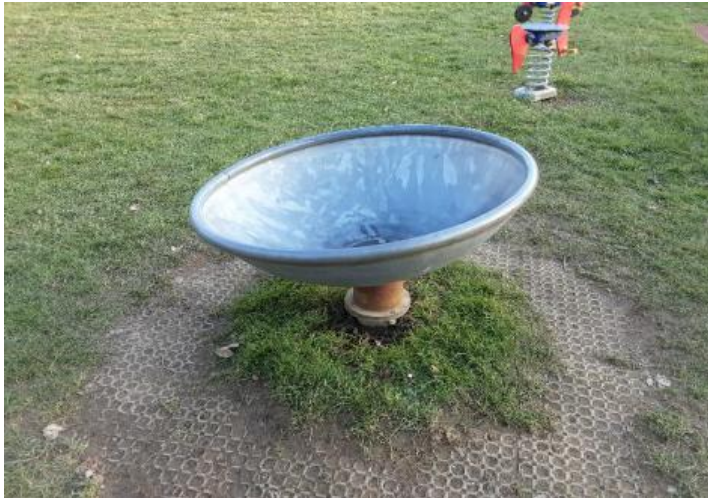
Item: Rotor Play - Spinner Bowl
Manufacturer: Sutcliffe Play Limited

Finding: The grass mats are silted up and the soil is compacted; this may have an effect on the impact absorbing properties of the surface

Action: Consider HIC testing impact absorbing properties to ensure the correct surface qualities are maintained for the equipment and replace as required

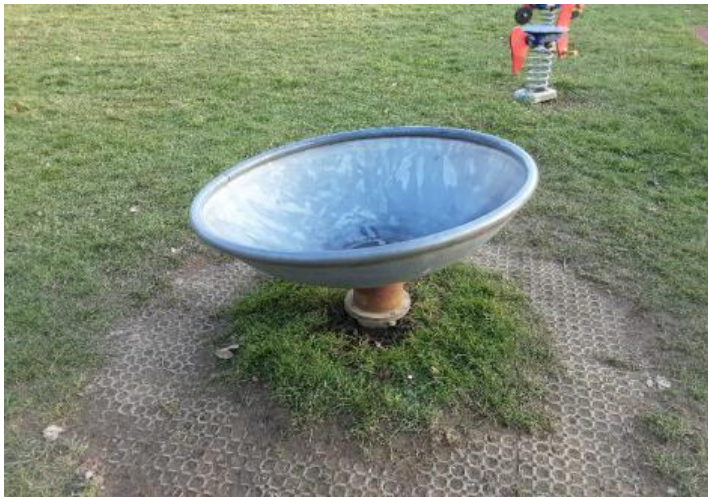
Item: Rotor Play - Spinner Bowl
Manufacturer: Sutcliffe Play Limited

Finding: The paintwork on this item has been damaged or worn exposing the metal underneath which is rusting

Action: Treat any rusting components and repaint

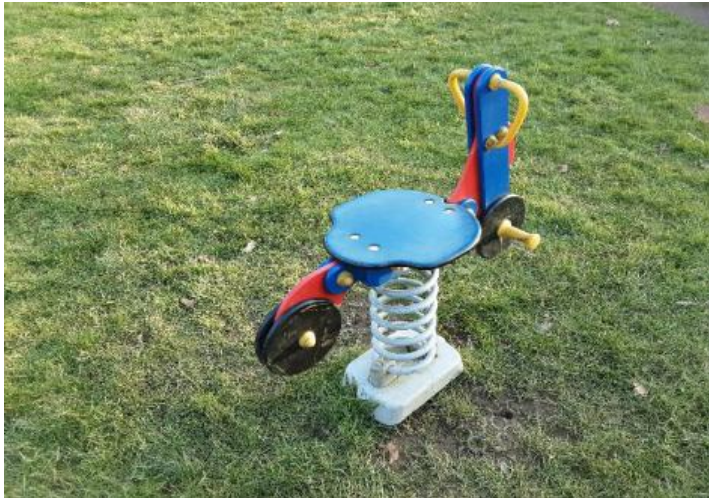
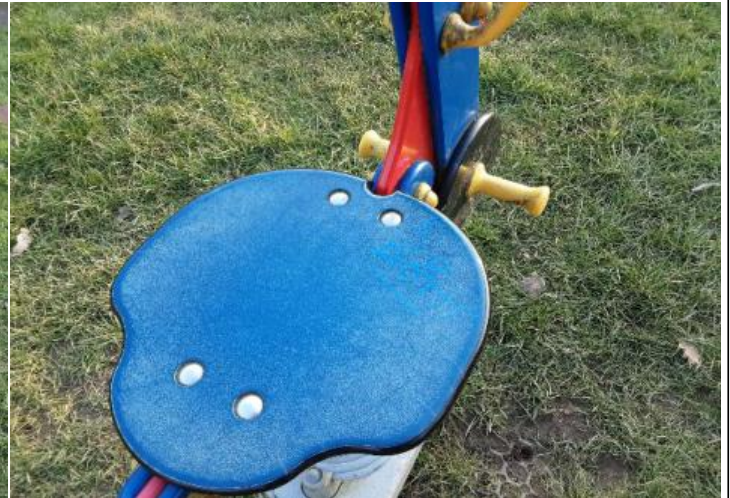
Item: Rocking Equipment - Spring Motorbike
Manufacturer: Ledon

Finding: There is some graffiti present

Action: Remove the graffiti

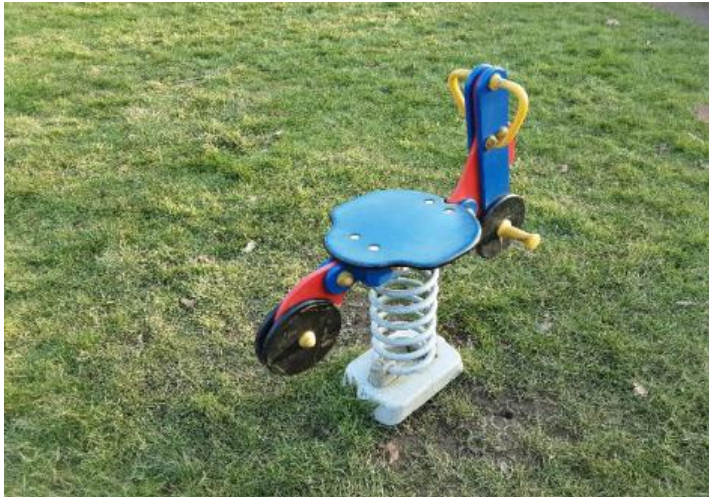
Item: Rocking Equipment - Spring Motorbike
Manufacturer: Ledon

Finding: The spring clamps are loose

Action: Tighten all loose fixings

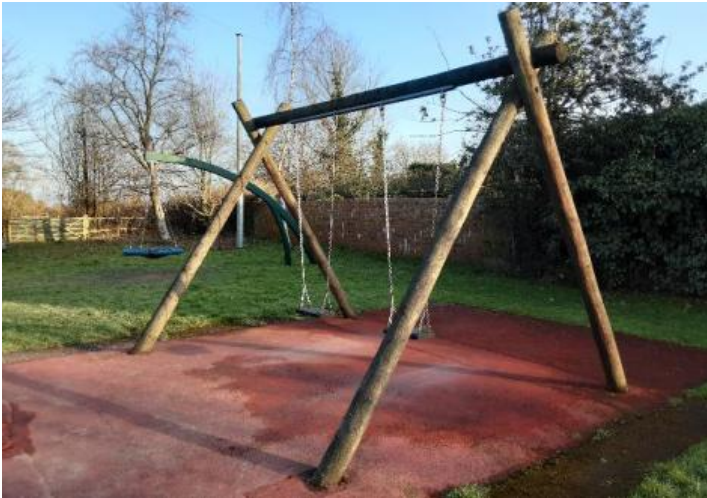
Item: Swings - 1 Bay 2 Seat (Flat)
Manufacturer: Playdale Playgrounds Ltd

Finding: The timber has a number of splits/shakes or air cracks and this may affect the stability or allow water ingress which will accelerate the rotting process

Action: Monitor to ensure the splits do not cross through fixing points of the structure and/or cause any instability

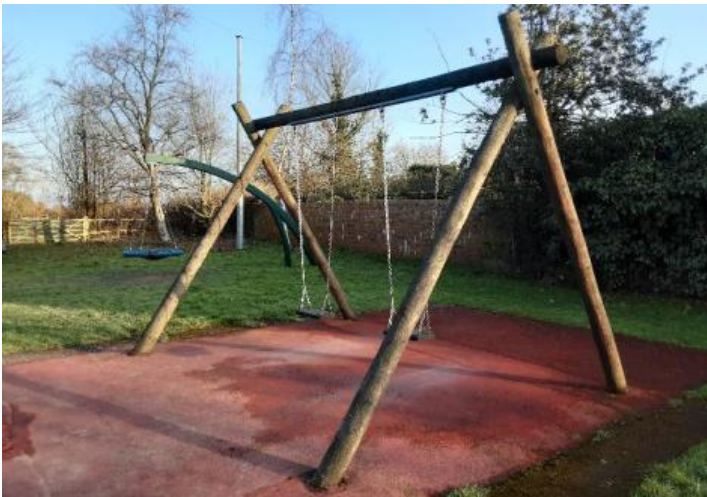
Item: Swings - 1 Bay 2 Seat (Flat)
Manufacturer: Playdale Playgrounds Ltd

Finding: The bushes are showing signs of wear

Action: Monitor for any further deterioration and replace as required

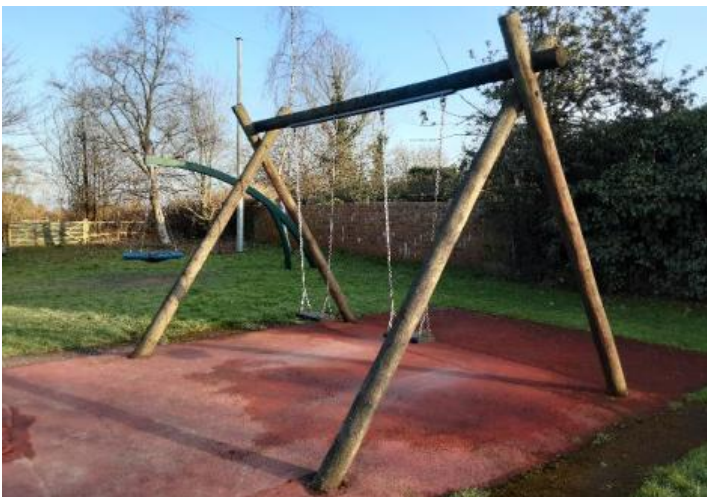
Item: Swings - 1 Bay 2 Seat (Flat)
Manufacturer: Playdale Playgrounds Ltd

Finding: There is some notable evidence of chain wear

Action: Monitor for any further deterioration and replace when 40% worn

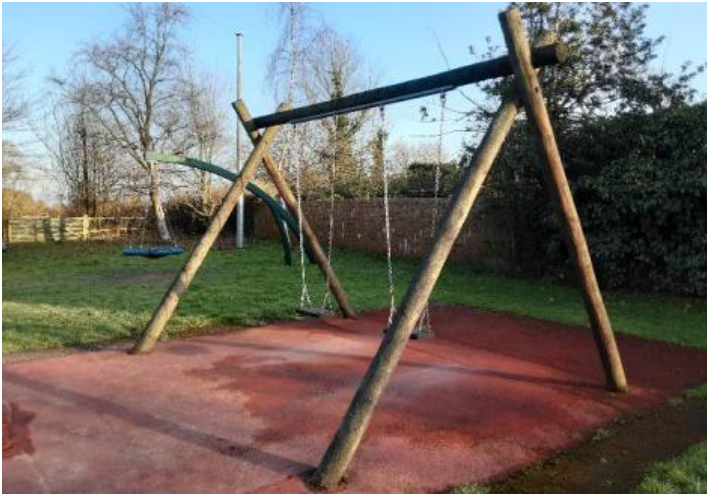
Item: Swings - 1 Bay 2 Seat (Flat)
Manufacturer: Playdale Playgrounds Ltd

Finding: There is some evidence of rot in the timber

Action: Monitor for any further deterioration and replace as required

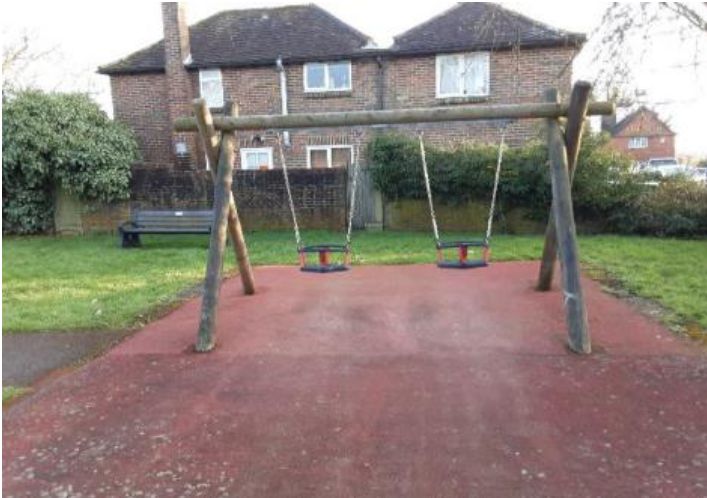
Item: Swings - 1 Bay 2 Seat (Cradle)
Manufacturer: Playdale Playgrounds Ltd

Finding: The timber has a number of splits/shakes or air cracks and this may affect the stability or allow water ingress which will accelerate the rotting process
Action: Monitor to ensure the splits do not cross through fixing points of the structure and/or cause any instability

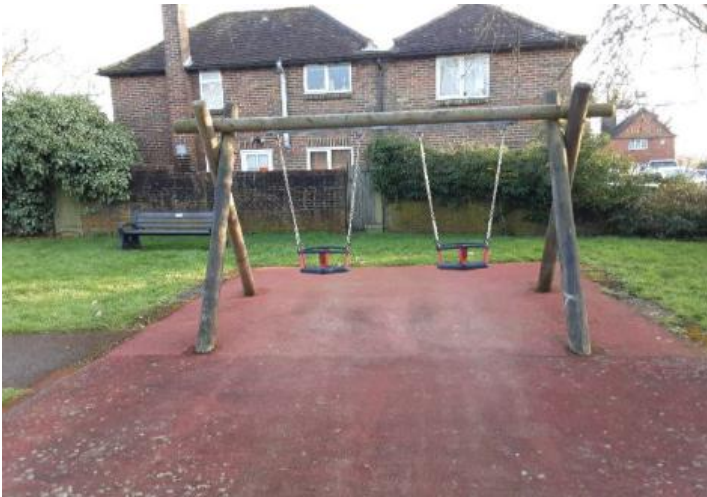
Item: Swings - 1 Bay 2 Seat (Cradle)
Manufacturer: Playdale Playgrounds Ltd

Finding: There is/are bolt cap covers missing or damaged on the item
Action: Replace missing or damaged bolt cap covers

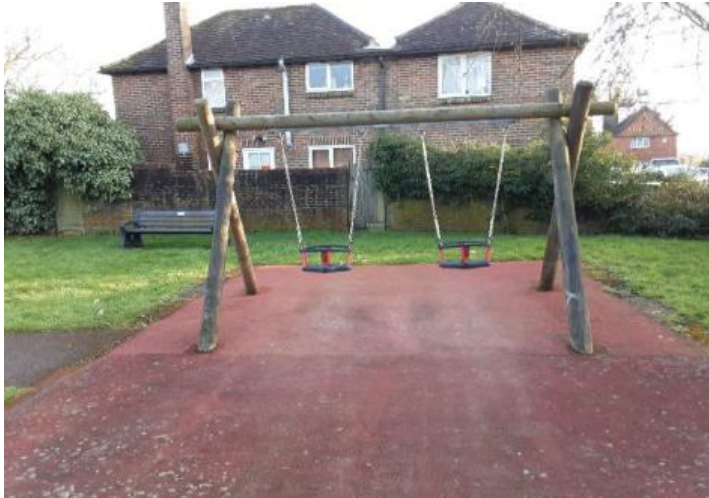
Item: Swings - 1 Bay 2 Seat (Cradle)
Manufacturer: Playdale Playgrounds Ltd

Finding: There is some evidence of rot in the timber

Action: Monitor for any further deterioration and replace as required

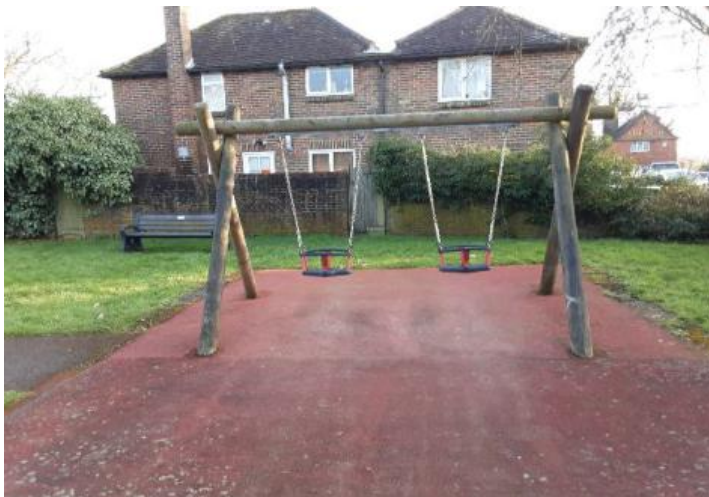
Item: Swings - 1 Bay 2 Seat (Cradle)
Manufacturer: Playdale Playgrounds Ltd

Finding: There is some notable evidence of chain wear

Action: Monitor for any further deterioration and replace when 40% worn

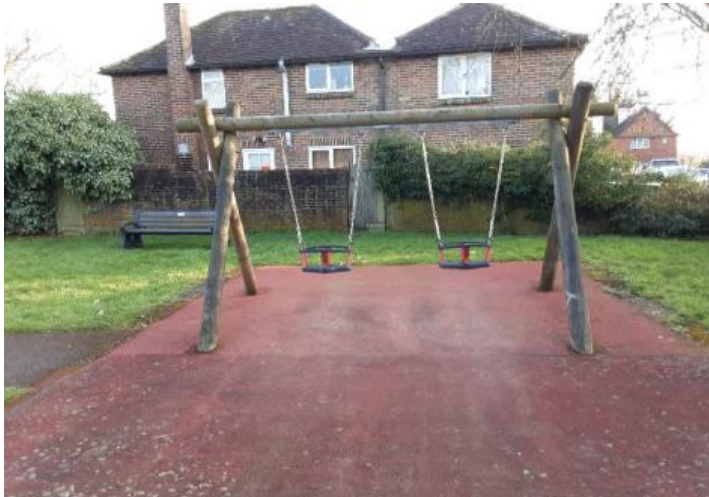
Item: Swings - 1 Bay 2 Seat (Cradle)
Manufacturer: Playdale Playgrounds Ltd

Finding: One of the seat connectors is loose

Action: Secure all loose connections

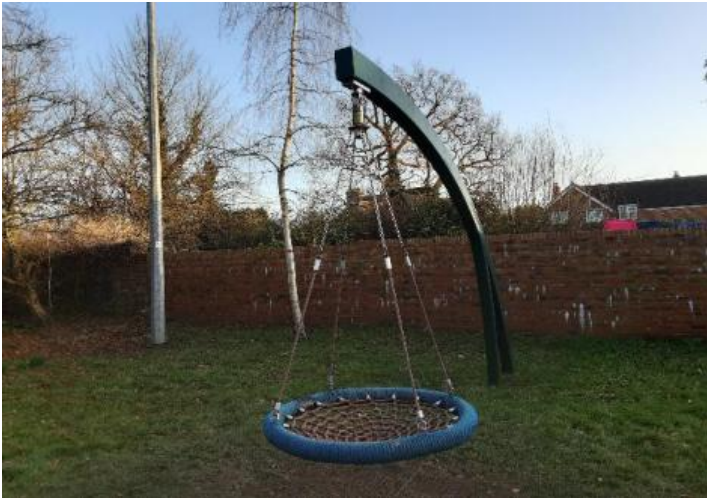
Item: Swings - Cantilever Swing - Type 3
Manufacturer: Not Identified

Finding: The incorrect seat design has been installed on this swing; there are unique designs for Type 1 and Type 3 swings that provide differing impact attenuating properties to the leading edges of the seat and/or has incorrectly aligned seat eye fixings which will lead to accelerated wear.

Action: Consider replacing with the correct design seat
