Annual Inspection

Rusper Parish Council

High Street Playground

High Street, Rusper, West Sussex, RH12 4PX

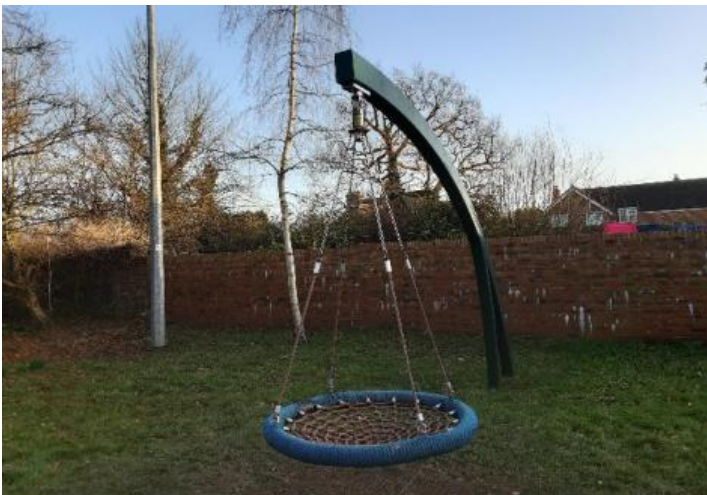
Item: Swings - Cantilever Swing - Type 3
Manufacturer: Not Identified

The grass mats are silted up and the soil is compacted; this may have an effect on the impact absorbing properties of the surface - Consider HIC testing impact absorbing properties to ensure the correct surface qualities are maintained for the equipment and replace as required

Finding: The grass mats are silted up and the soil is compacted; this may have an effect on the impact absorbing properties of the surface

Action: Consider HIC testing impact absorbing properties to ensure the correct surface qualities are maintained for the equipment and replace as required

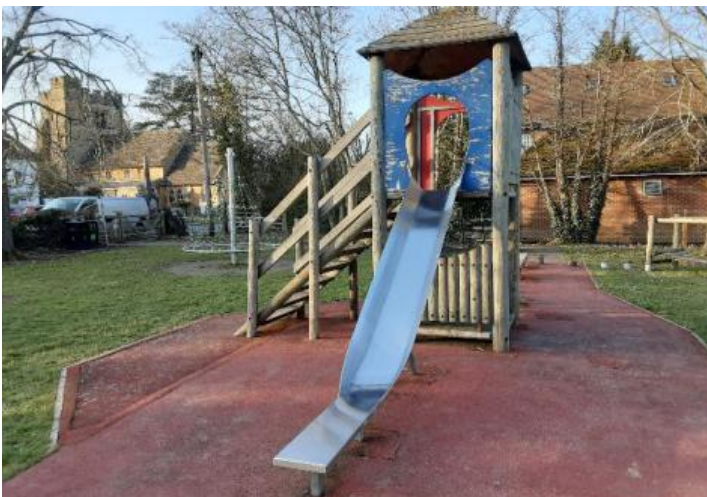
Item: Activity Equipment - Multi Play (Junior)
Manufacturer: Playdale Playgrounds Ltd

There is moderate damage to the surface - Repair the damaged areas of surfacing

Finding: There is moderate damage to the surface

Action: Repair the damaged areas of surfacing

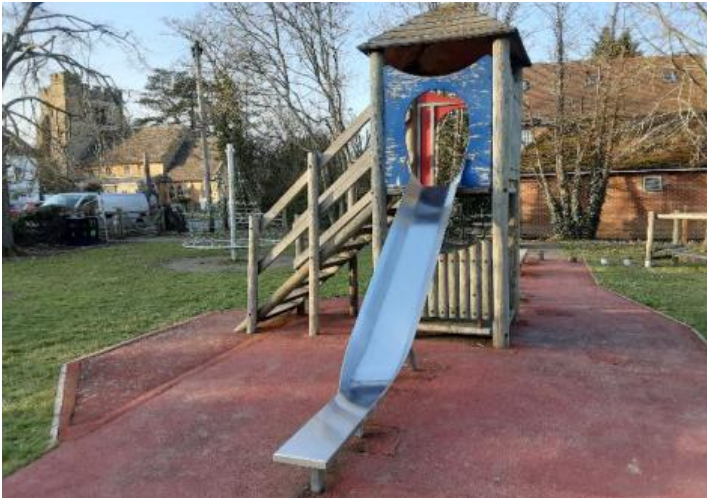
Item: Activity Equipment - Multi Play (Junior)
Manufacturer: Playdale Playgrounds Ltd

There are splits in the timber running through fixing points and creating some instability in the structure - Replace all affected timber parts

Finding: There are splits in the timber running through fixing points and creating some instability in the structure
Action: Replace all affected timber parts

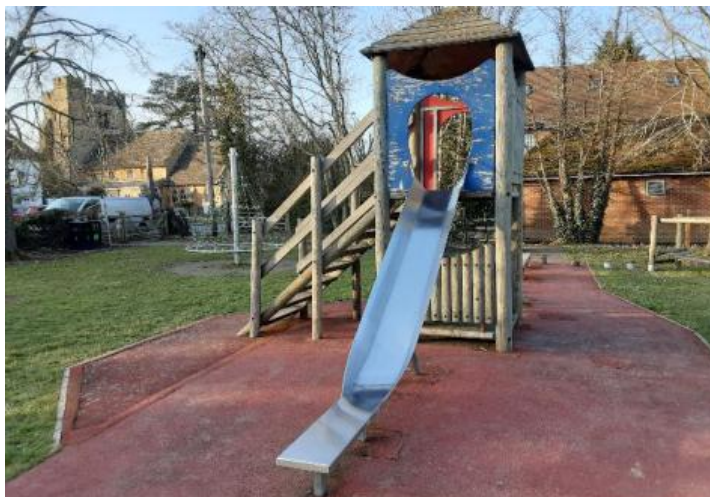
Item: Activity Equipment - Multi Play (Junior)
Manufacturer: Playdale Playgrounds Ltd

The item fails to meet the requirements of BS EN 1176 Part 1 4.2.7.2 head and neck entrapment in the barriers and/or steps - Monitor - No remedial work recommended

Finding: The item fails to meet the requirements of BS EN 1176 Part 1 4.2.7.2 head and neck entrapment in the barriers and/or steps

Action: Monitor - No remedial work recommended

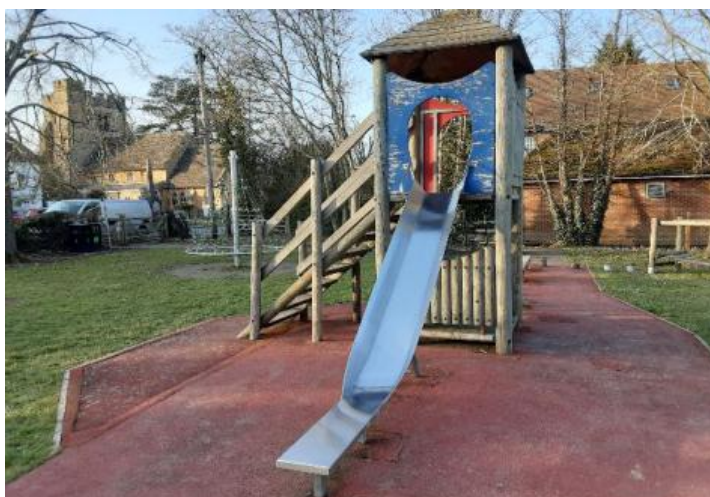
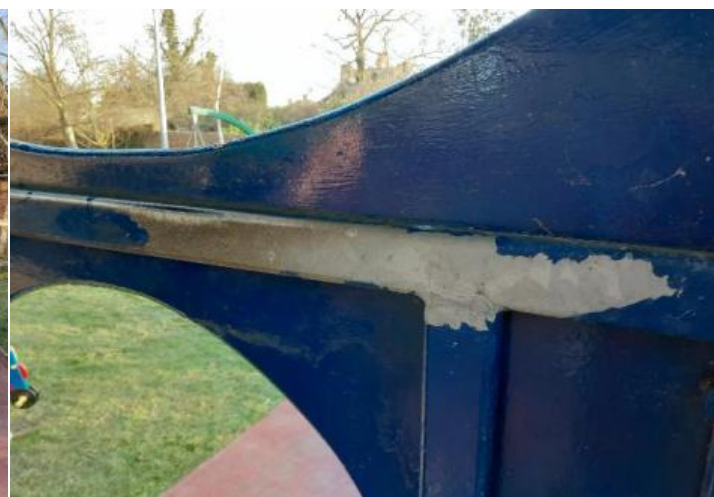
Item: Activity Equipment - Multi Play (Junior)
Manufacturer: Playdale Playgrounds Ltd

Finding: The paint is flaking off the metalwork

Action: Rub down and re-paint

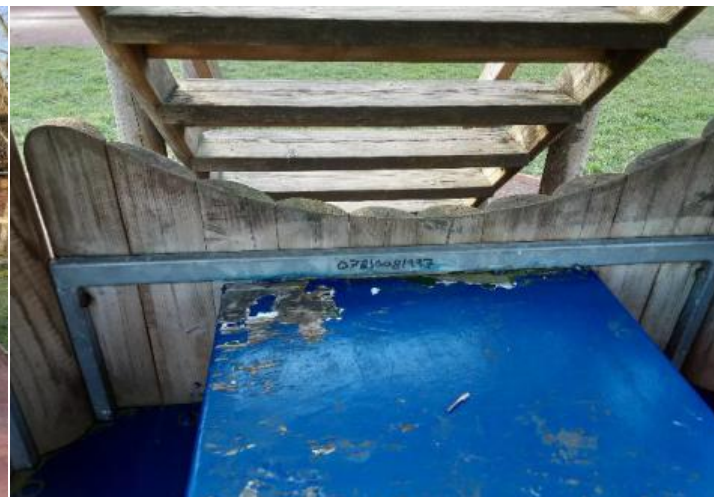
Item: Activity Equipment - Multi Play (Junior)
Manufacturer: Playdale Playgrounds Ltd

Finding: There is some graffiti present

Action: Remove the graffiti

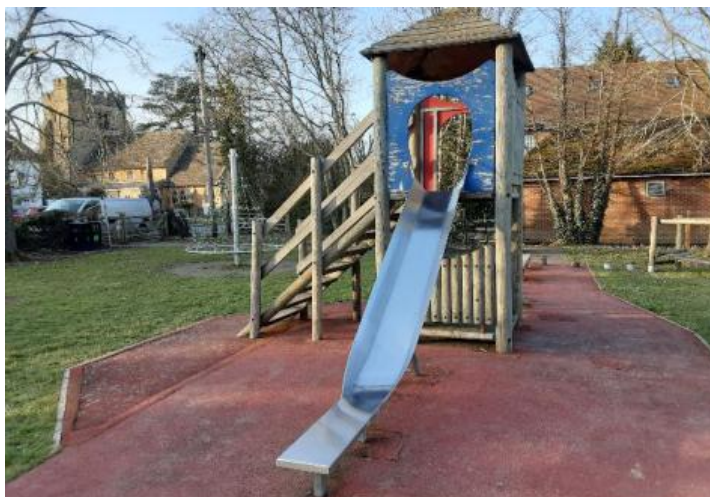
Item: Activity Equipment - Multi Play (Junior)
Manufacturer: Playdale Playgrounds Ltd

The slide is predominately south facing and will catch the majority of the sun's heat during the day. Slide surfaces can become very warm during periods of sustained sunny weather - Monitor - No remedial work recommended

Finding: The slide is predominately south facing and will catch the majority of the sun's heat during the day. Slide surfaces can become very warm during periods of sustained sunny weather

Action: Monitor - No remedial work recommended

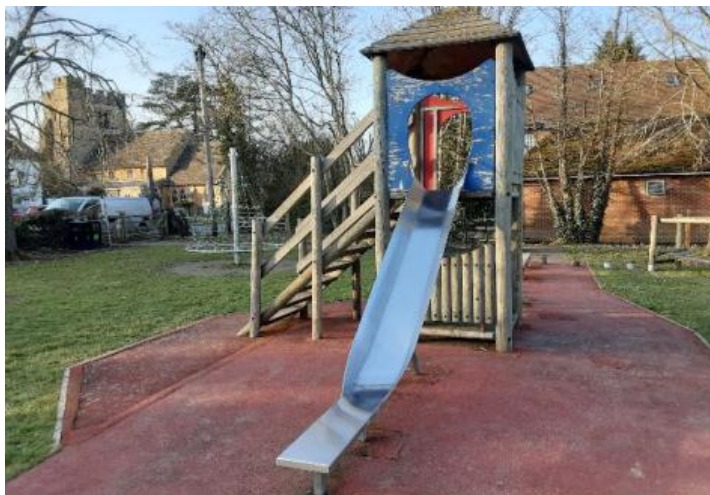
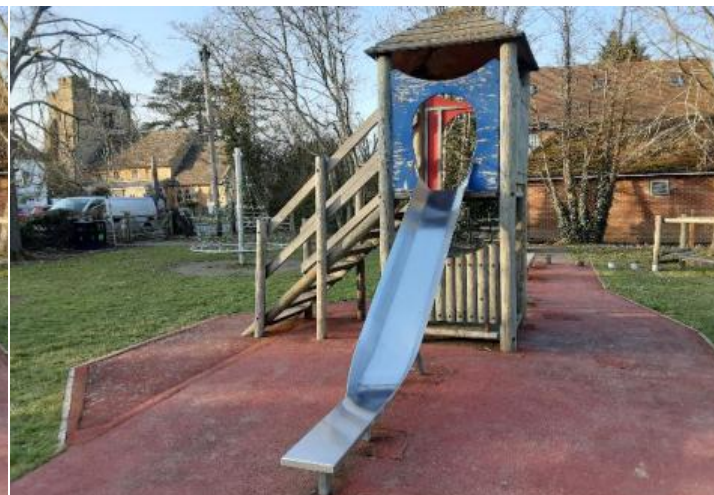
Item: Activity Equipment - Multi Play (Junior)
Manufacturer: Playdale Playgrounds Ltd

There are a number of dents in the slide surface - Monitor for any further deterioration and repair as required

Finding: There are a number of dents in the slide surface

Action: Monitor for any further deterioration and repair as required

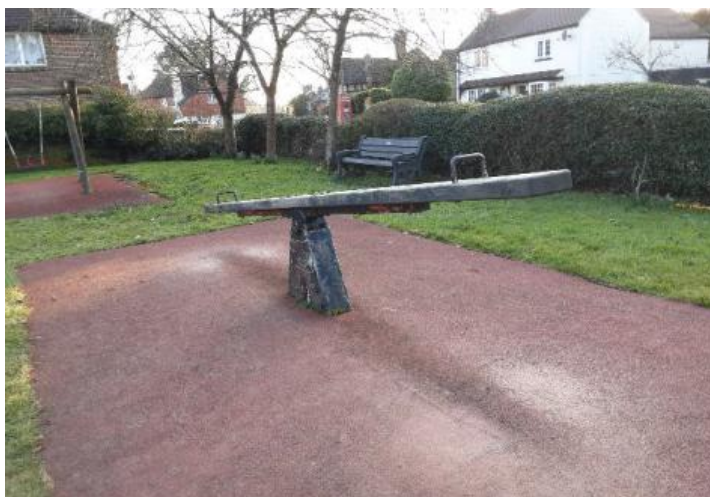
Item: Rocking Equipment - See Saw
Manufacturer: Hirst & Sons Ltd

There is some minor wear to the pivot mechanism - Monitor for any further deterioration and repair as required

Finding: There is some minor wear to the pivot mechanism

Action: Monitor for any further deterioration and repair as required

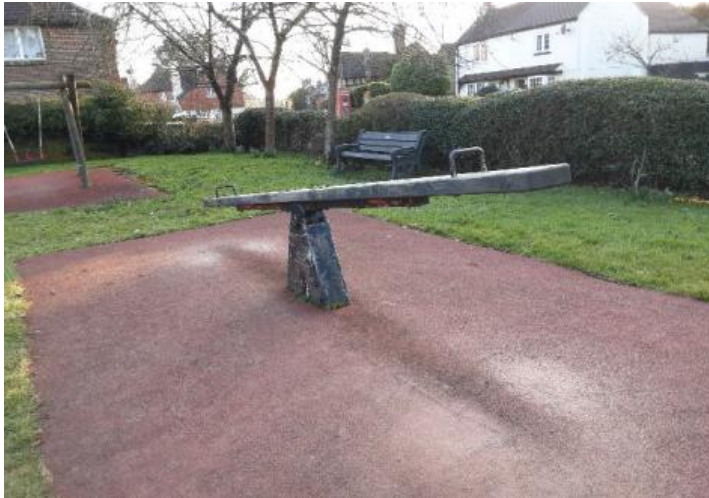
Item: Rocking Equipment - See Saw
Manufacturer: Hirst & Sons Ltd

The paintwork on this item has been damaged or worn exposing the metal underneath which is rusting - Treat any rusting components and repaint

Finding: The paintwork on this item has been damaged or worn exposing the metal underneath which is rusting

Action: Treat any rusting components and repaint

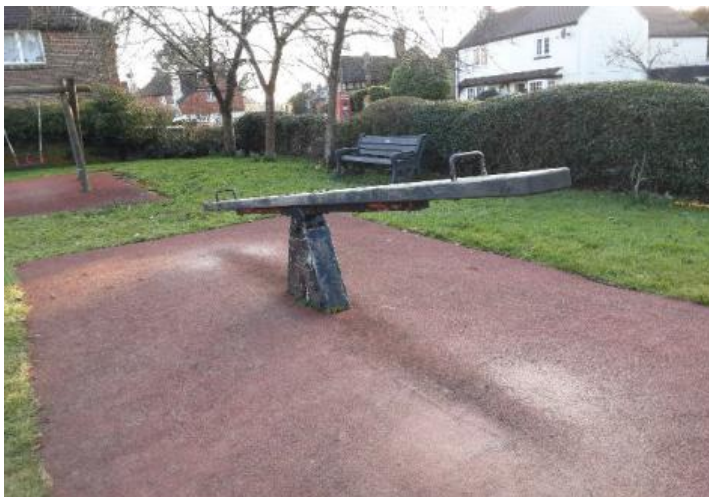
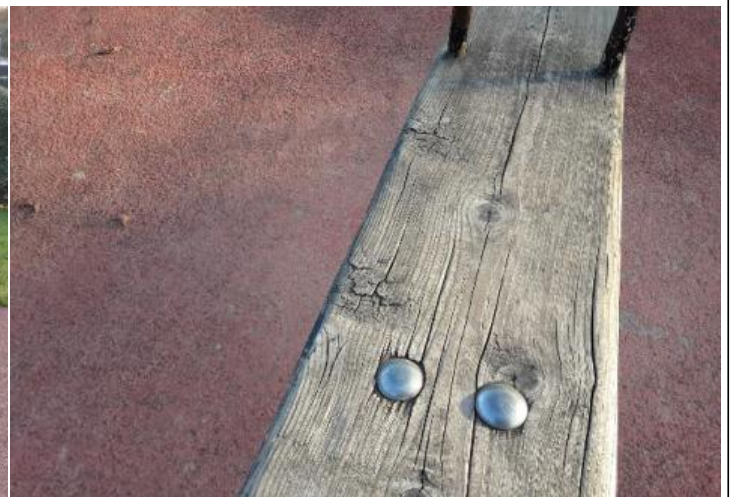
Item: Rocking Equipment - See Saw
Manufacturer: Hirst & Sons Ltd

Finding: Parts of the timber are rough or splintered

Action: Remove all rough or sharp edges

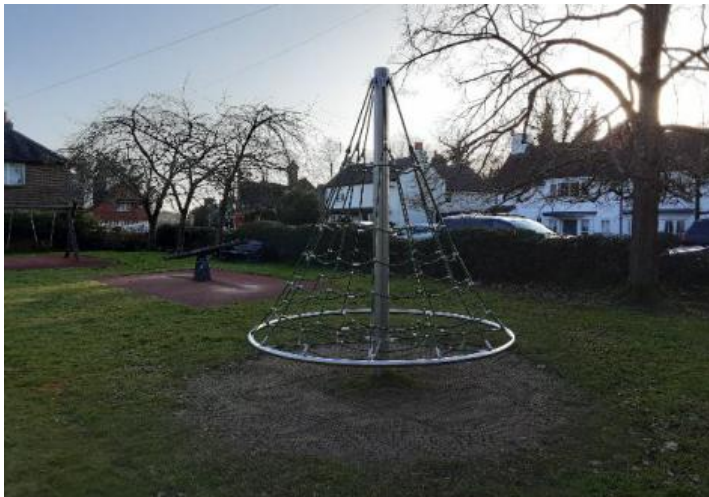
Item: Rotor Play - Cone Climber
Manufacturer: Tayplay Ltd

The grass mats are silted up and the soil is compacted; this may have an effect on the impact absorbing properties of the surface - Consider HIC testing impact absorbing properties to ensure the correct surface qualities are maintained for the equipment and replace as required

Finding: The grass mats are silted up and the soil is compacted; this may have an effect on the impact absorbing properties of the surface

Action: Consider HIC testing impact absorbing properties to ensure the correct surface qualities are maintained for the equipment and replace as required

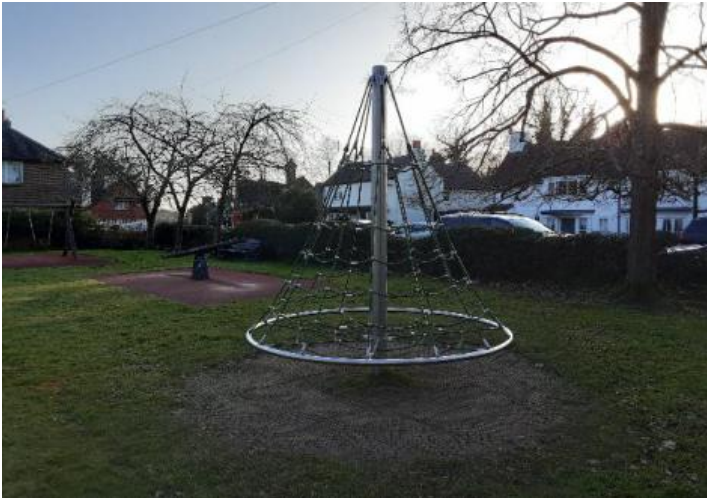
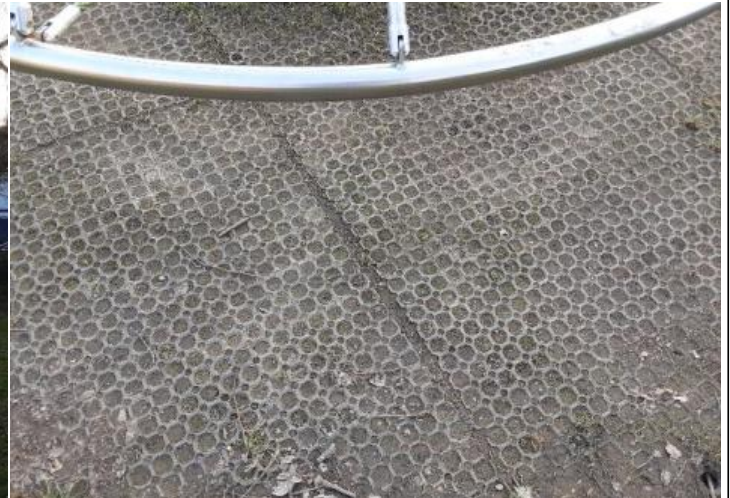
Item: Rotor Play - Cone Climber
Manufacturer: Tayplay Ltd

Risk Level: L - Low Risk
Surface: Grass Matrix Tiles

Finding: There are gaps opening between the grass mat tiles

Action: Provide additional ties or secure / reinstate surface tiles

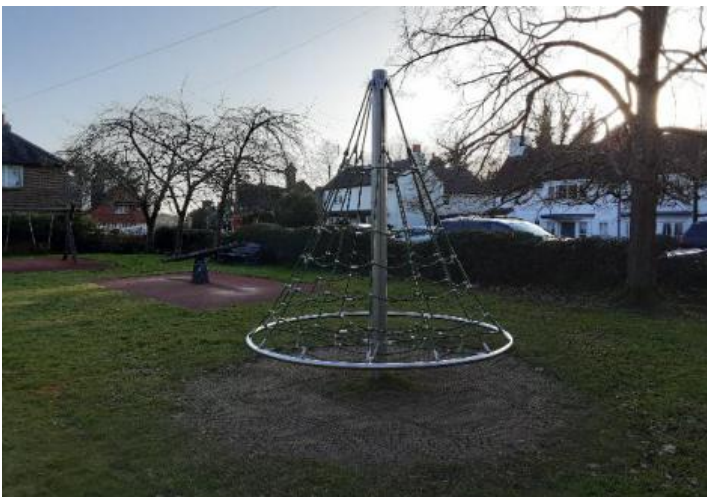
Item: Rotor Play - Cone Climber
Manufacturer: Tayplay Ltd

Risk Level: L - Low Risk
Surface: Grass Matrix Tiles

Finding: The surface has subsided in some areas

Action: Monitor for any further deterioration and repair as required
