Annual Inspection

Rusper Parish Council

High Street Playground

High Street, Rusper, West Sussex, RH12 4PX

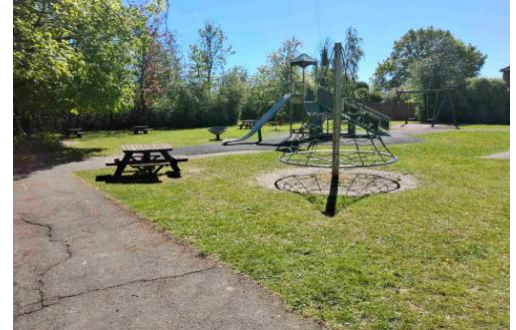
Item: Site General
Manufacturer: Owner/Operator
Surface Type: N/A
Item Quantity: 1
Equipment Compliance: N/A
Surface Area Compliance: N/A

There is some damage to the tarmac surfacing - Repair the damaged areas of surfacing

The safety surface is beginning to wear - Monitor for any further deterioration and repair as required

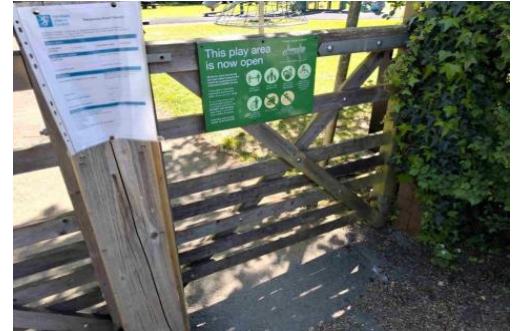
Item: Gate
Manufacturer: Not Identified
Surface Type: Bitmac
Item Quantity: 1
Equipment Compliance: N/A
Surface Area Compliance: N/A

There is or are fixings missing on the item - Replace all missing fixings

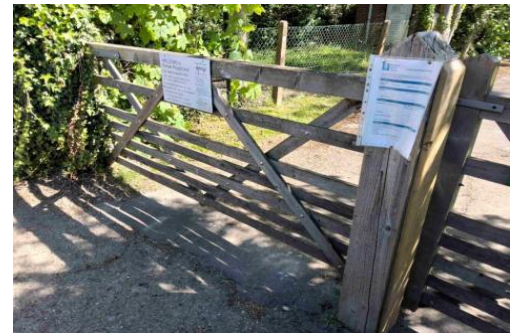
Item: Gate - Maintenance
Manufacturer: Not Identified
Surface Type: Bitmac
Item Quantity: 1
Equipment Compliance: N/A
Surface Area Compliance: N/A

There is some evidence of rot in the timber - Monitor for any further deterioration and replace as required

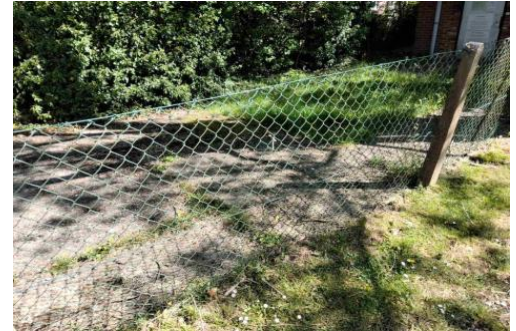
Item: Fence - Chainlink
Manufacturer: Not Identified
Surface Type: Grass
Item Quantity: 1
Equipment Compliance: N/A
Surface Area Compliance: N/A

There is some damage to the fence sections - Monitor for any further deterioration and repair as required

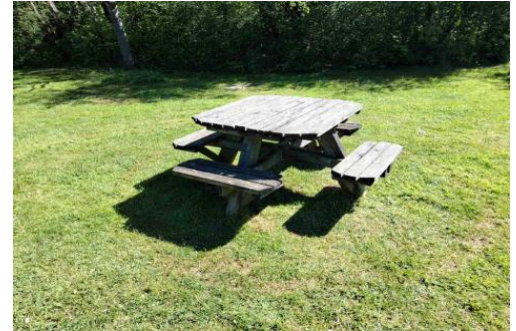
Item: Picnic Table
Manufacturer: Not Identified
Surface Type: Mixed Surface
Item Quantity: 5
Equipment Compliance: N/A
Surface Area Compliance: N/A

There are areas or parts of the timber on the structure that have rotted - Replace all affected timbers

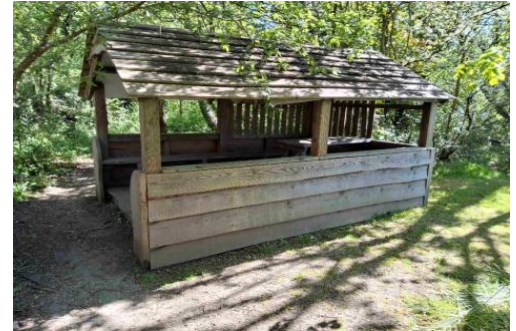
Item: Shelter
Manufacturer: Not Identified
Surface Type: Grass
Item Quantity: 1
Equipment Compliance: N/A
Surface Area Compliance: N/A

There is some evidence of rot in the timber - Monitor for any further deterioration and replace as required

The roof lining is damaged - Replace

The surface has eroded in some areas and may be slippery in wet conditions - Reinstate the surface

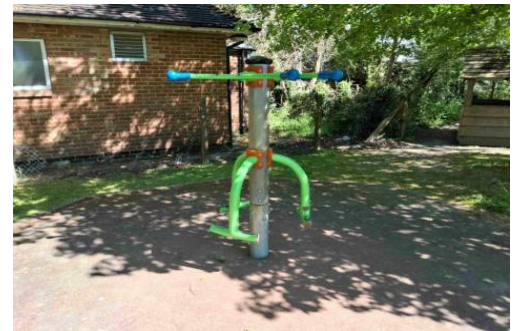
Item: Low Rotator
Manufacturer: Sutcliffe Play Limited
Surface Type: Wet Pour
Item Quantity: 1
Equipment Compliance: Yes
Surface Area Compliance: Yes

The paintwork on this item has been damaged or worn exposing the metal underneath which is rusting / corroding - Treat affected areas and repaint

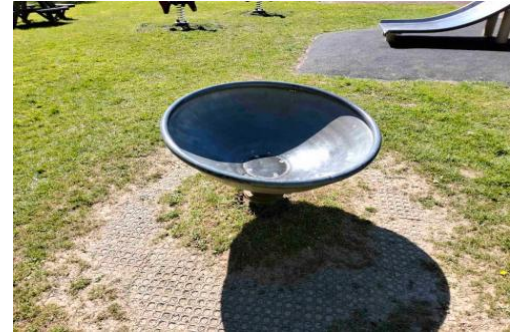
Item: Dish Roundabout
Manufacturer: Sutcliffe Play Limited
Surface Type: Grass Matrix Tiles
Item Quantity: 1
Equipment Compliance: Yes
Surface Area Compliance: Yes

There is surface corrosion / rust present on the item - Consider treating the item

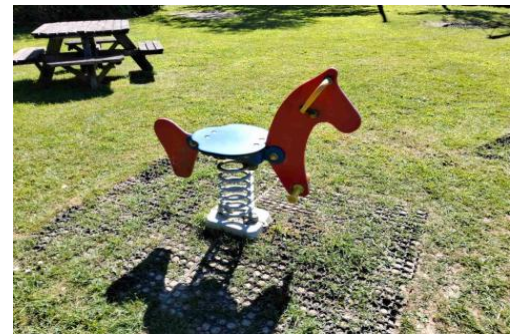
Item: Spring Horse
Manufacturer: Ledon
Surface Type: Grass Matrix Tiles
Item Quantity: 1
Equipment Compliance: Yes
Surface Area Compliance: Yes

The spring clamps are showing signs of wear - Monitor for any further deterioration and replace as required

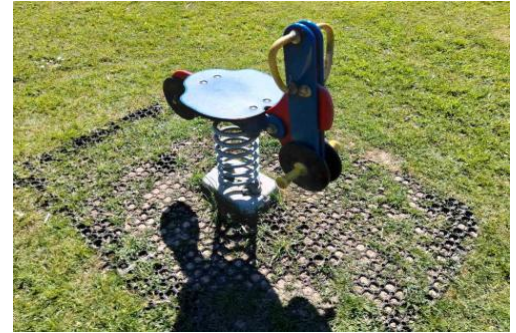
Item: Spring Motorbike
Manufacturer: Ledon
Surface Type: Grass Matrix Tiles
Item Quantity: 1
Equipment Compliance: Yes
Surface Area Compliance: Yes

The spring clamps are showing signs of wear - Monitor for any further deterioration and replace as required

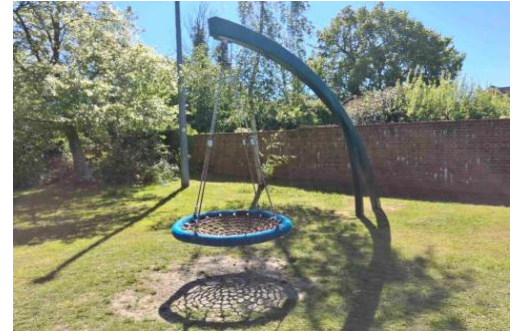
Item: Cantilever Swing - Type 3
Manufacturer: Not Identified
Surface Type: Grass Matrix Tiles
Item Quantity: 1
Equipment Compliance: No
Surface Area Compliance: Yes

There is/are finger entrapment/s between shackle and rope and the item fails to meet the requirements of BS EN 1176 Part 1 4.2.7.6 Entrapment of fingers - Monitor - No action given the risk assessment

There is some wear to the shackles. - Monitor for any further deterioration and replace when 40% worn

The universal joint is showing signs of wear - Monitor for any further deterioration and repair / replace as required

There are missing end caps - Replace

There is some notable evidence of chain wear - Monitor for any further deterioration and replace when 40% worn

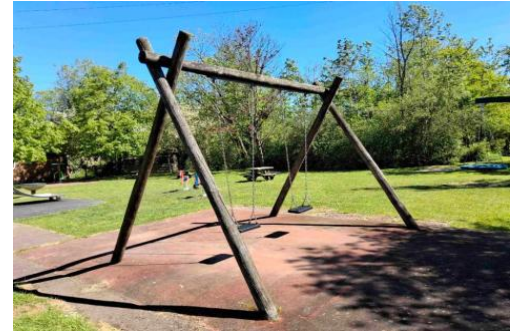
Item: 1 Bay 2 Seat (Flat)
Manufacturer: Playdale Playgrounds Ltd
Surface Type: Wet Pour
Item Quantity: 1
Equipment Compliance: Yes
Surface Area Compliance: Yes

There is some evidence of rot in the timber - Monitor for any further deterioration and replace as required

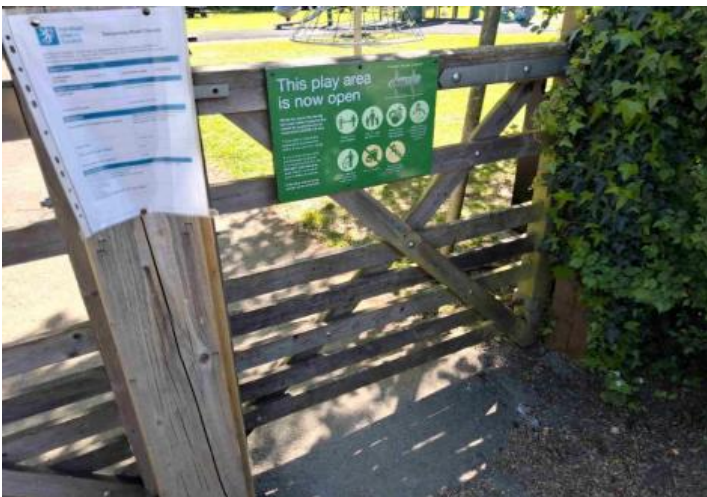
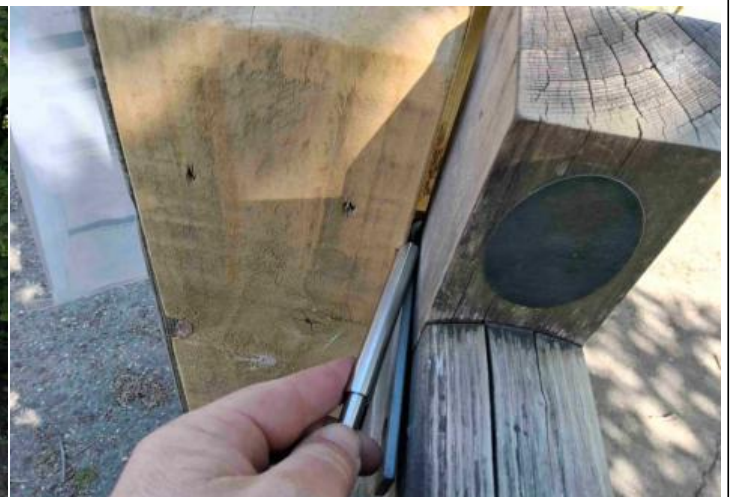
Item: Gates - Gate
Manufacturer: Not Identified

Finding: There are openings that are less than 12mm that could trap or crush fingers

Action: Provide a 12mm gap throughout full range of motion at both sides of gate

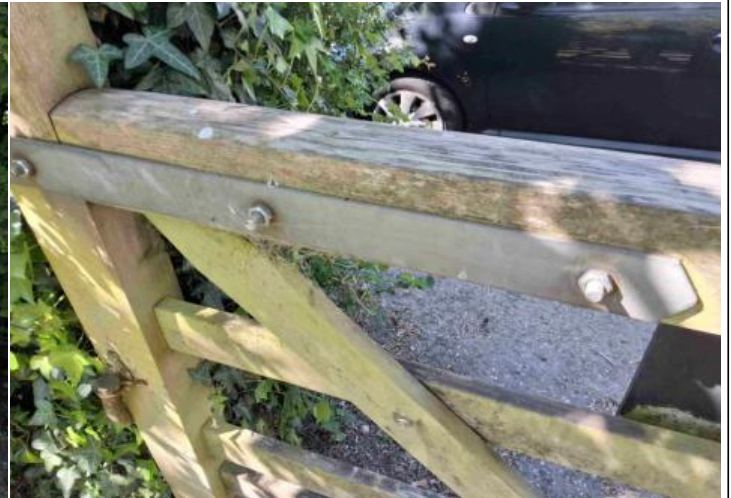
Item: Gates - Gate
Manufacturer: Not Identified

Finding: There are projecting bolt thread(s) present

Action: Remove excess thread length and deburr or provide cap

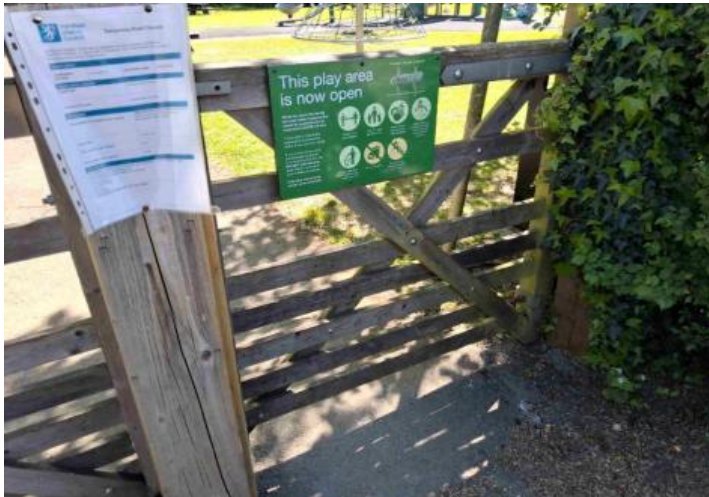
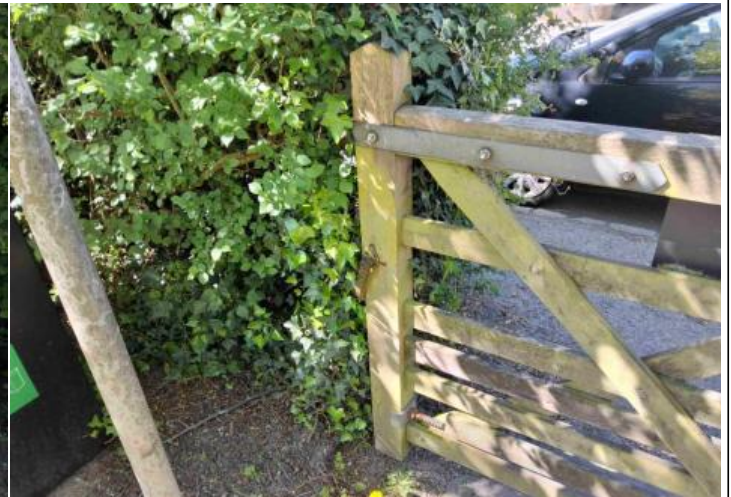
Item: Gates - Gate
Manufacturer: Not Identified

Finding: The gate is closing too quickly (less than 4 seconds)

Action: Take corrective action to ensure that the gate closes in 4-8 seconds from 90 degrees

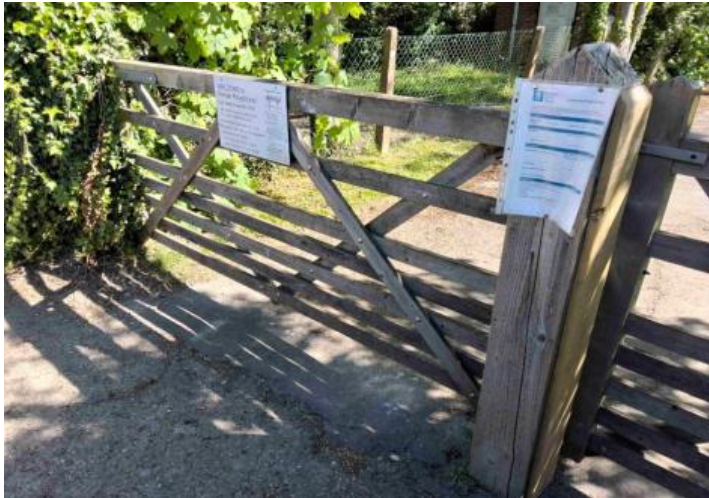
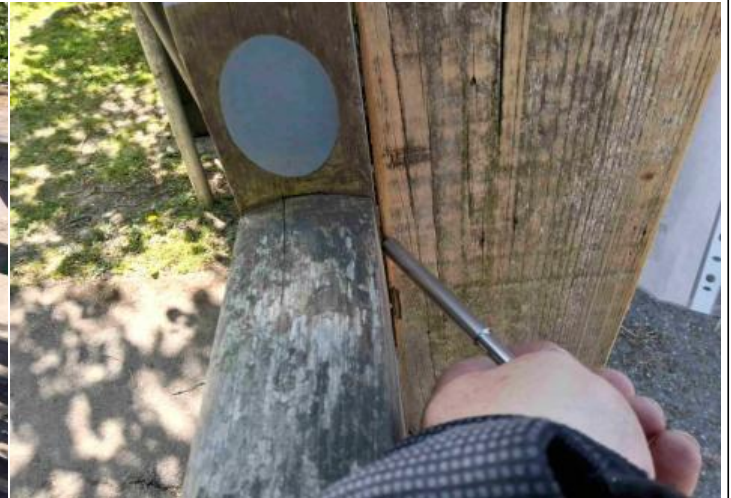
Item: Gates - Gate - Maintenance
Manufacturer: Not Identified

Finding: There are openings that are less than 12mm that could trap or crush fingers

Action: Provide a 12mm gap throughout full range of motion at both sides of gate

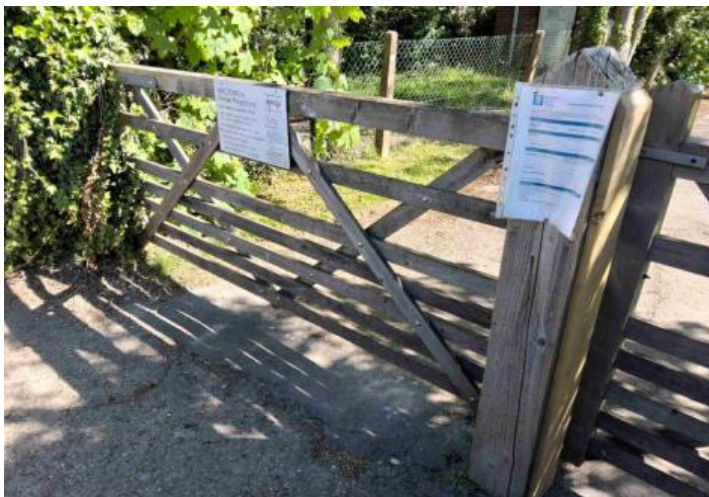
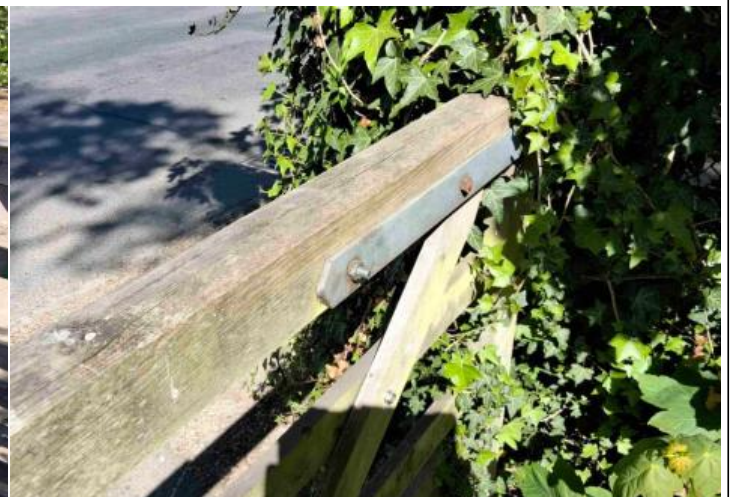
Item: Gates - Gate - Maintenance
Manufacturer: Not Identified

Finding: There are projecting bolt thread(s) present

Action: Remove excess thread length and deburr or provide cap

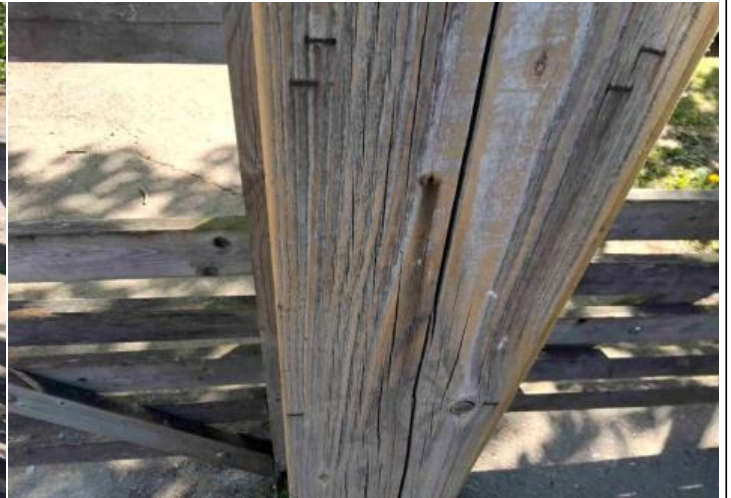
Item: Gates - Gate - Maintenance
Manufacturer: Not Identified

Finding: There are redundant staples in the posts

Action: Remove staples

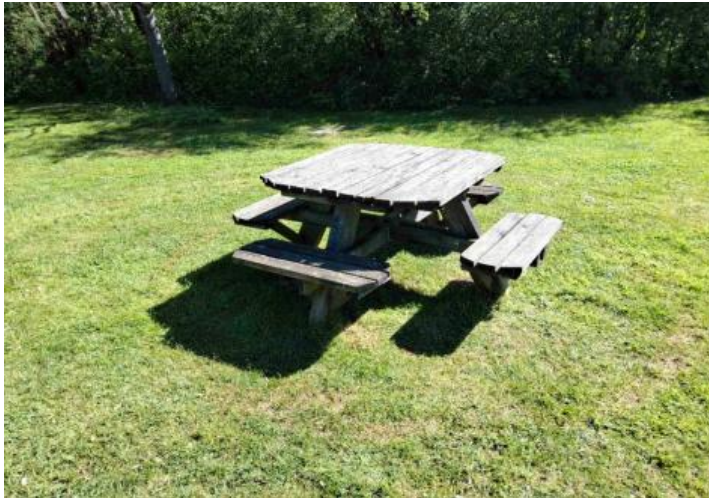
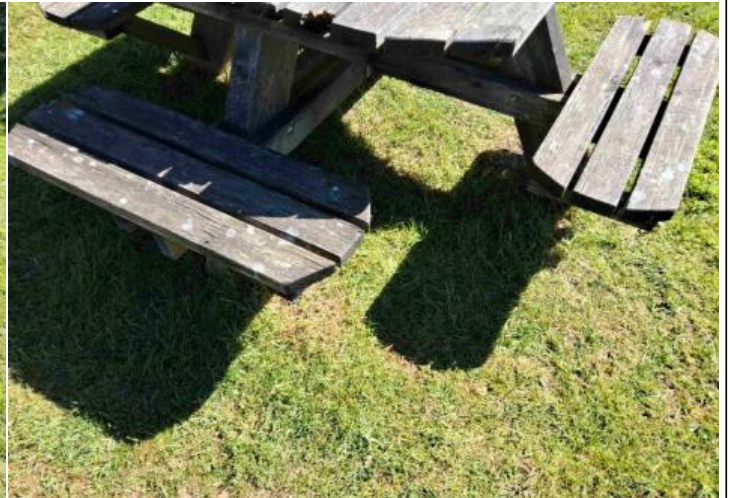
Item: Ancillary Items - Picnic Table
Manufacturer: Not Identified

Finding: The table/s is/are not secured to the ground and there is some potential for the item/s to be moved within falling spaces of equipment

Action: Secure to the ground

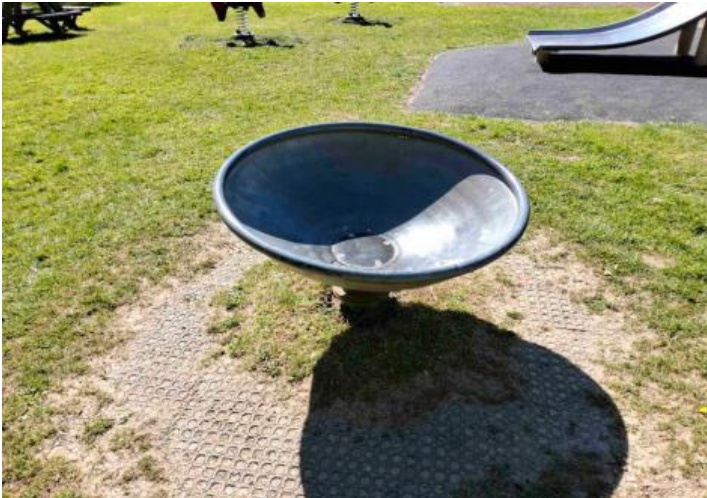
Item: Rotor Play - Dish Roundabout
Manufacturer: Sutcliffe Play Limited

Finding: There is surface corrosion / rust present on the item

Action: Consider treating the item

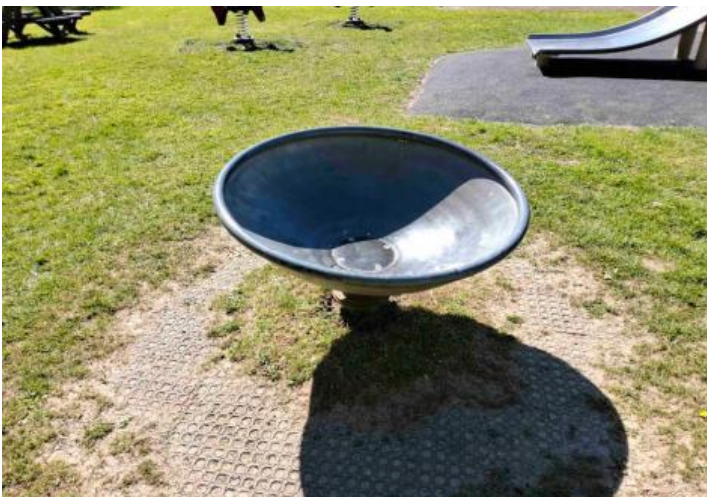
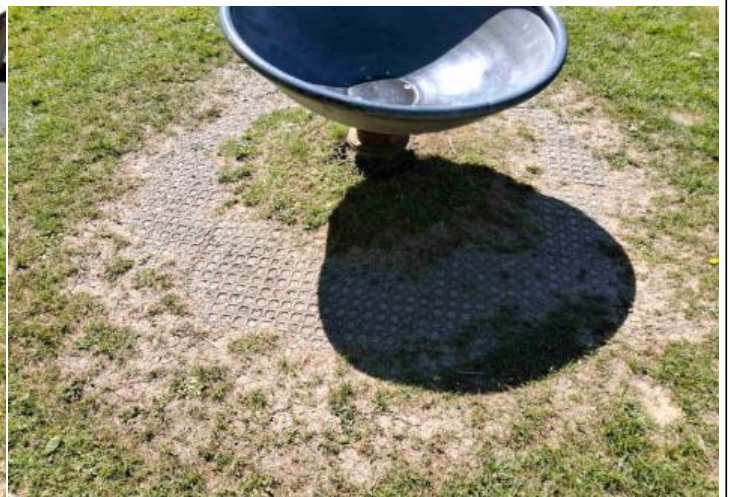
Item: Rotor Play - Dish Roundabout
Manufacturer: Sutcliffe Play Limited

Finding: The grass mats are silted up, the soil is compacted and the area will become very slippery when the soil is wet.

Action: Reinstate as required

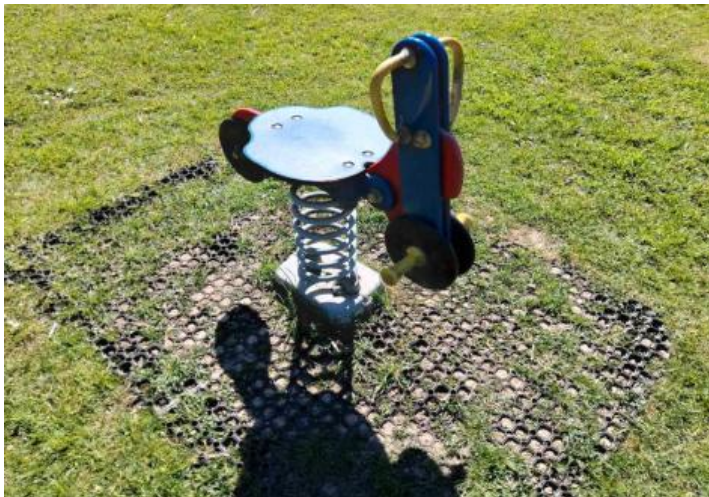
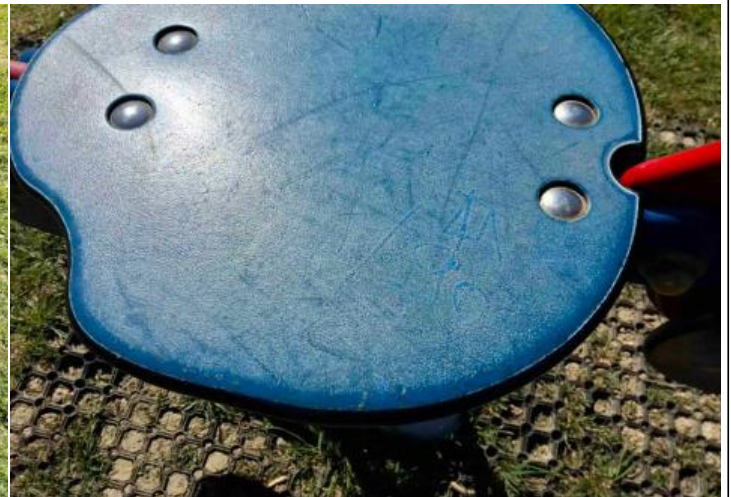
Item: Rocking Equipment - Spring Motorbike
Manufacturer: Ledon

Finding: There is some graffiti present

Action: Remove the graffiti

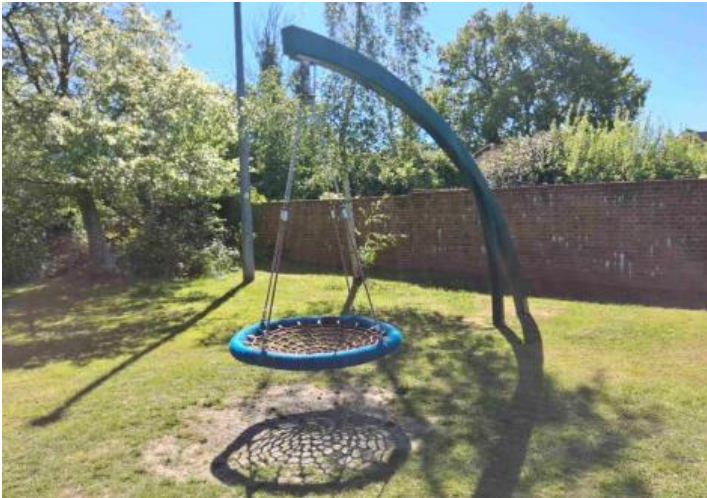
Item: Swings - Cantilever Swing - Type 3
Manufacturer: Not Identified

Finding: There are missing end caps

Action: Replace

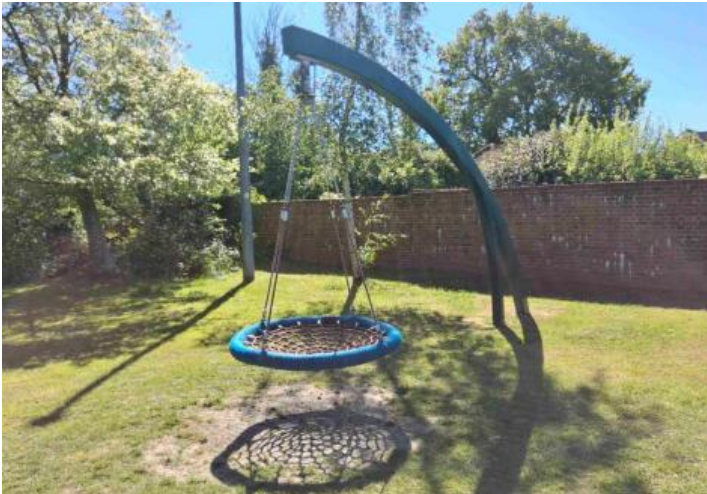
Finding: There is some wear to the shackles.

Action: Monitor for any further deterioration and replace when 40% worn

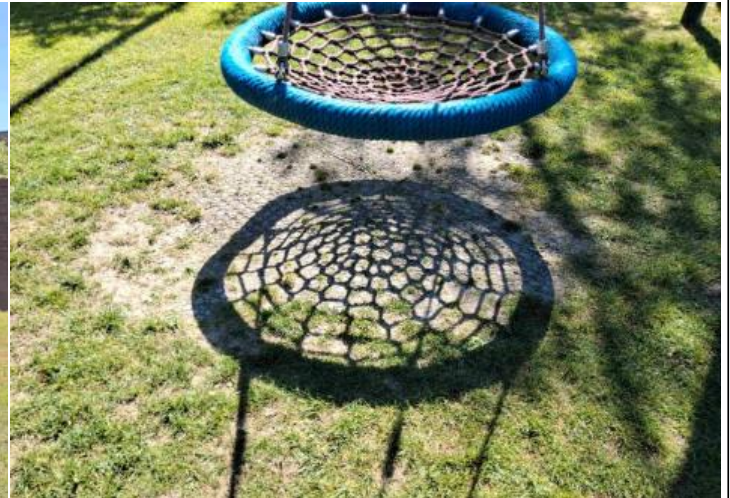
Finding: The grass mats are silted up and the soil is compacted; this may have an effect on the impact absorbing properties of the surface. Consideration should be given to HIC testing the surface to verify impact attenuating properties (<https://playinspections.co.uk/inspection-services/safety-surface-testing/>)

Action: Contact our office for a quotation for this service

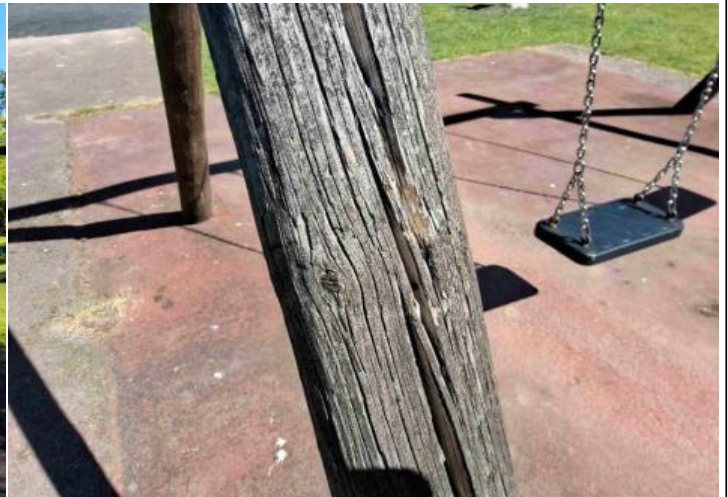
Finding: Parts of the timber are rough or splintered

Action: Remove all rough or sharp edges

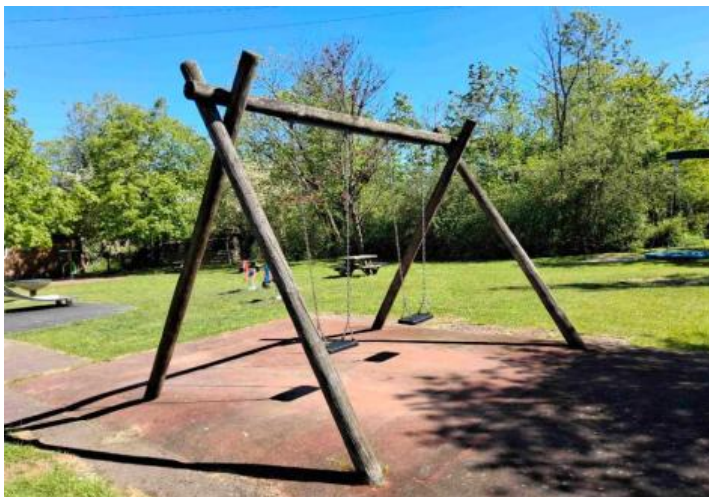
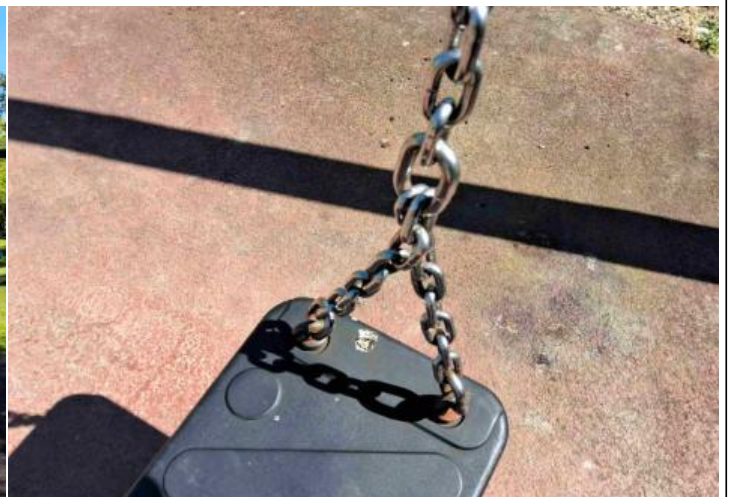
Finding: There is bird excrement on site

Action: Clean and maintain area

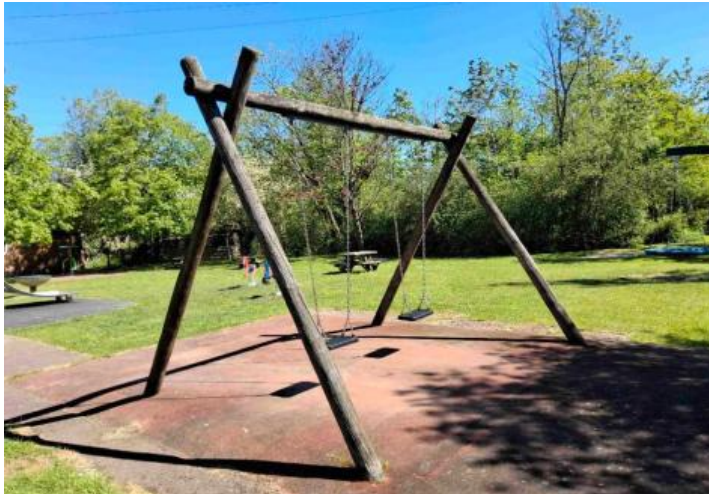
Finding: There is some notable evidence of chain wear

Action: Monitor for any further deterioration and replace when 40% worn

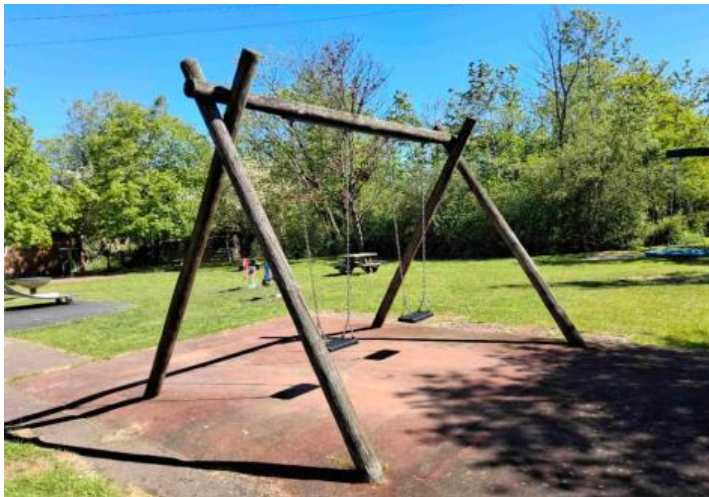
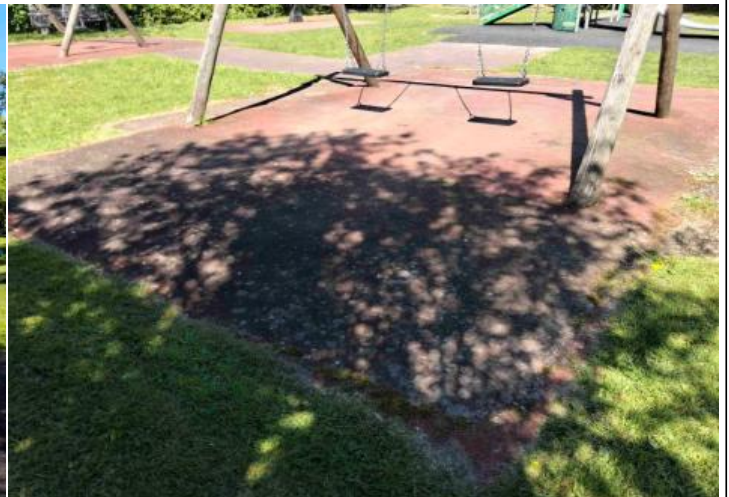
Finding: There is weed / vegetation growth within the surface

Action: Remove weed / vegetation growth

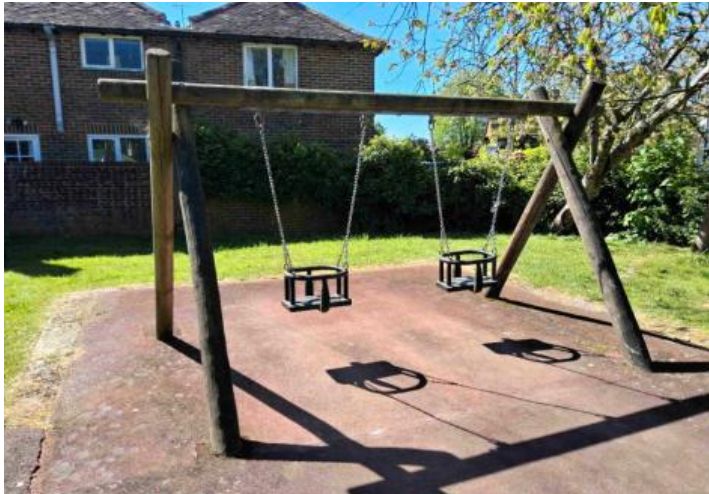
Finding: There is some notable evidence of chain wear

Action: Monitor for any further deterioration and replace when 40% worn

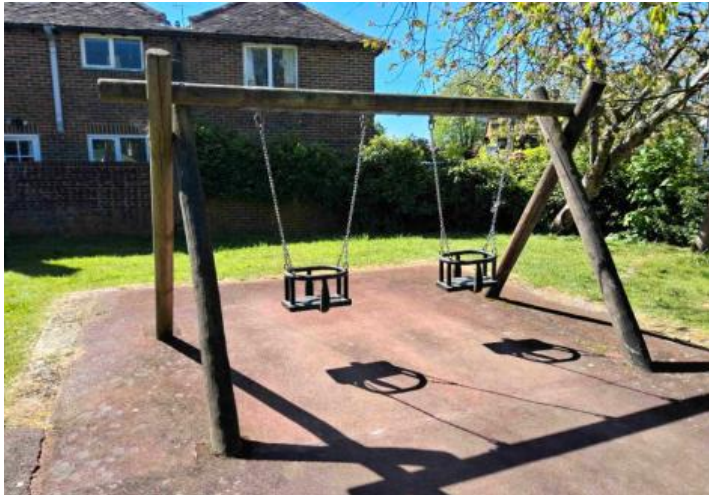
Finding: There is some wear to the connecting links

Action: Monitor for any further deterioration and replace when 40% worn

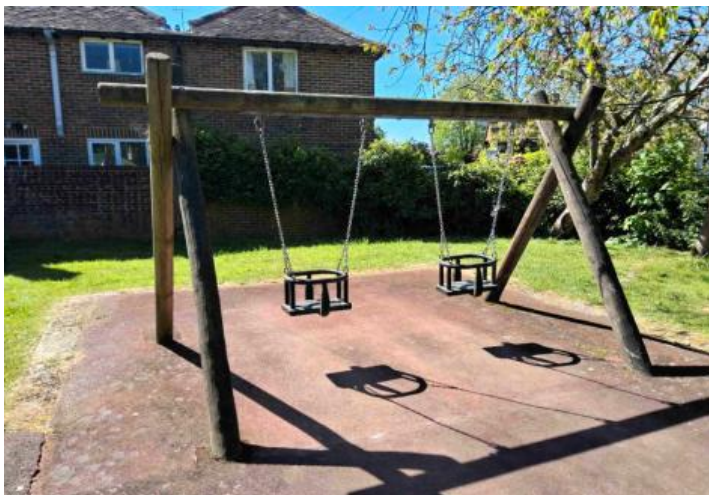
Finding: The bush / bushes is / are showing signs of wear

Action: Monitor for any further deterioration and replace as required

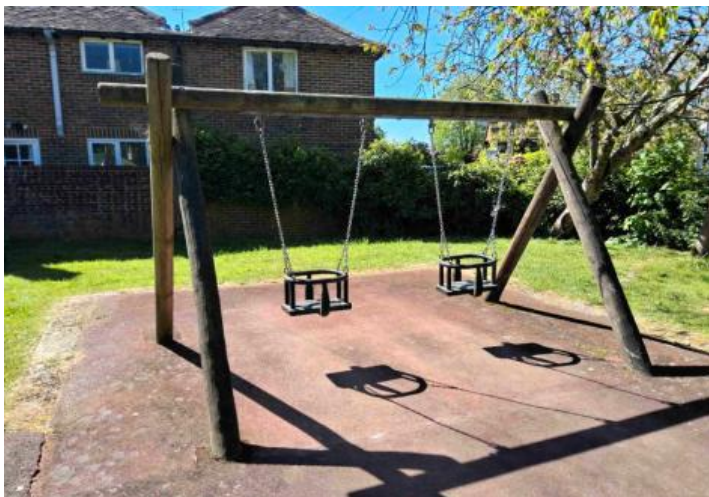
Finding: The timber stain is in poor condition

Action: Prepare all affected parts and re-stain with an appropriate preservative

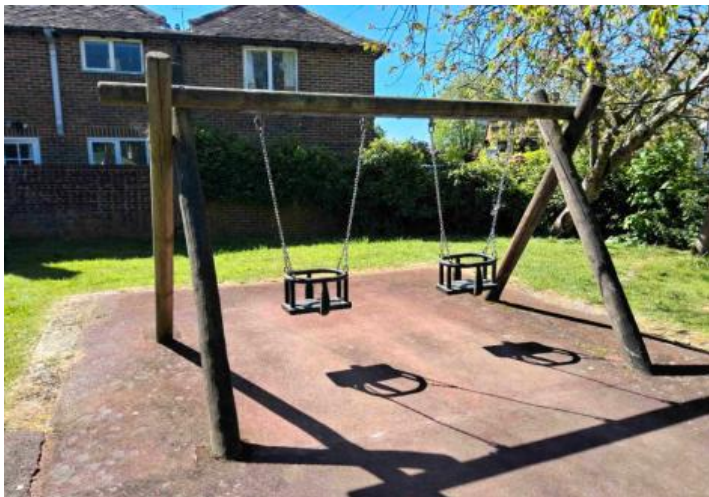
Finding: The timber has a number of splits/shakes or air cracks and this may affect the stability or allow water ingress which will accelerate the rotting process. Timber splits may also create rough / splintering edges.

Action: Monitor, sand down any rough edges and ensure the splits do not cross through fixing points of the structure and/or cause any instability

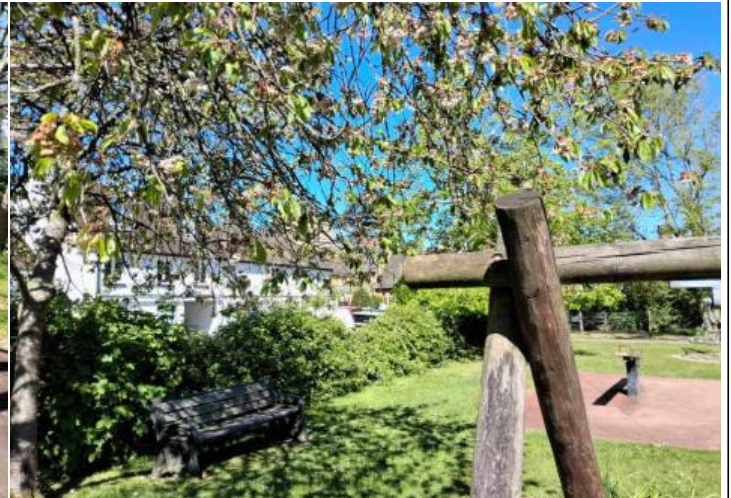
Finding: The tree canopy overhangs the equipment and is less than 2.0m away

Action: Lift tree canopy to ensure a minimum clearance of 2.0m from the equipment

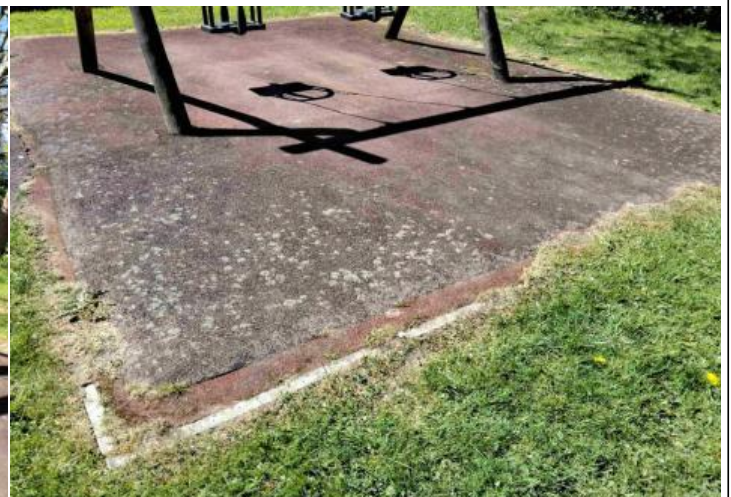
Finding: There is weed / vegetation growth within the surface

Action: Remove weed / vegetation growth

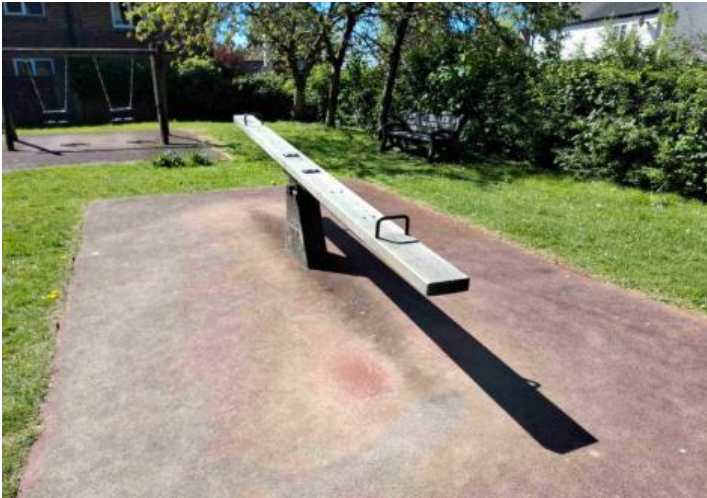
Finding: There is some play within the pivot mechanism

Action: Monitor for any further deterioration and repair as required

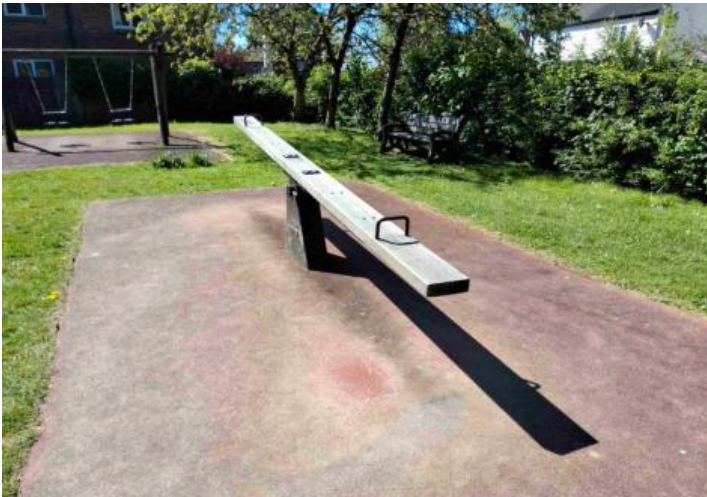
Finding: The paintwork on this item has been damaged or worn exposing the metal underneath which is rusting / corroding

Action: Treat affected areas and repaint

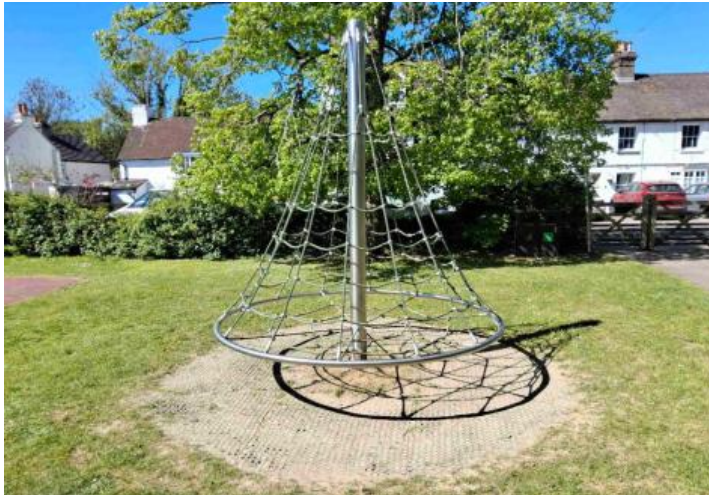
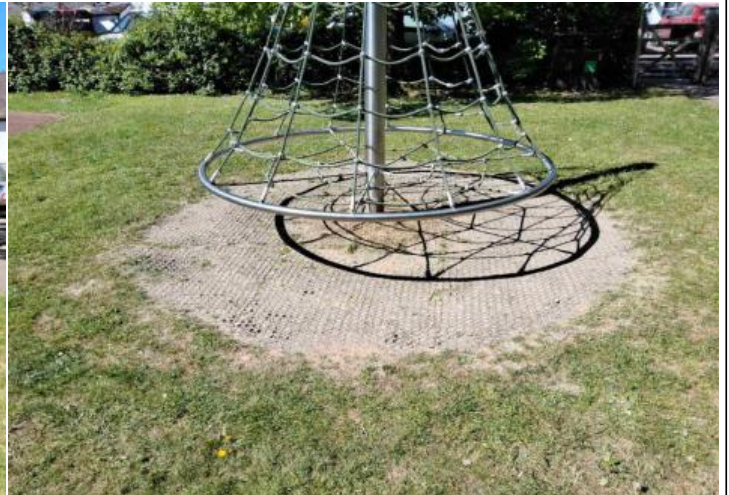
Finding: The grass mats are silted up and the soil is compacted; this may have an effect on the impact absorbing properties of the surface. Consideration should be given to HIC testing the surface to verify impact attenuating properties (<https://playinspections.co.uk/inspection-services/safety-surface-testing/>)

Action: Contact our office for a quotation for this service

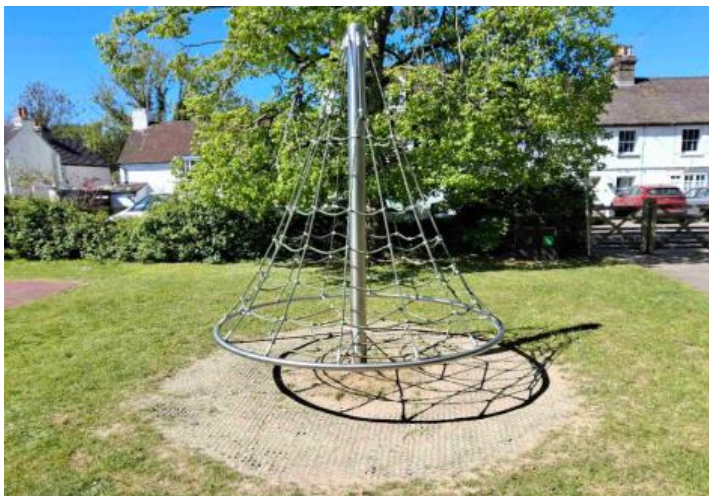
Finding: The grass mat surface is notably uneven in places and may cause users to trip or roll ankles

Action: Level the surface if possible and infill any voids

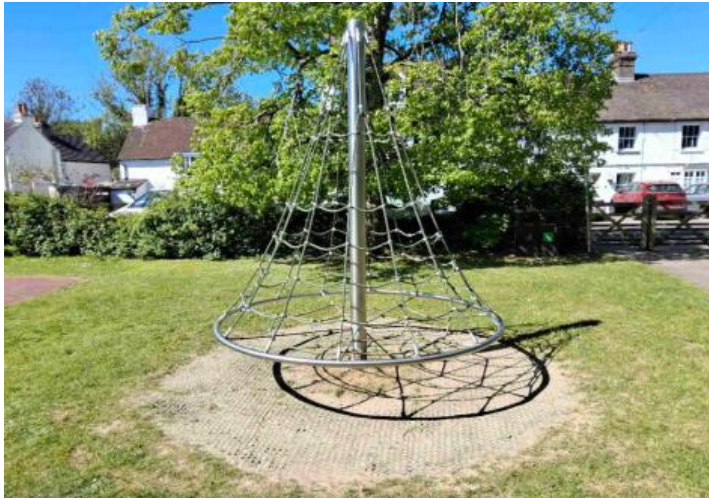
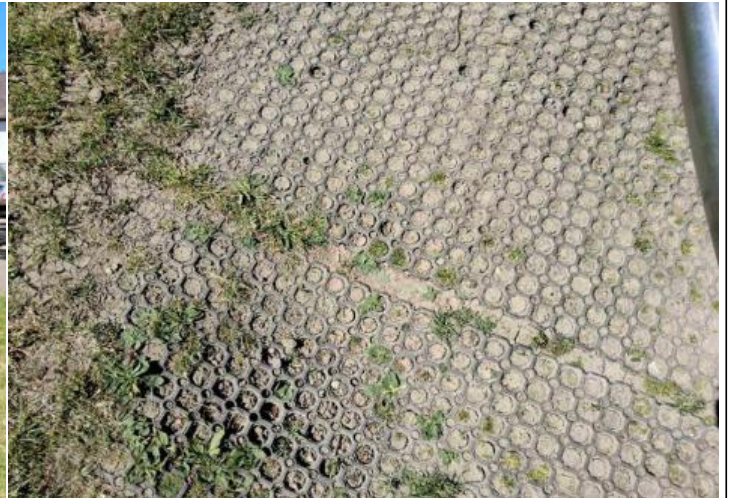
Finding: There are gaps opening between the grass mat tiles

Action: Provide additional ties or secure / reinstate surface tiles

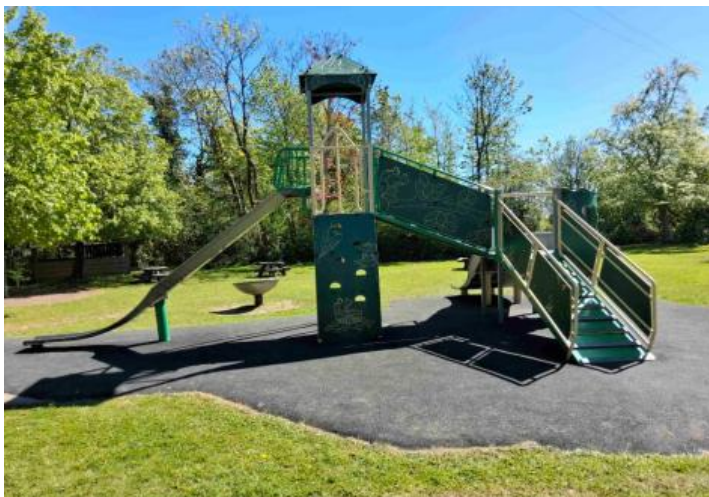
Finding: Insert/s missing or damaged

Action: Replace
